MASSACHUSETTS HIGHWAY DEPARTMENT
STRUCTURES INSPECTION FIELD REPORT

ROUTINE INSPECTION

BR. DEPT. NO. E-07-004

CITY/TOWN EDGARTOWN	8-STRUCTURE NO. E07004-43B-MUN-NBI	11-Kilo. POINT 001.046	41-STATUS A:OPEN	90-ROUTINE INSP. DATE SEP 16, 2003
07-FACILITY CARRIED HWY DIKE RD	MEMORIAL NAME/LOCAL NAME	27-YR BUILT 1995	106-YR REBUILT 0000	YR REHAB'D (NON 106) 0000
06-FEATURES INTERSECTED WATER POUCHA POND	26-FUNCTIONAL CLASS Rural Local	DIST. BRIDGE INSPECTION ENGINEER D. A. Palmer		
43-STRUCTURE TYPE Timber Stringer/Girder	22-OWNER Town Agency	21-MAINTAINER Town Agency	TEAM LEADER T. J. McKenna	
107-DECK TYPE Timber	WEATHER sunny	TEMP. (air) 70°C	TEAM MEMBERS S. R. WARN

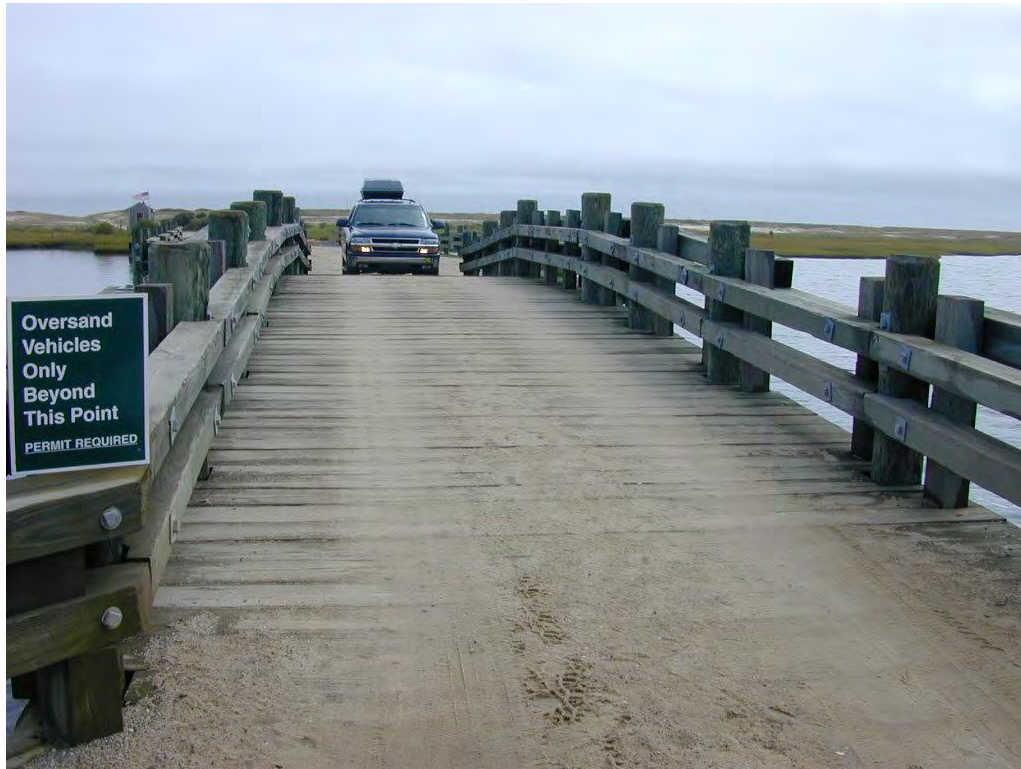
Deck is made up of single ply timber, the top of the deck planks are covered with sand, and starting to wear, see photo #1.

Photo 1: Build up of sand on wearing surface, minor settlement and rutting at both approaches

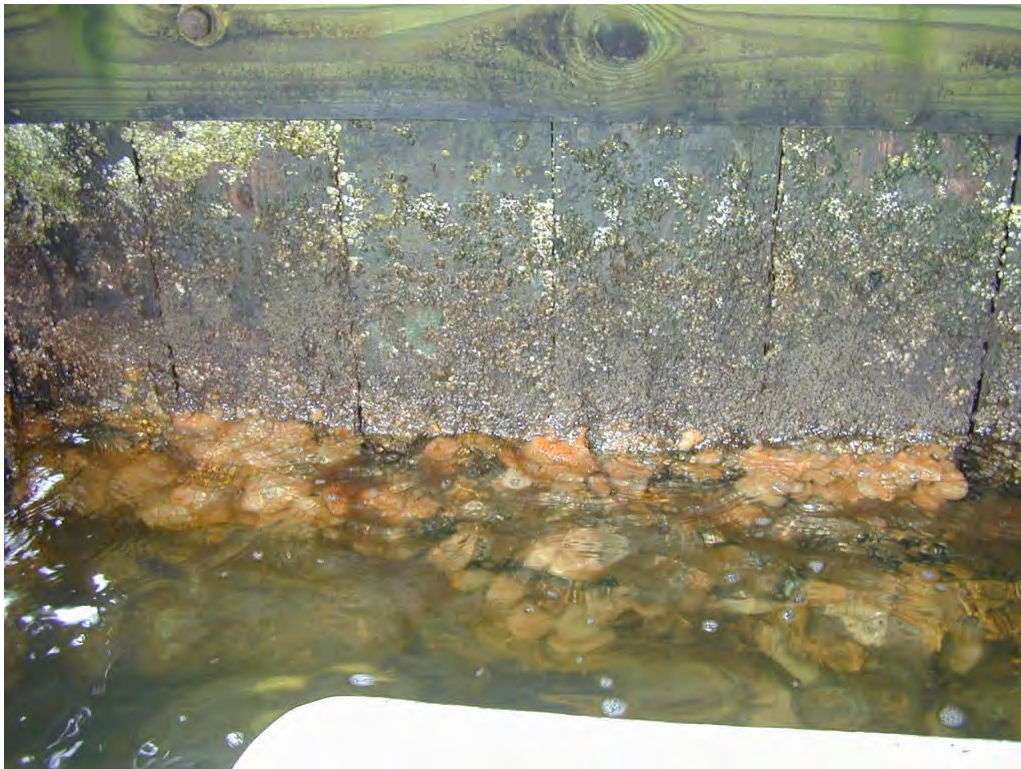
Photo 2: Build up of marine growth along both breastwalls

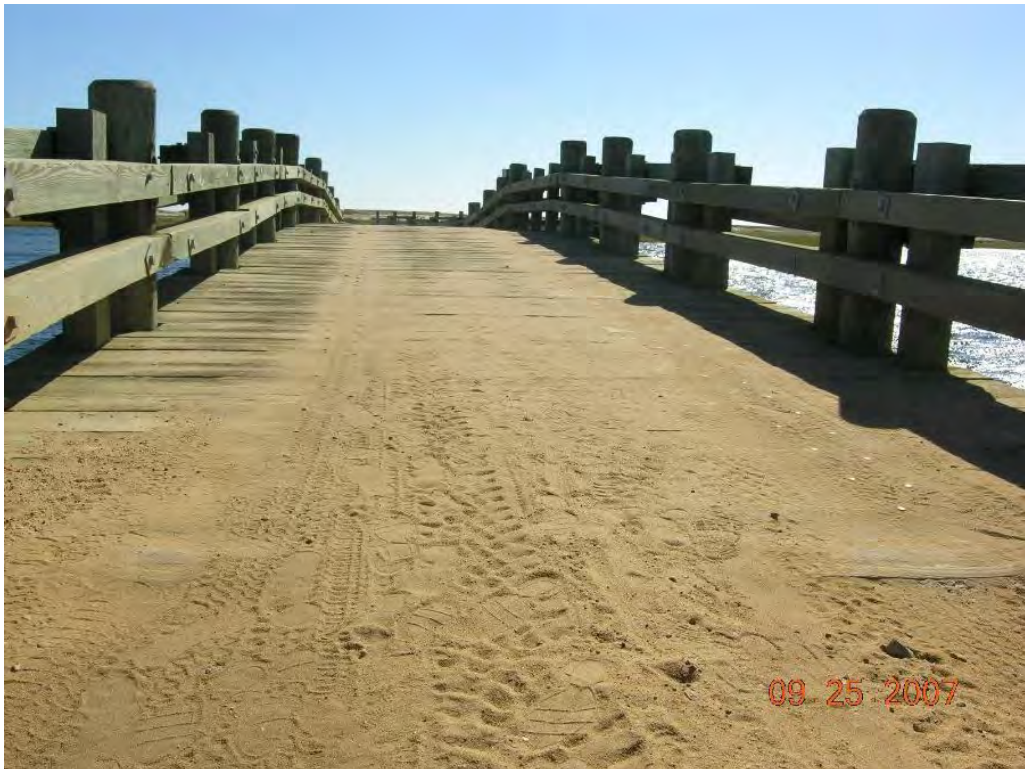
Photo 4: Wearing surface

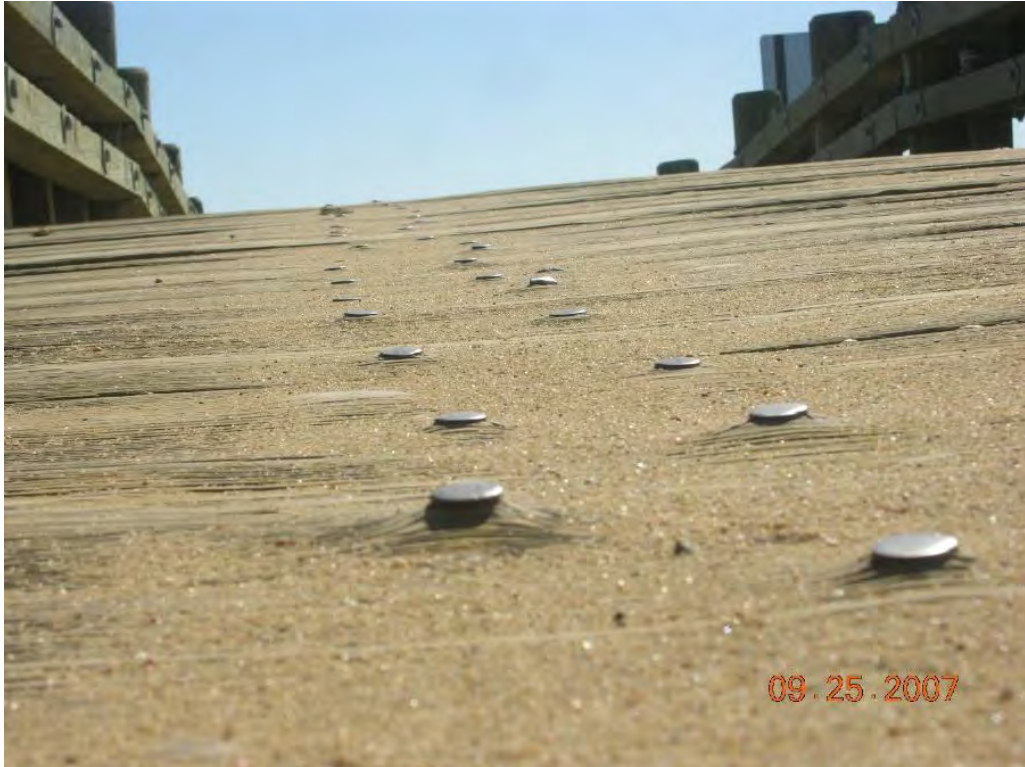
Photo 5: Wheel path wear

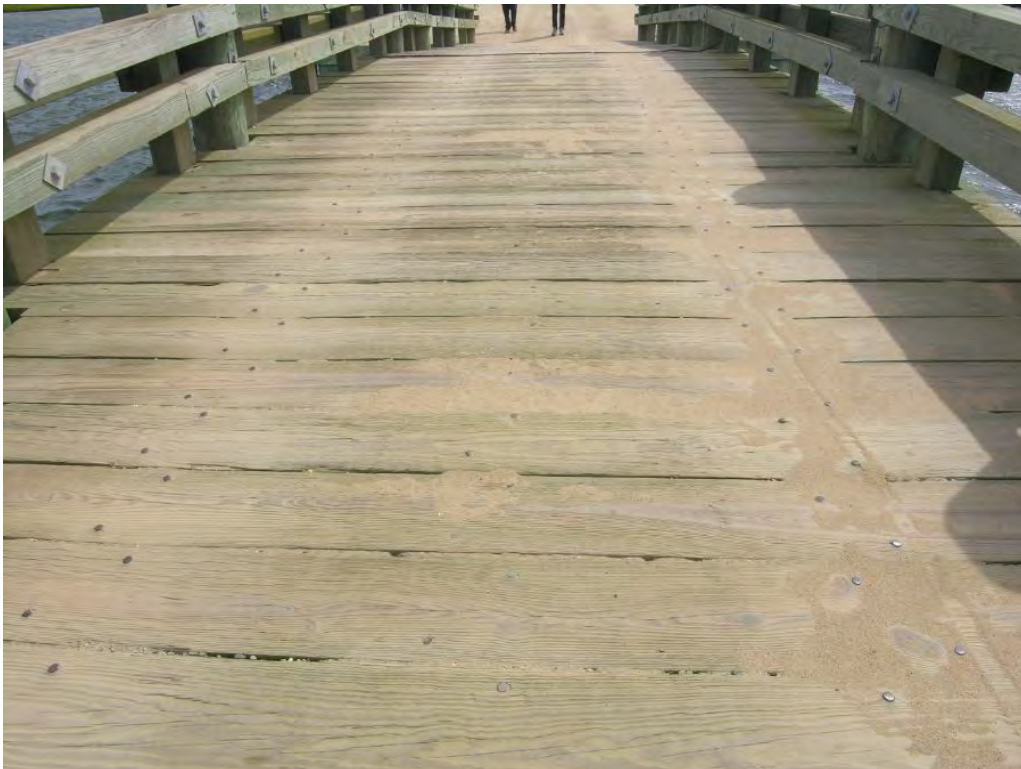
Photo 4: Timber wearing surface abrasion.

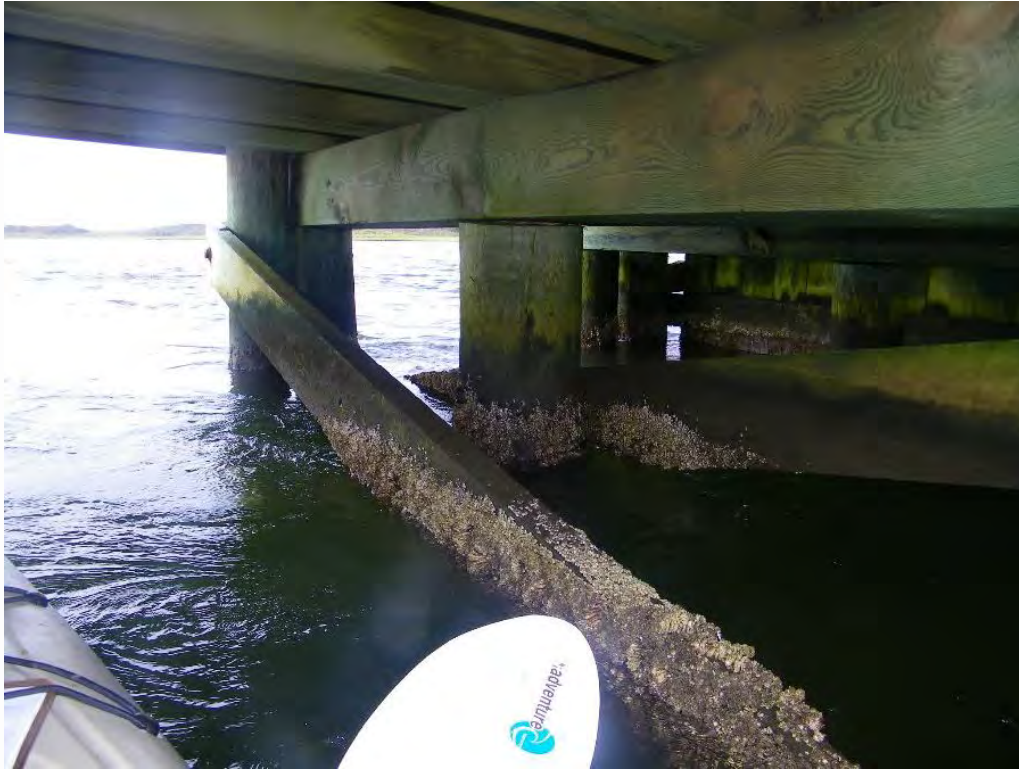
Photo 7: Pile/bent #2, east diagonal marine growth.

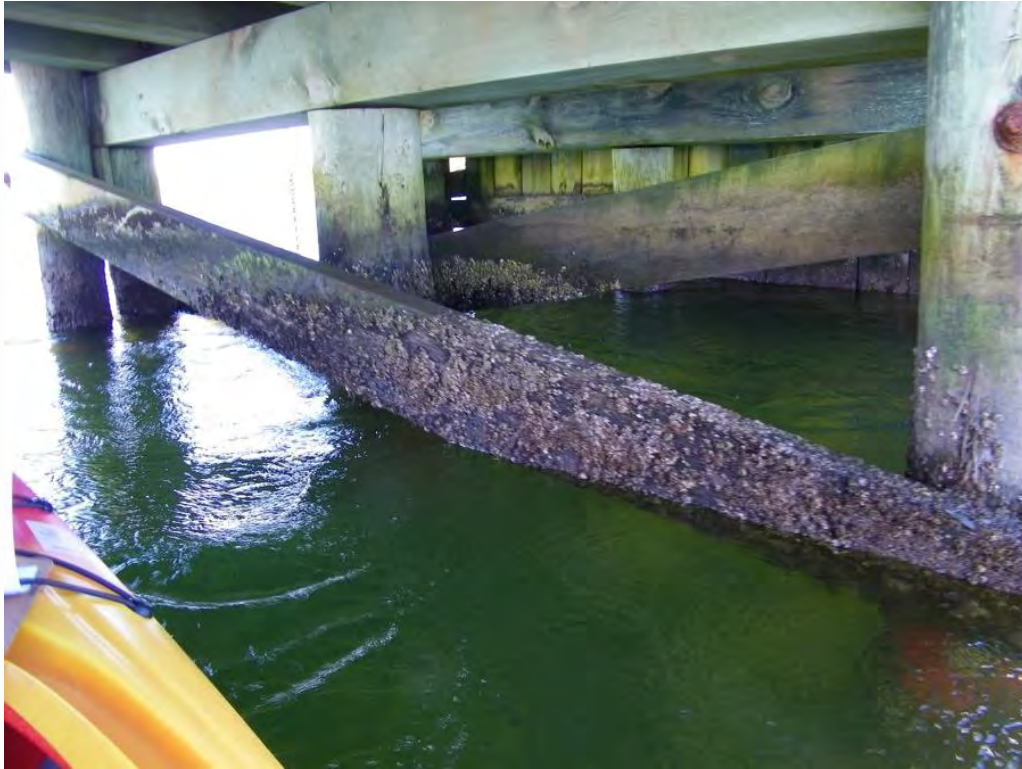
Photo 7: View pile bent 2, marine growth.

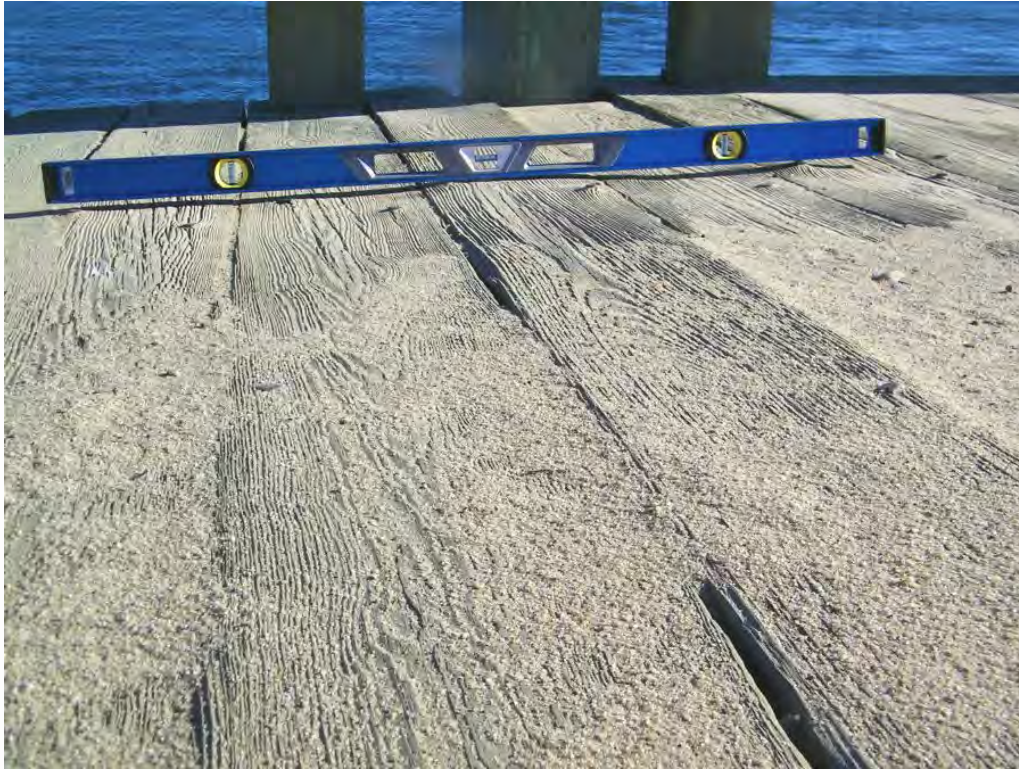
Photo 11: Common 1" spacings between top of nail heads and wheel rutting wear.

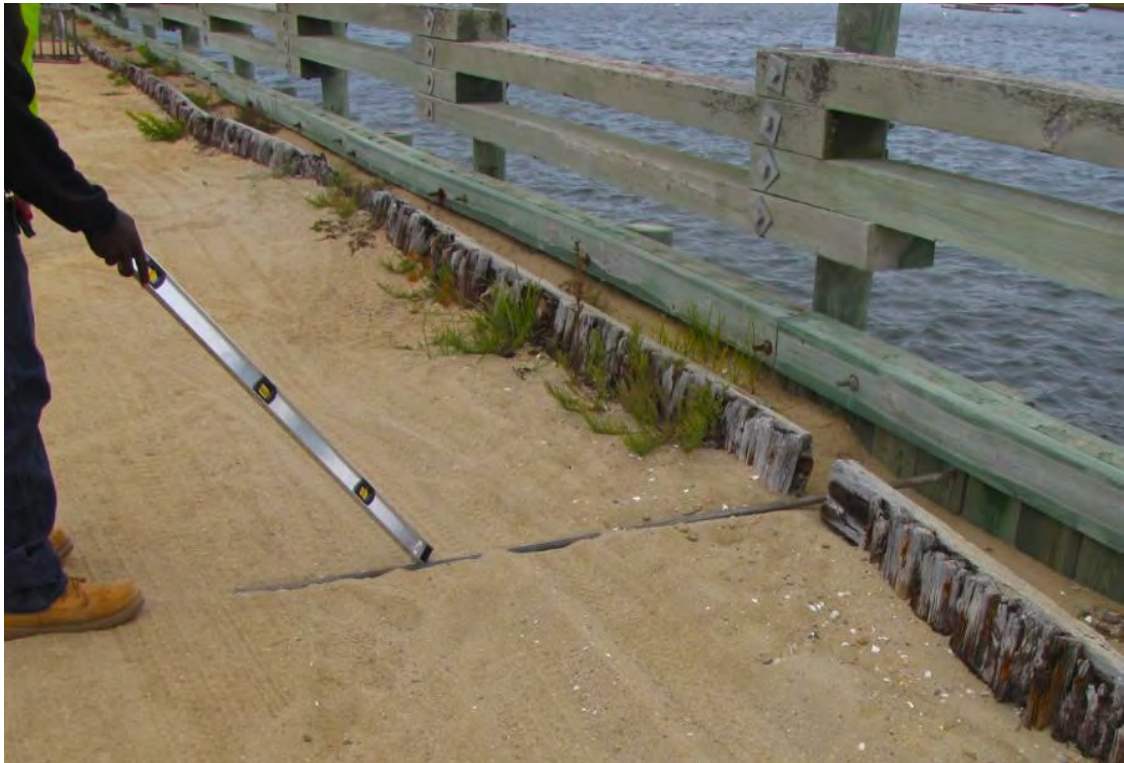
Photo 8: Close up of previous photo. Isolated exposed tie rod

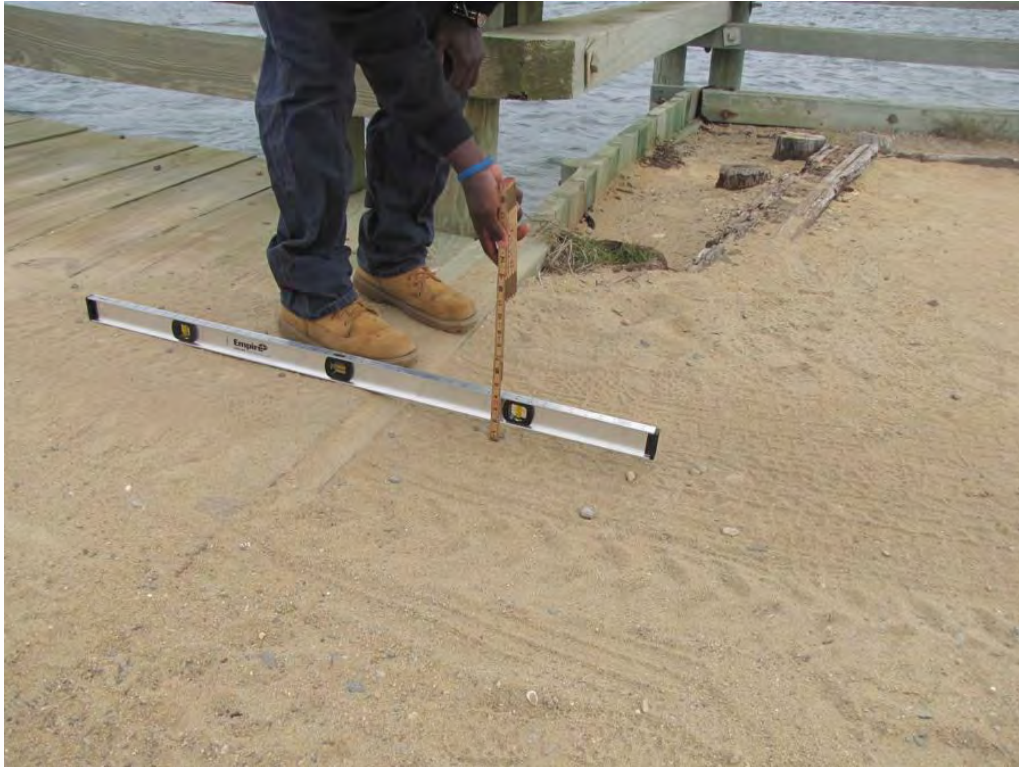
Photo 9: Typical settlement/rutting in wheel path at approach to bridge up 1-1/2"

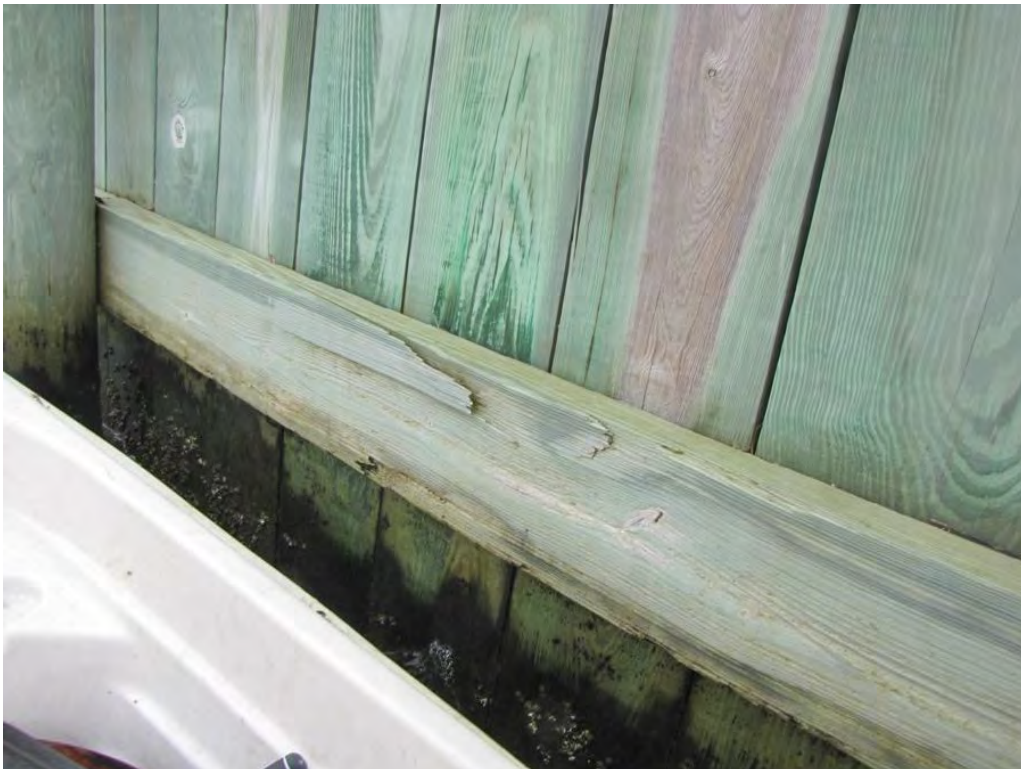
Photo 16: NE wingwall, isolated crack in lower timber

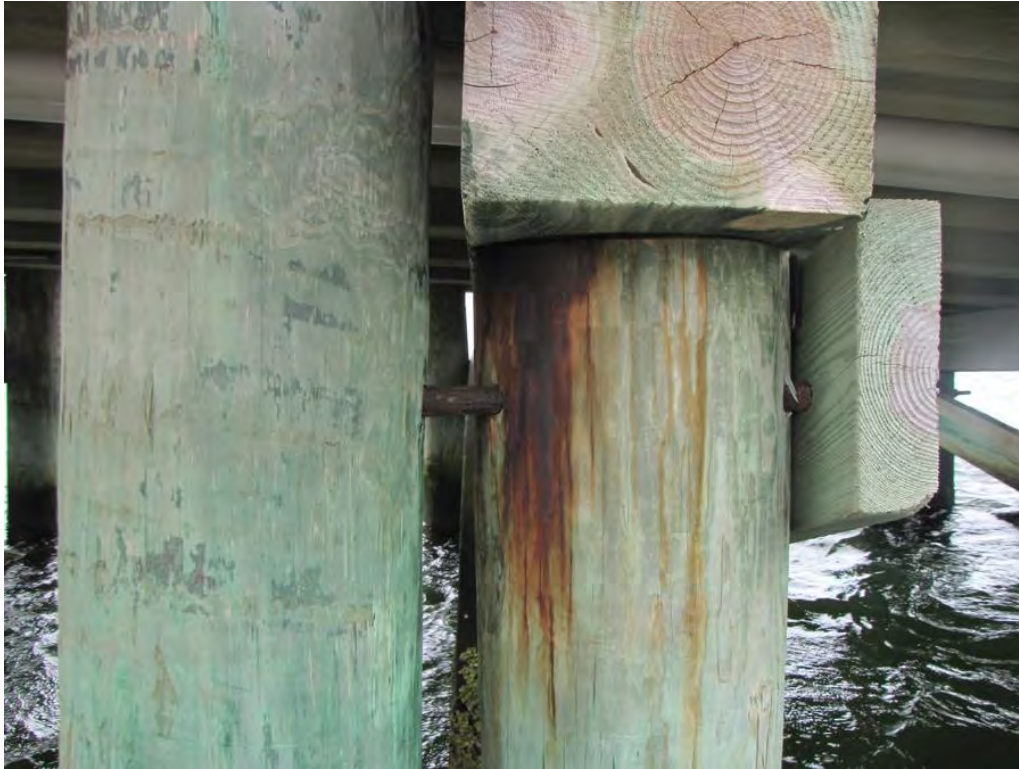
Photo 21: Some bolts showing some corrosion, scale, and start of section loss

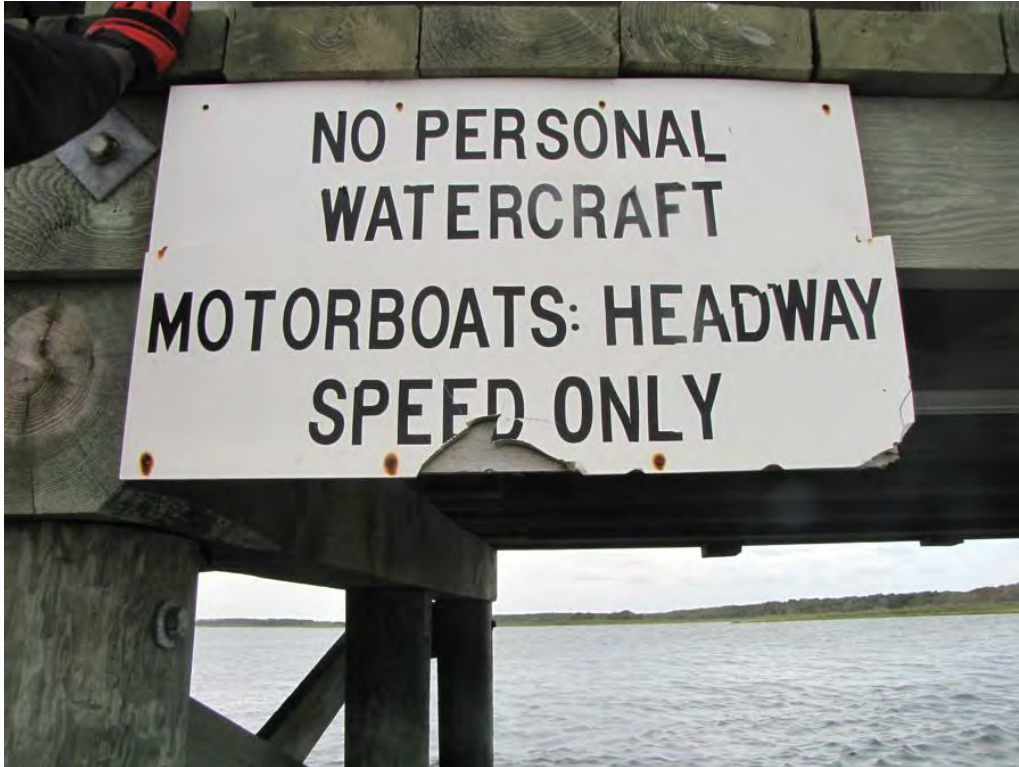
Photo 23: Sign over north face of navigation channel is damaged

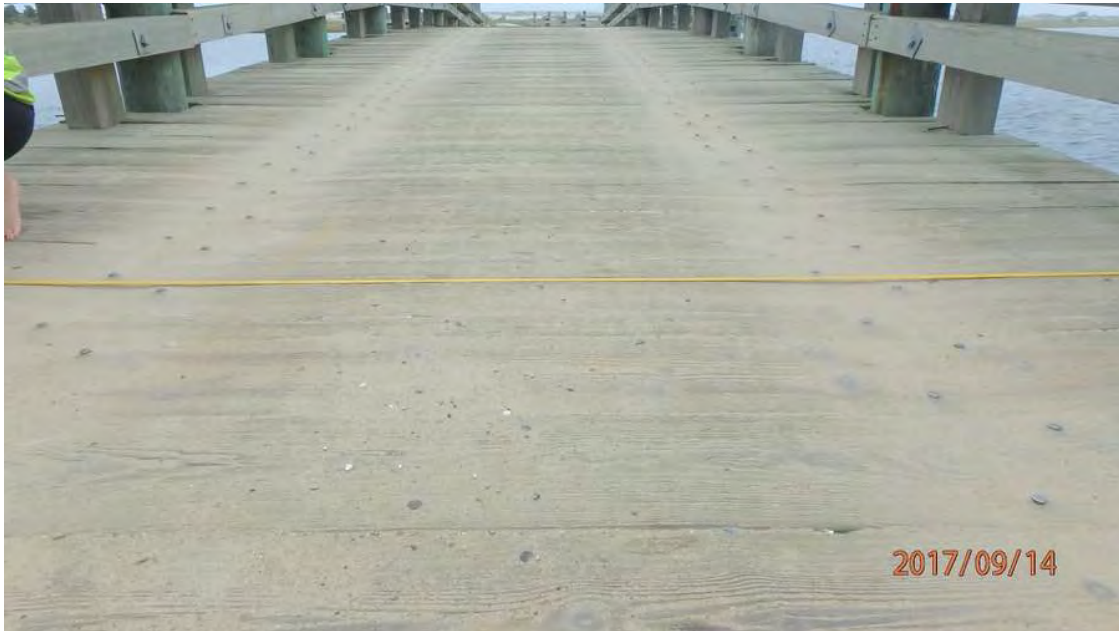
Photo 5: Close up view wearing surface rutting in the wheel path.

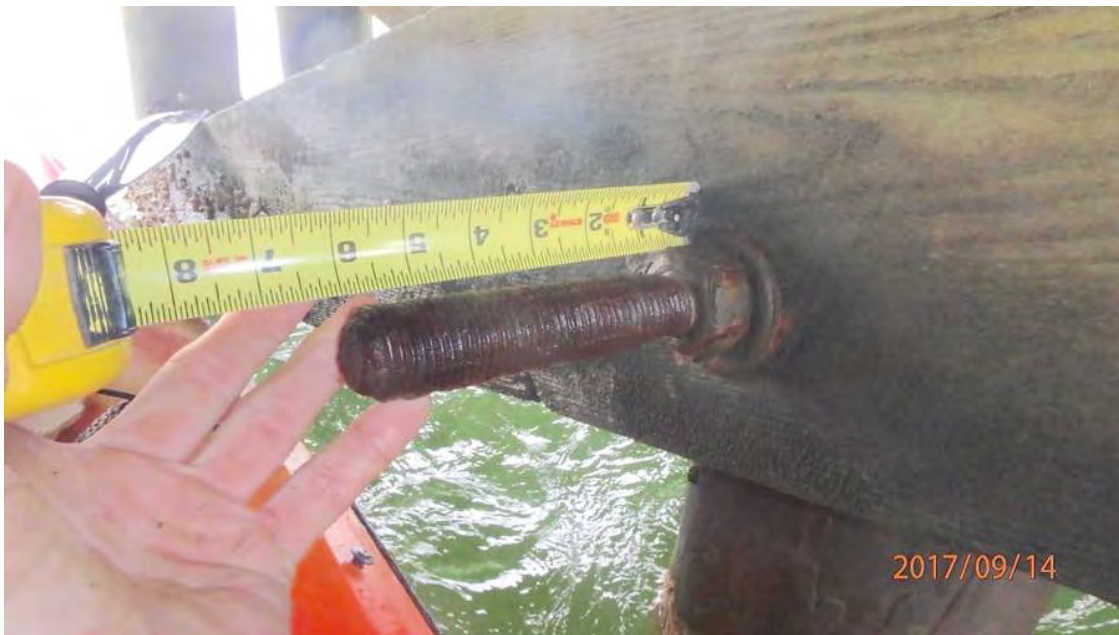
Photo 8: Common rusting fastening hardware conditions in the tidal zone.

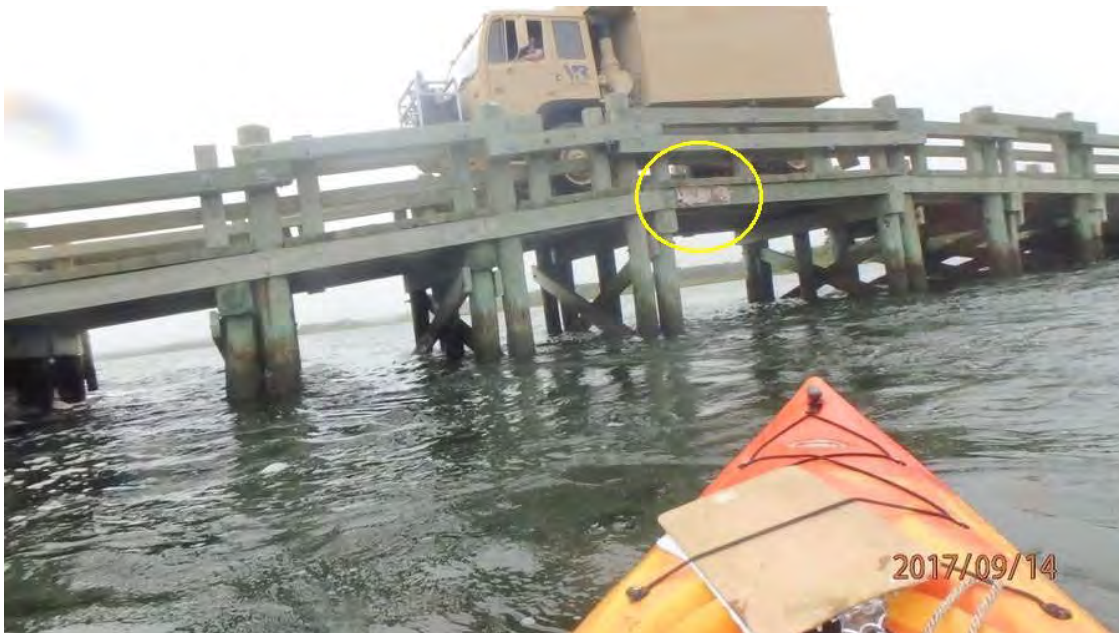
Photo 12: North elevation, channel sign missing, and truck traffic.

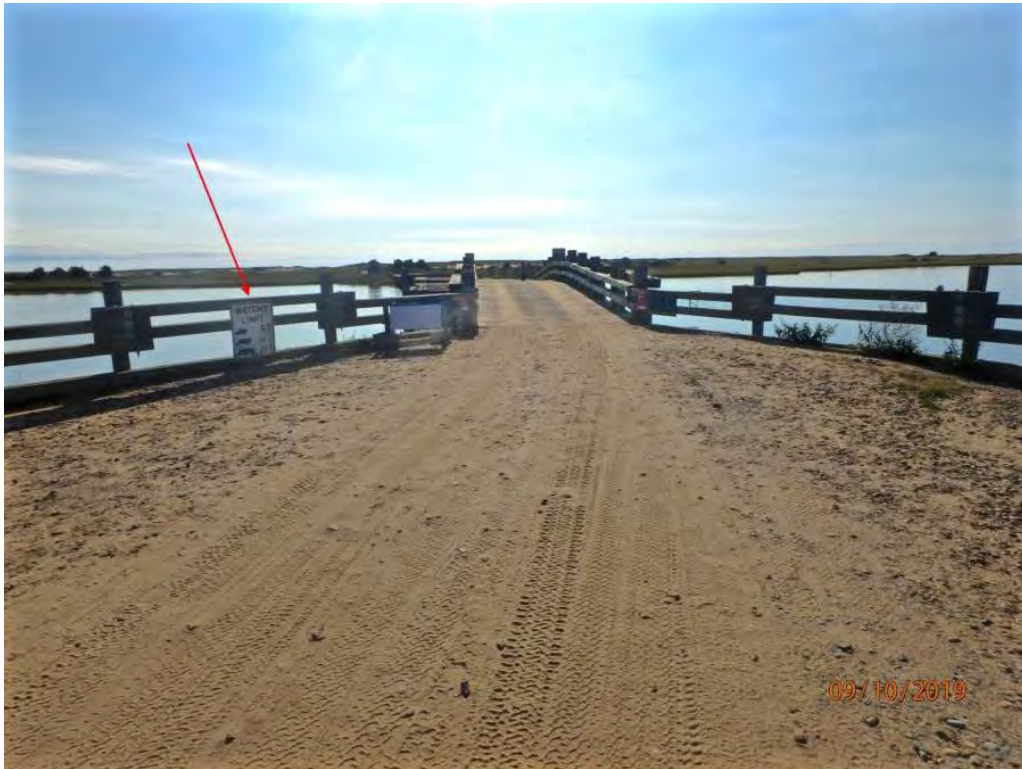
Photo 1: West approach, at-bridge weight posting sign installed at inadequate height

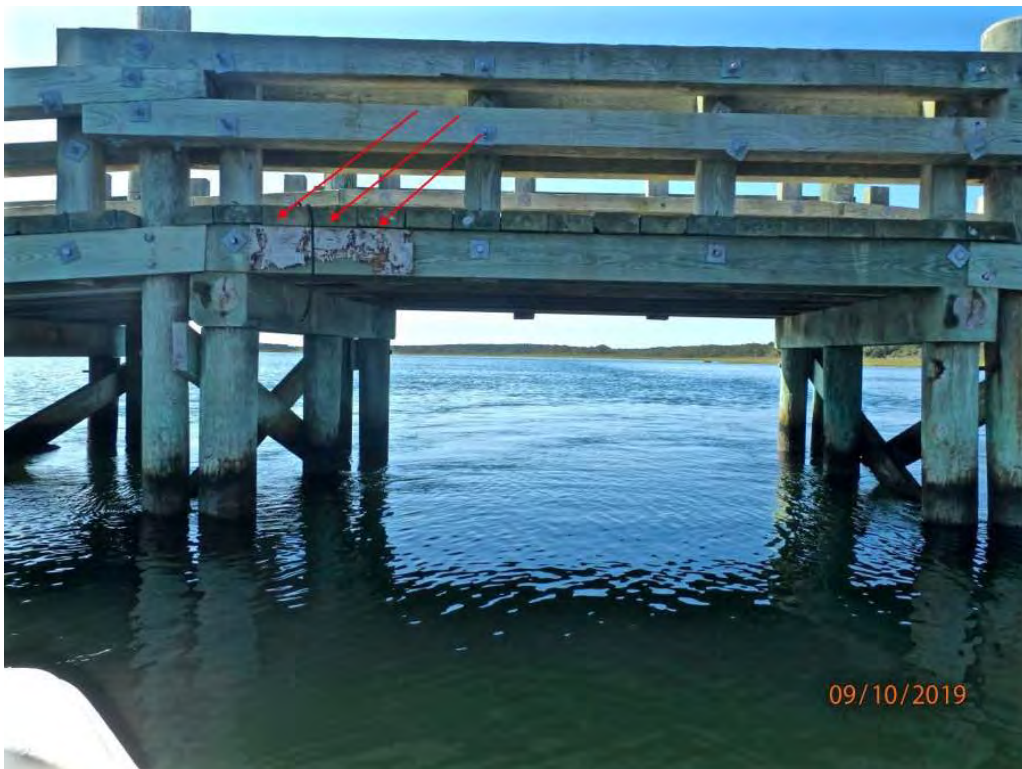
Photo 2: Span 5 north elevation, broken & missing navigation channel indicator sign

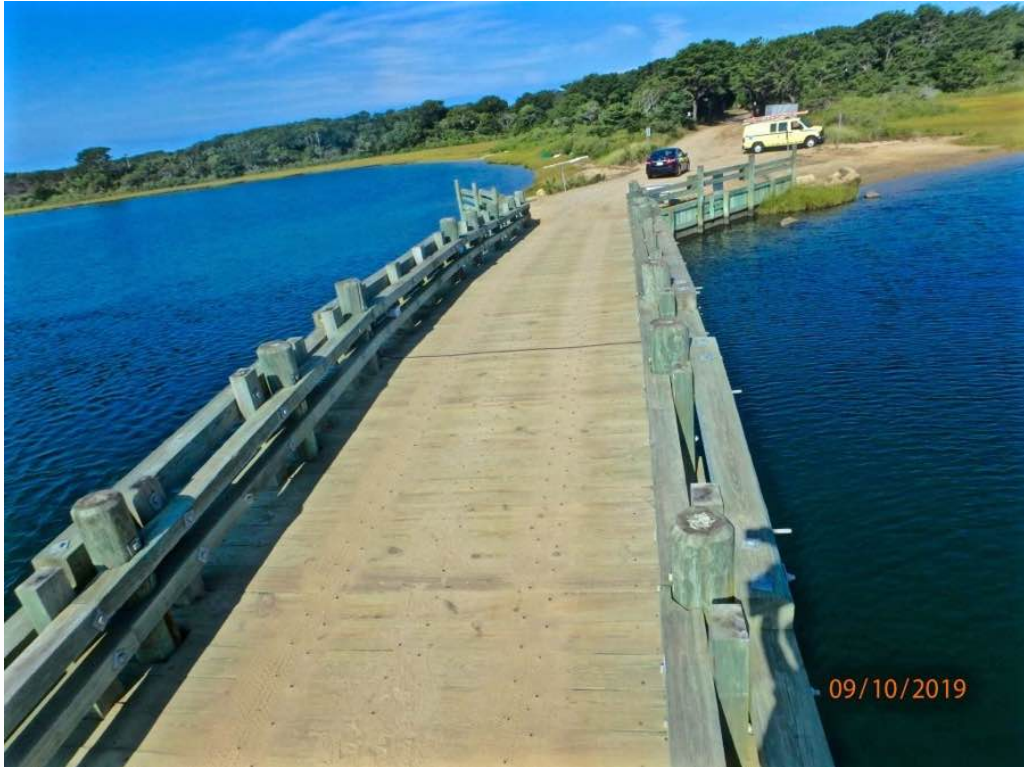
Photo 3: General wearing surface looking west, sand accumulation in abraded wheel paths

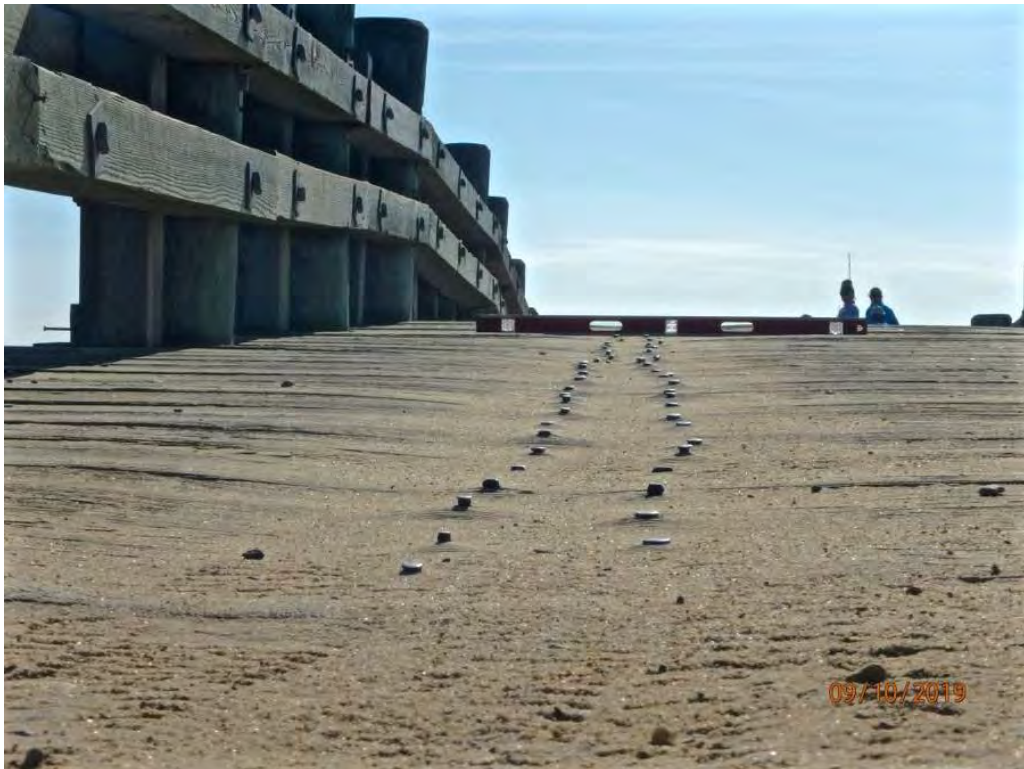
Photo 4: North wheel path looking east (Level @ Bent 4), abraded wheel path w/ sand accumulation & protruding fasteners

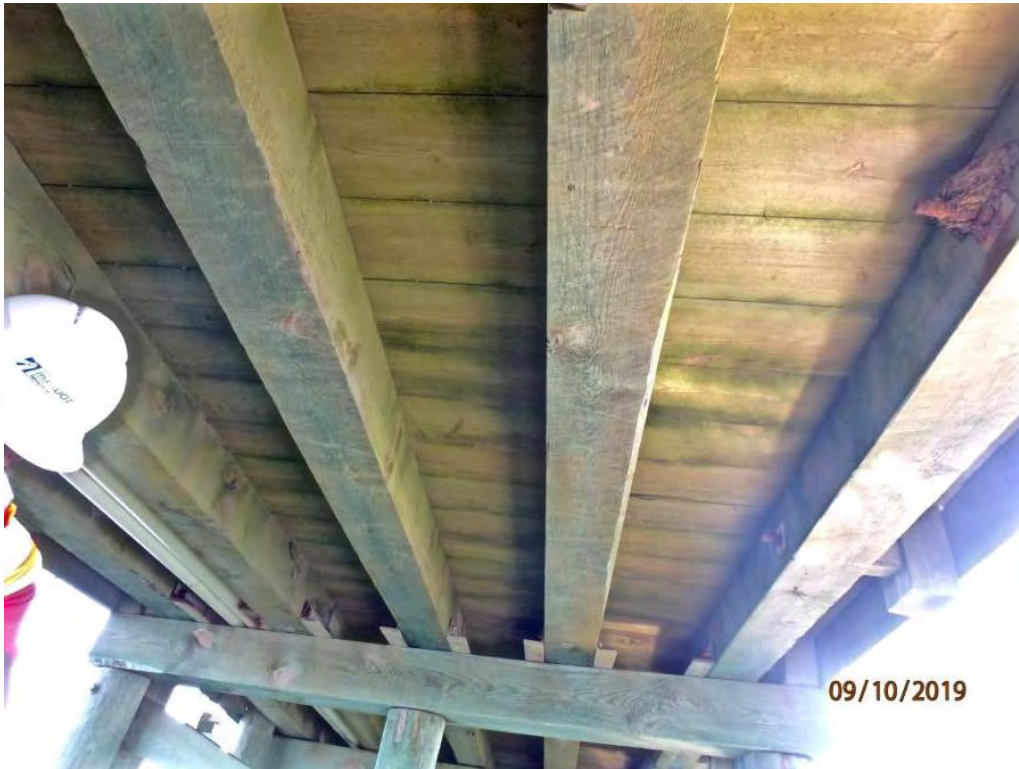
Photo 5: General underside Span 5 looking east, minor mildew staining throughout soffit

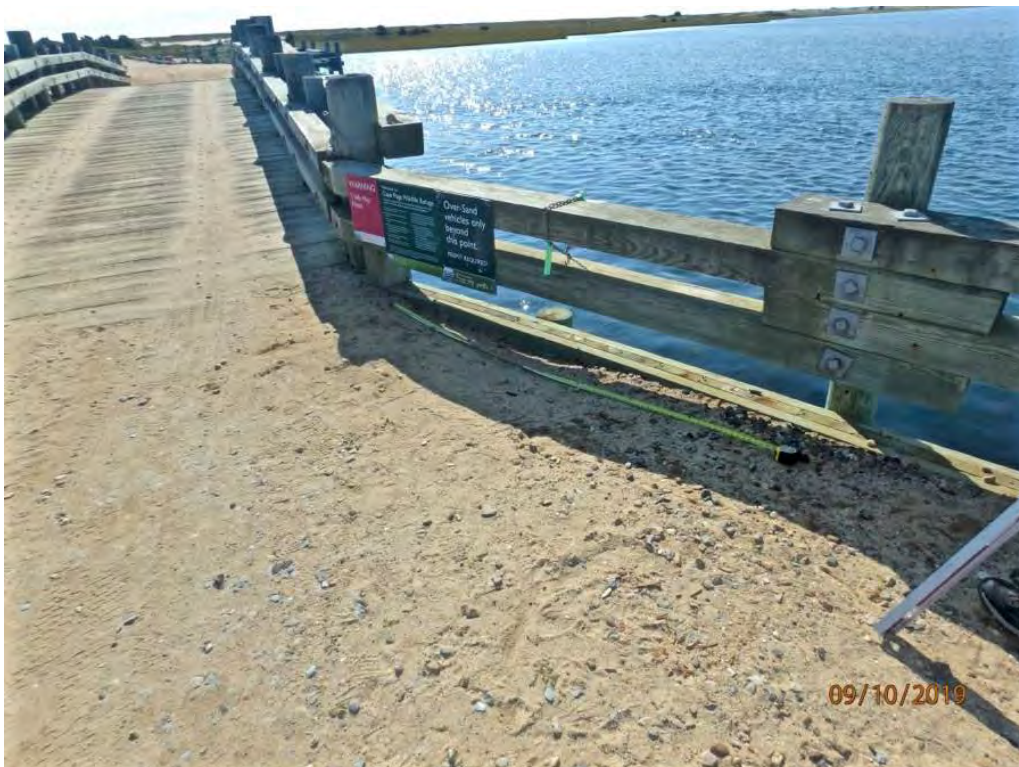
Photo 6: Southwest immediate approach roadway, corrective action taken since last inspection only minor erosion remains

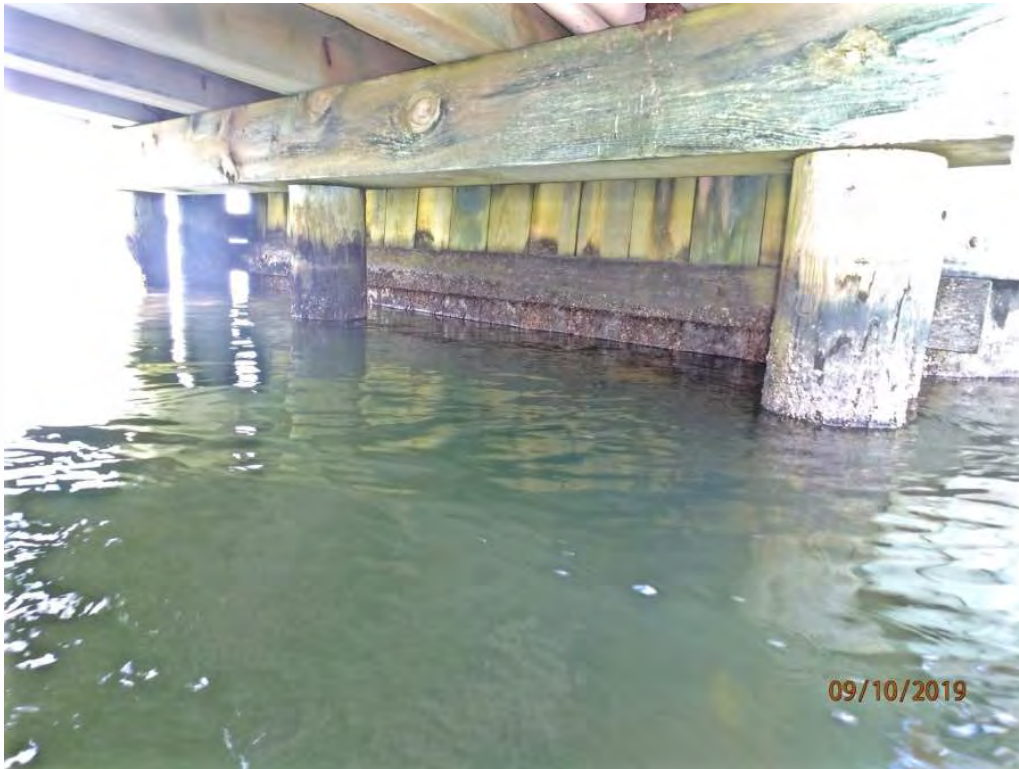
Photo 13: General view of west abutment bent & bulkhead, mildew staining & marine growth throughout

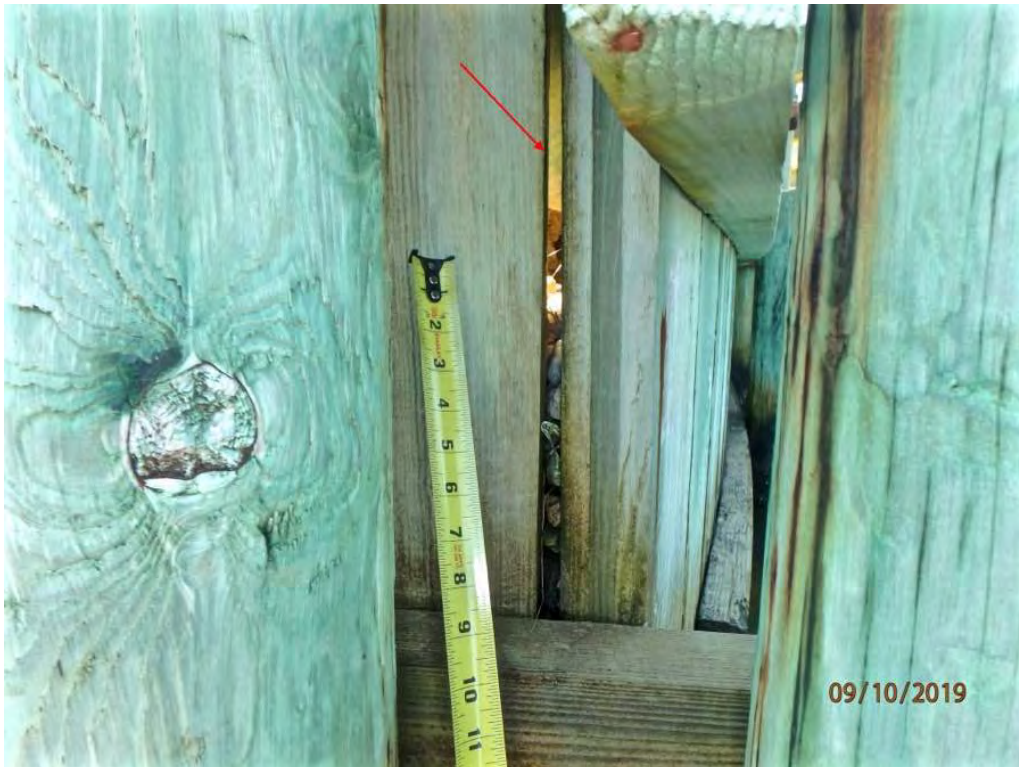
Photo 14: North corner of east abutment bulkhead looking south, bulging/bowing & gap w/ wingwall bulkhead

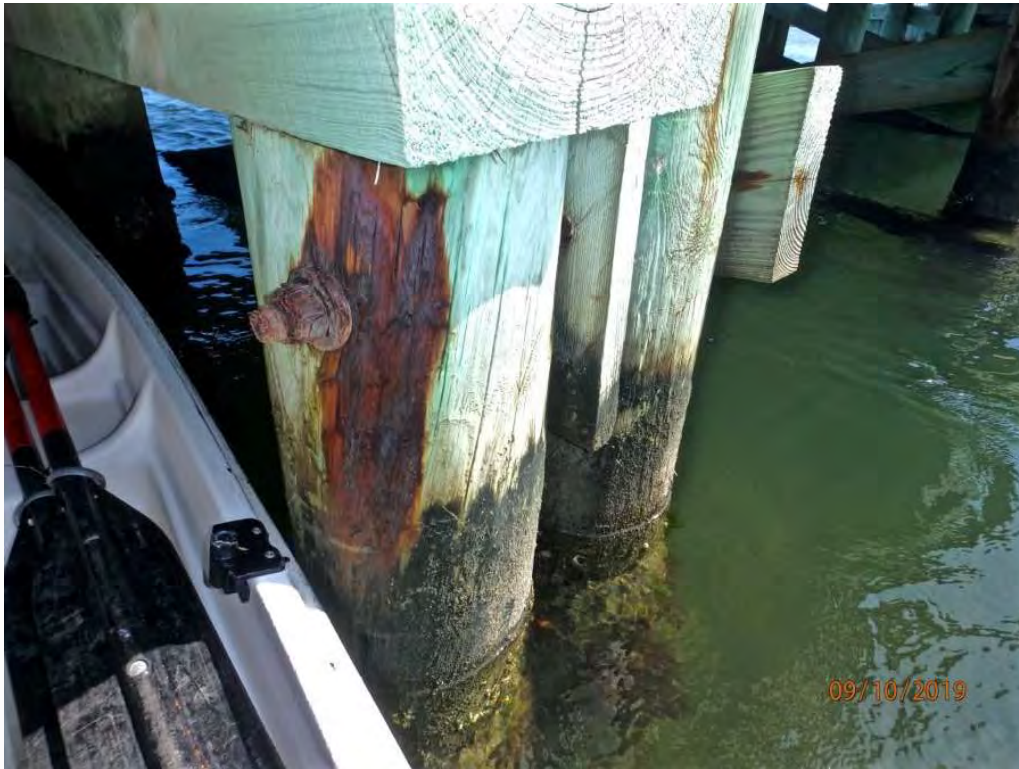
Photo 19: Bent 1 south piles, minor wane w/ rust staining

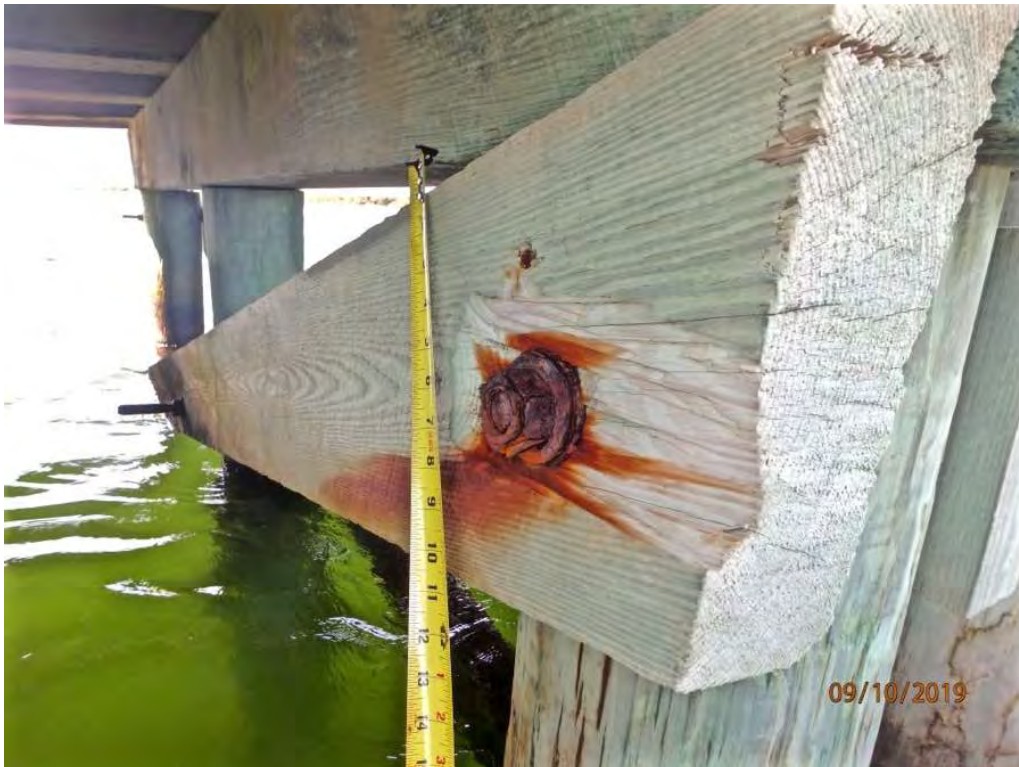
Photo 20: Bent 7 north end of east diagonal bracing, corrosion of fastener hardware

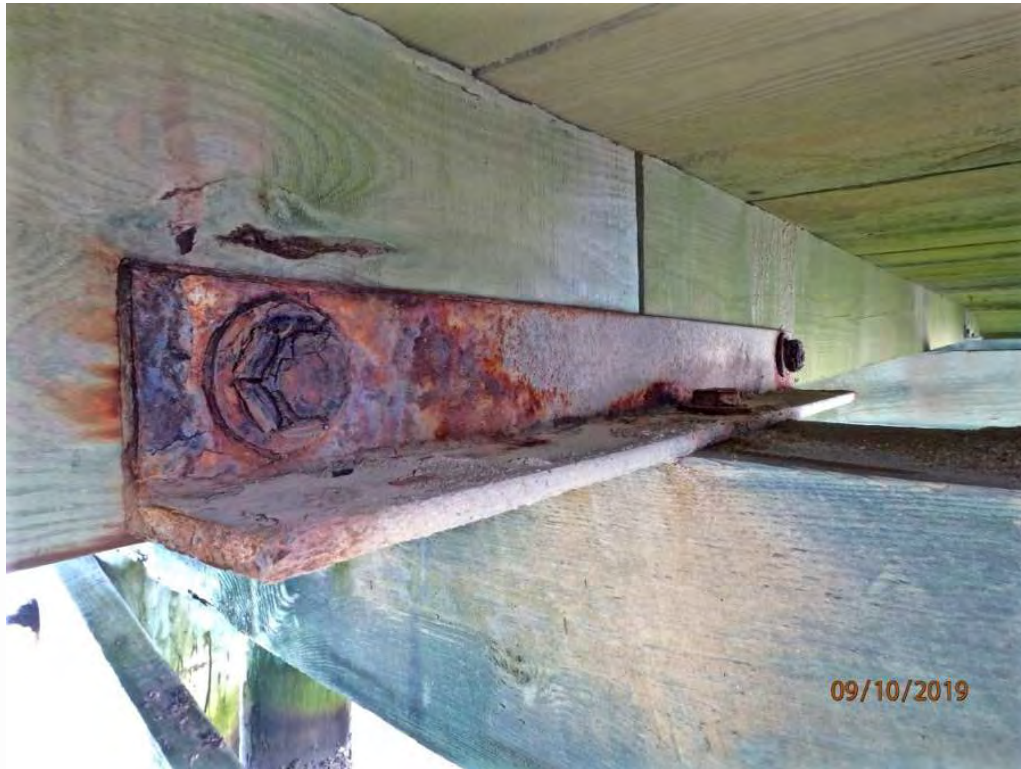
Photo 21: Bent 2 Beam 3 south keeper, corrosion to fastener hardware & angle

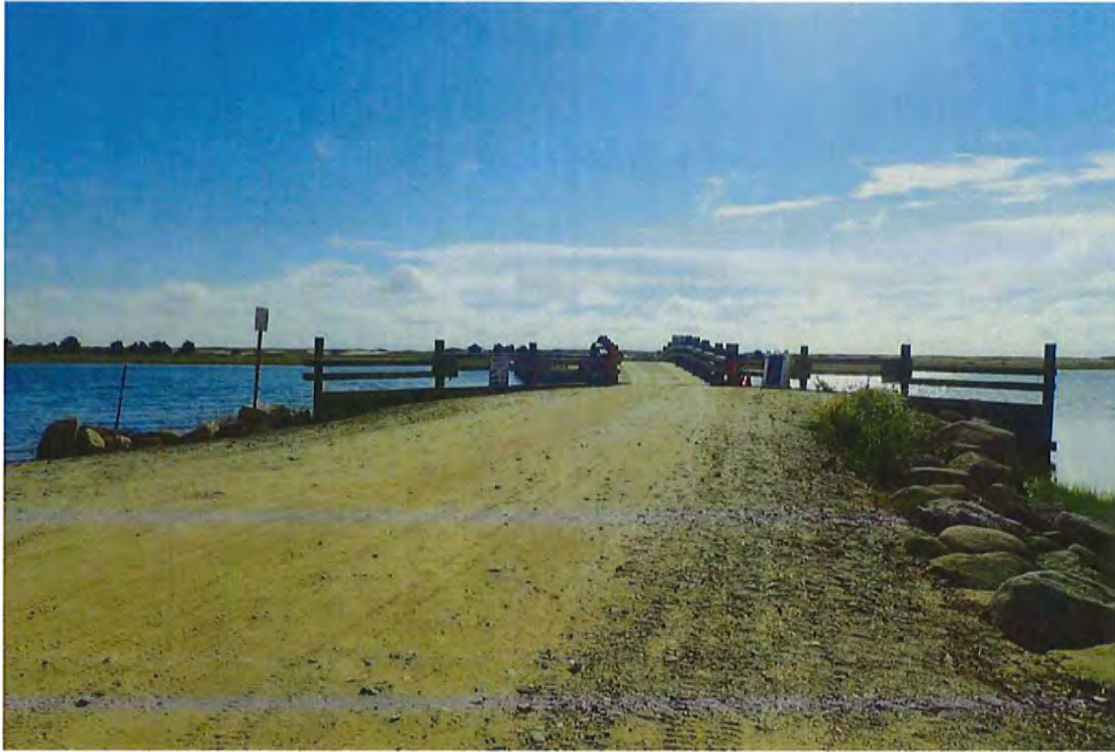
Photo 1: West approach, at-bridge weight posting sign installed at inadequate height.
