MASSACHUSETTS HIGHWAY DEPARTMENT
STRUCTURES INSPECTION FIELD REPORT

ROUTINE INSPECTION

BR. DEPT. NO. E-07-004

CITY/TOWN EDGARTOWN	8-STRUCTURE NO. E07004-43B-MUN-NBI	11-Kilo. POINT 001.046	41-STATUS A:OPEN	90-ROUTINE INSP. DATE SEP 16, 2003
07-FACILITY CARRIED HWY DIKE RD	MEMORIAL NAME/LOCAL NAME	27-YR BUILT 1995	106-YR REBUILT 0000	YR REHAB'D (NON 106) 0000
06-FEATURES INTERSECTED WATER POUCHA POND	26-FUNCTIONAL CLASS Rural Local	DIST. BRIDGE INSPECTION ENGINEER D. A. Palmer		
43-STRUCTURE TYPE Timber Stringer/Girder	22-OWNER Town Agency	21-MAINTAINER Town Agency	TEAM LEADER T. J. McKenna	
107-DECK TYPE Timber	WEATHER sunny	TEMP. (air) 70°C	TEAM MEMBERS S. R. WARN

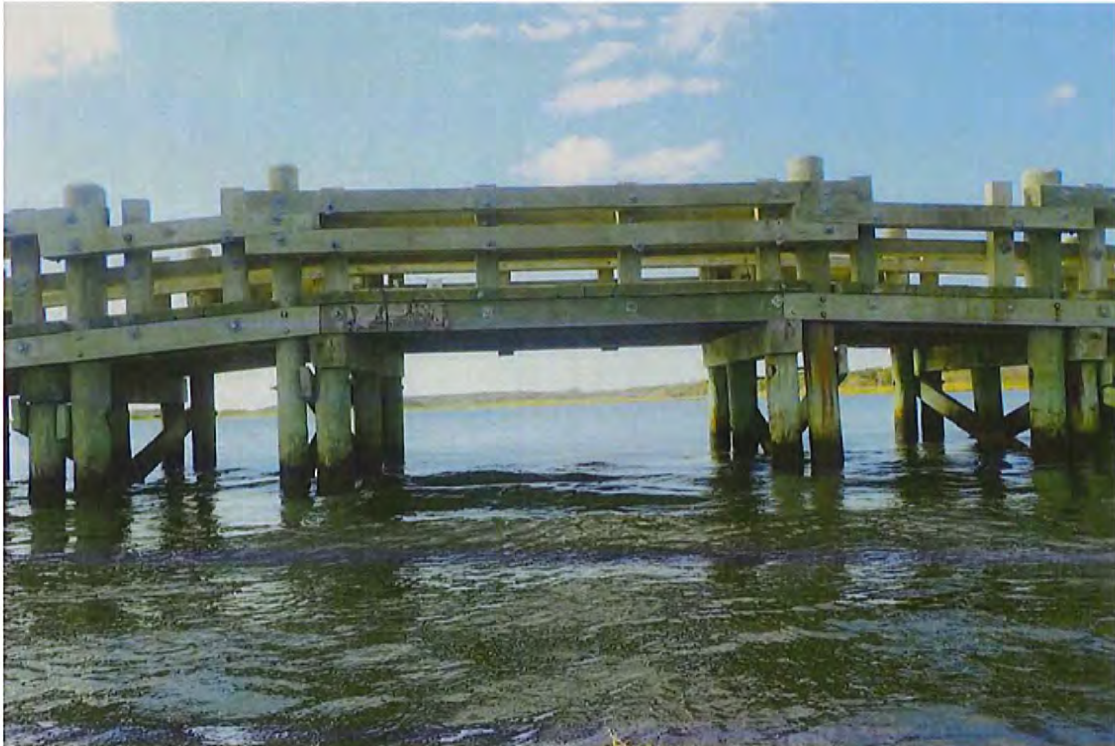
Photo 2: Span 5 north elevation, broken & missing navigation channel indicator sign.

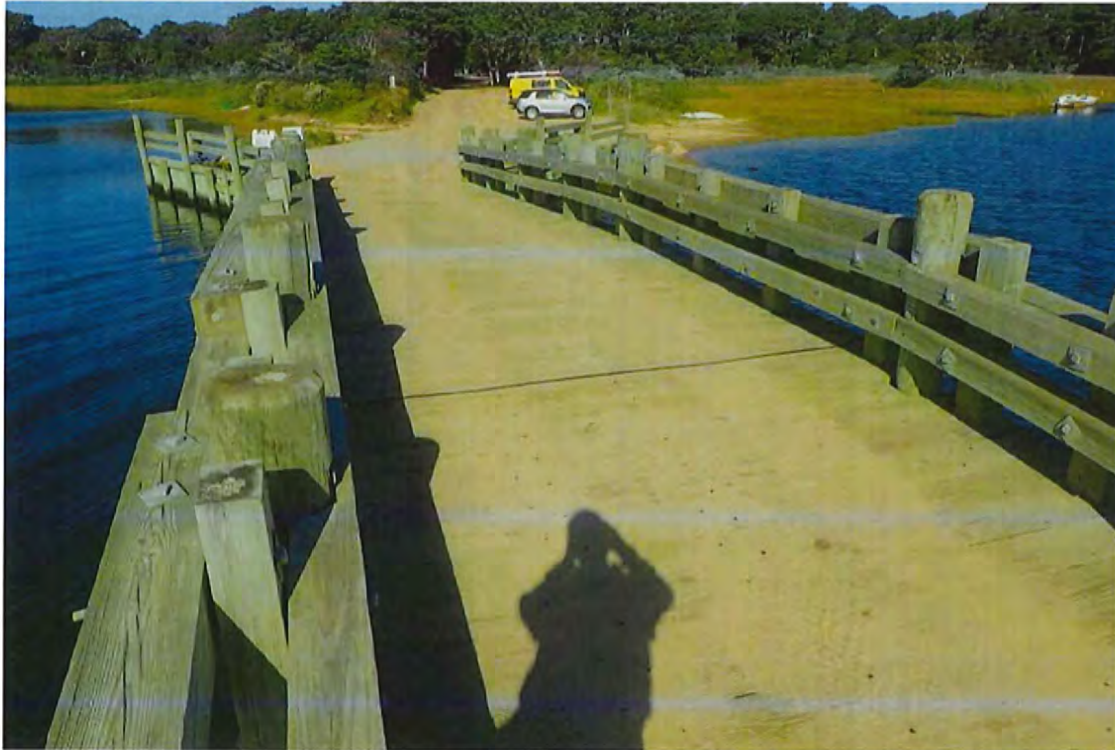
Photo 3: General wearing surface looking west, sand accumulation in abraded wheel paths.

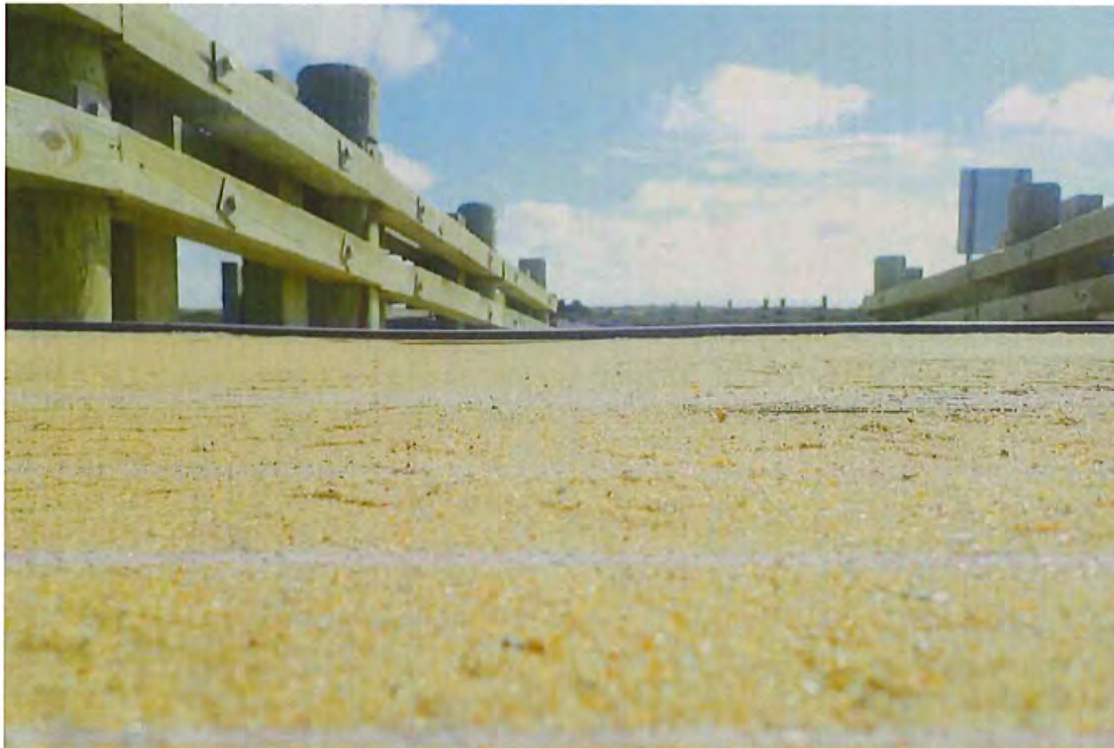
Photo 4: North wheel path looking east (Level @ Bent 4), abraded wheel path w/ sand accumulation & protruding fasteners.

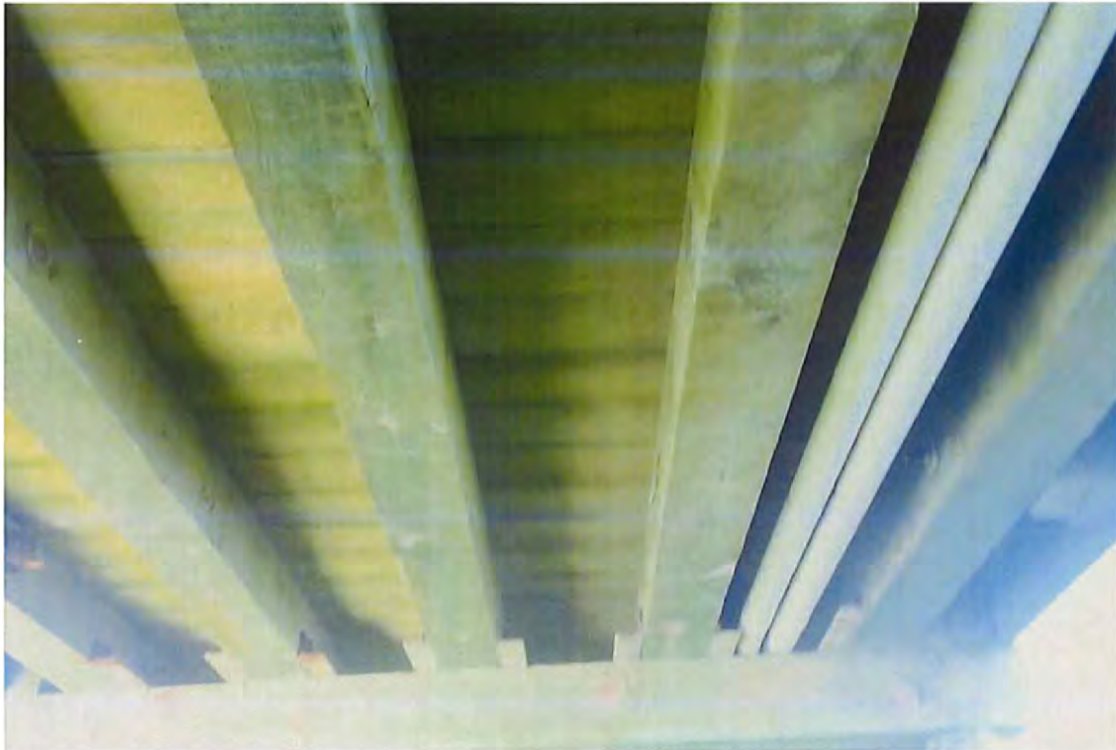
Photo 5: General underside Span 5 looking west, minor mildew staining throughout soffit.

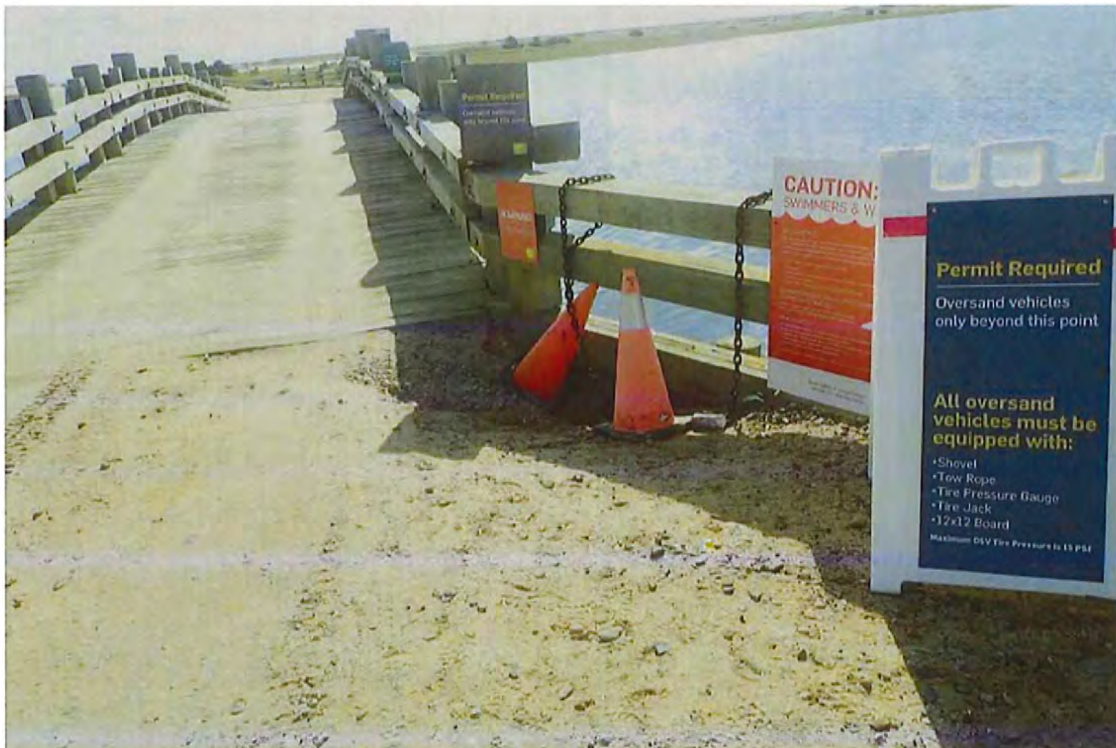
Photo 6: Southwest immediate approach roadway, erosion hole.

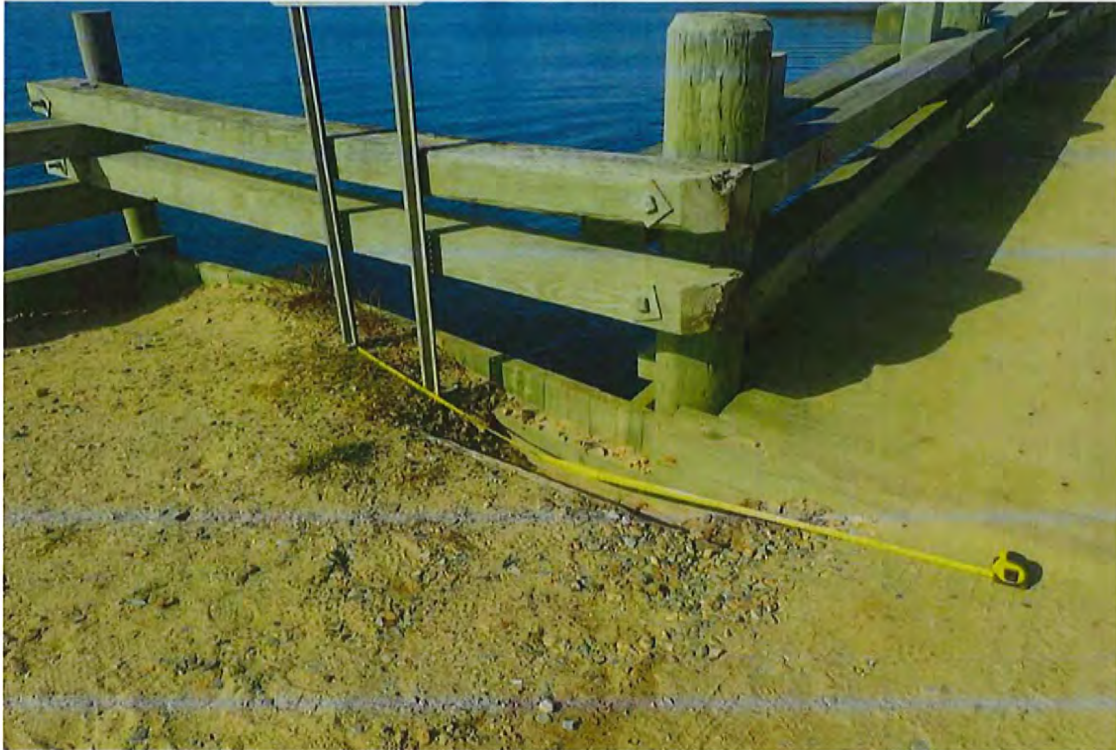
Photo 7: Southeast immediate approach roadway, erosion hole.

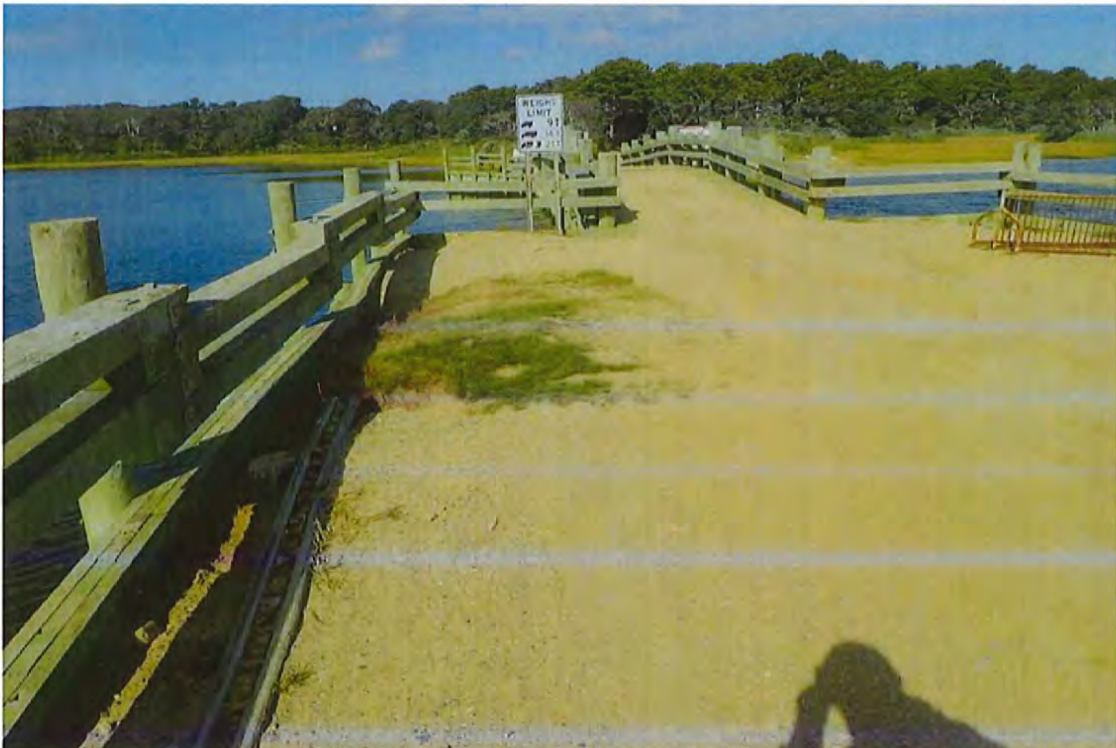
Photo 8: East approach along south wingwall bulkhead, moderate erosion.

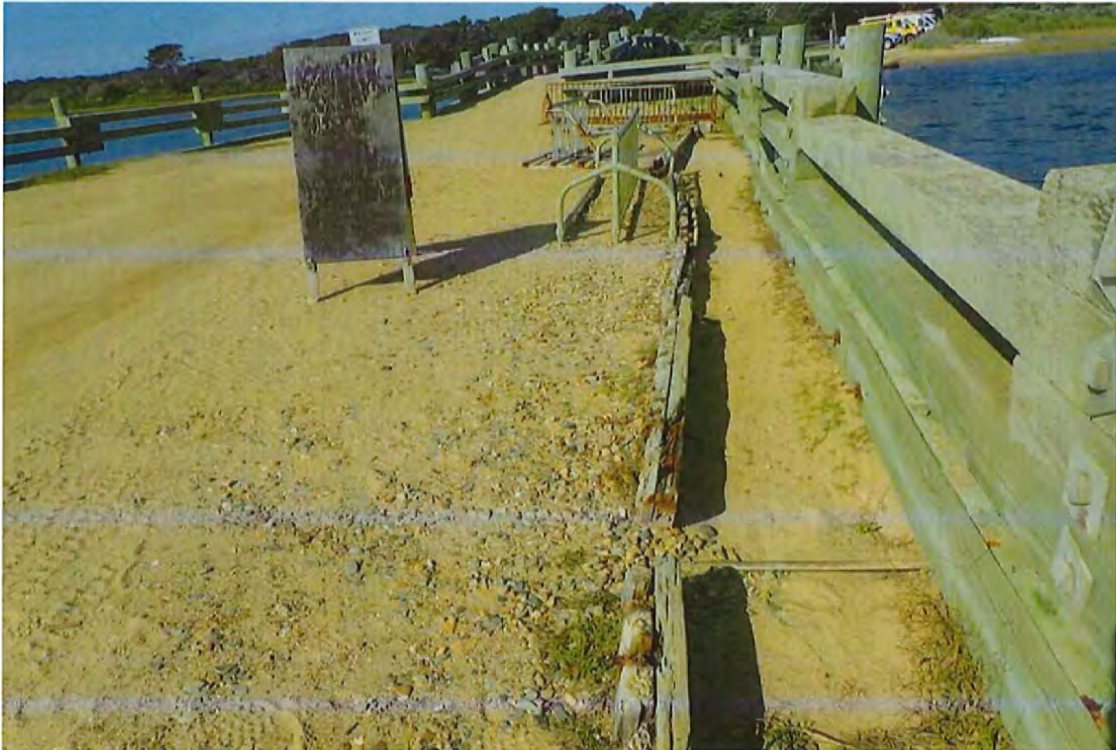
Photo 9: East approach along north wingwall bulkhead, erosion along abandoned bulkhead exposing tiebacks.

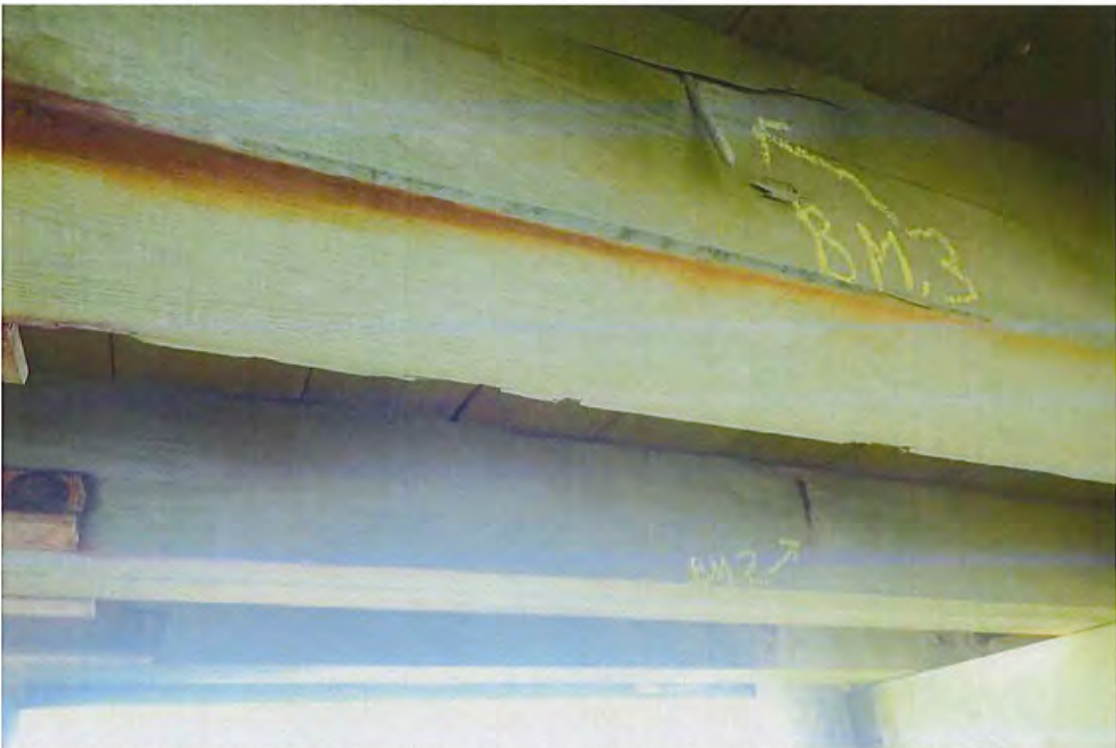
Photo 10: Span 2 Beam 2 north face, top edge split from misguided deck fastener.

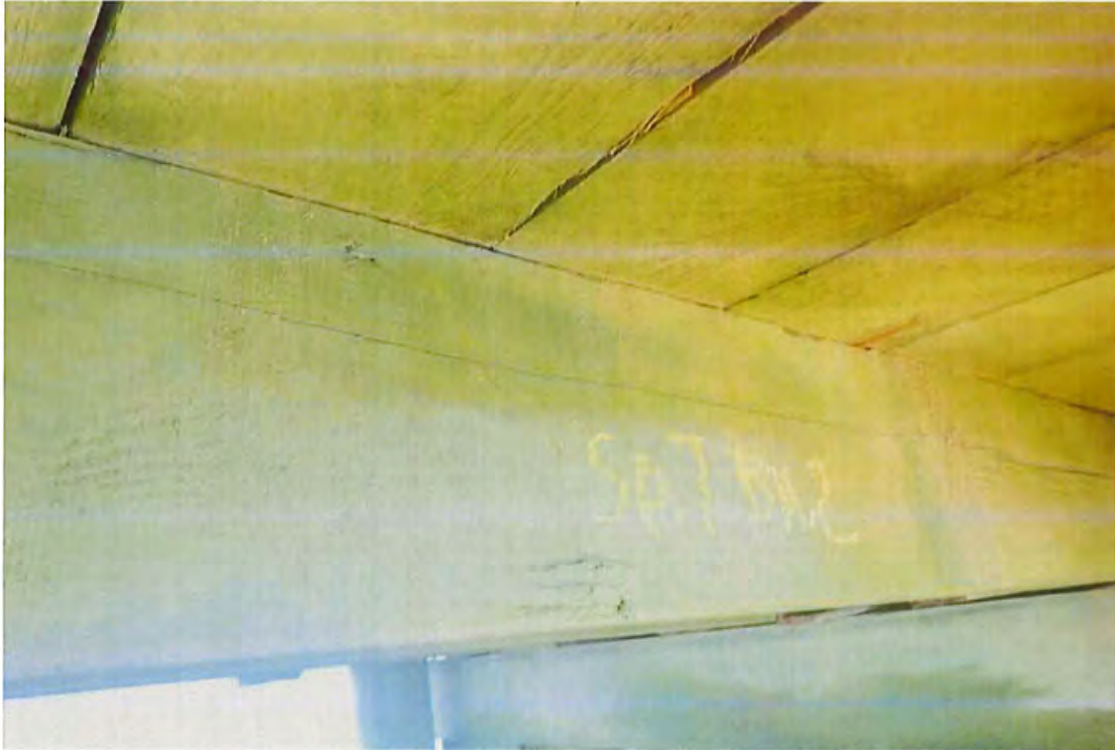
Photo 11: Span 7 Beam 2 south face, horizontal surface checking.

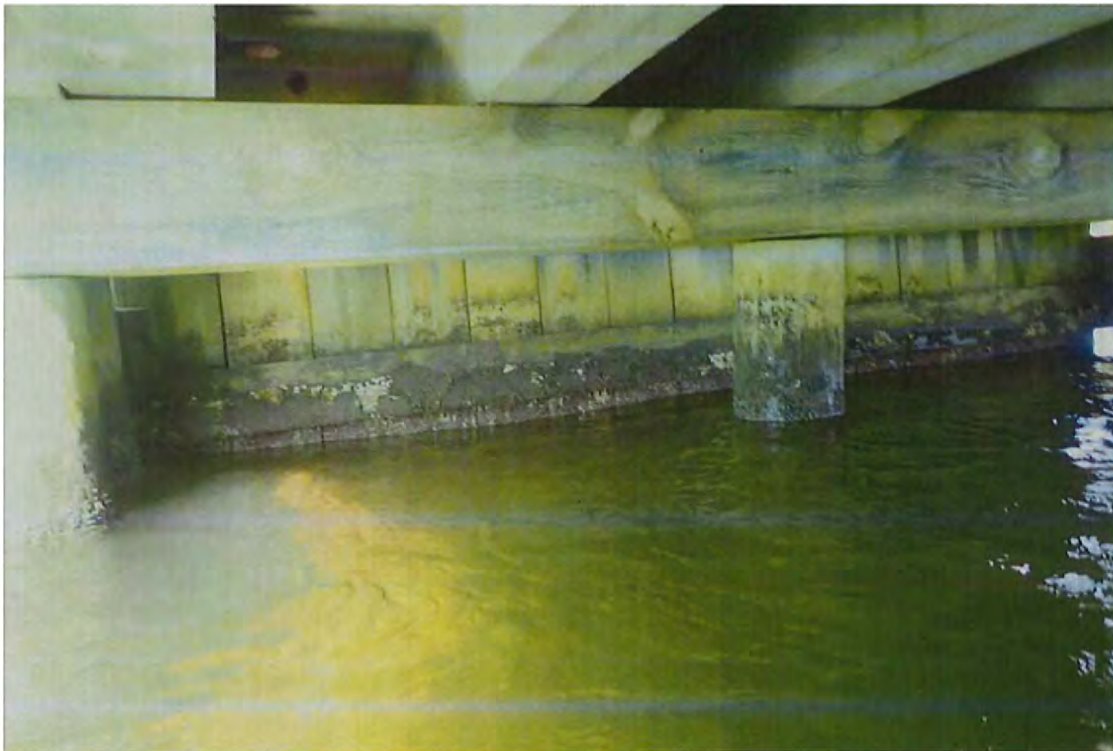
Photo 13: General view of west abutment bent & bulkhead, mildew staining & marine growth throughout.

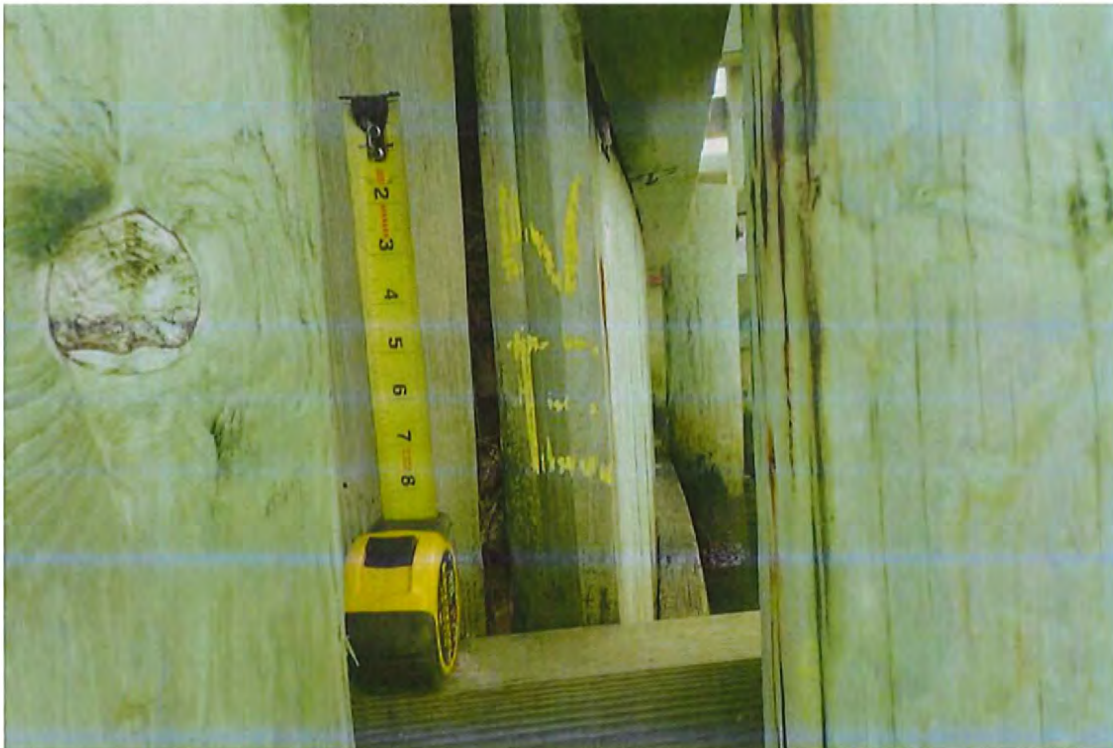
Photo 14: North corner of east abutment bulkhead looking south, bulging/bowing & gap w/ wingwall bulkhead.

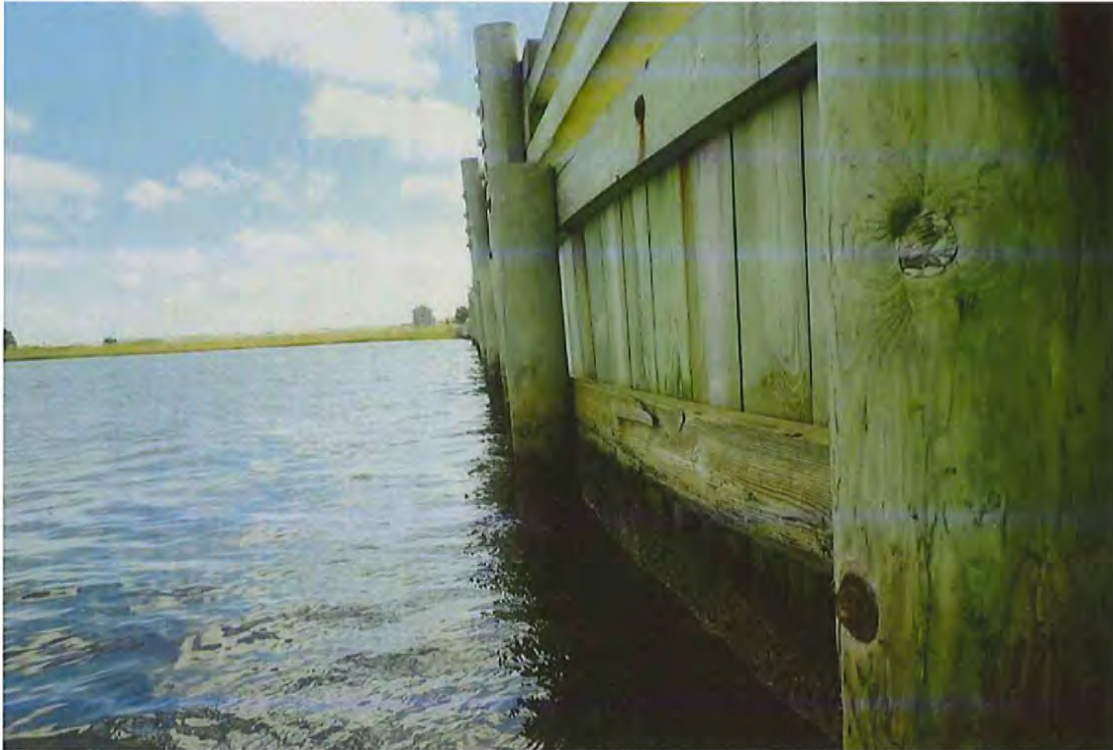
Photo 15: Northeast wingwall bulkhead between 1st & 2nd piles from west, split in middle wale.

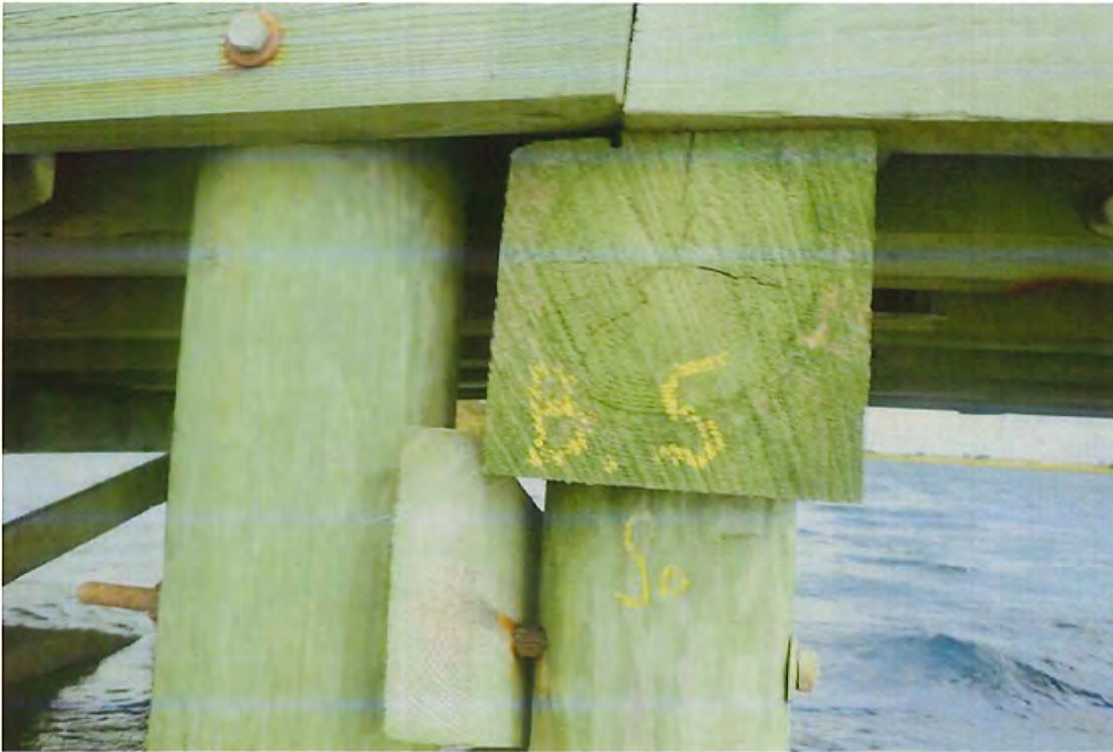
Photo 17: Bent 5 south face of cap, vertical end surface checks.

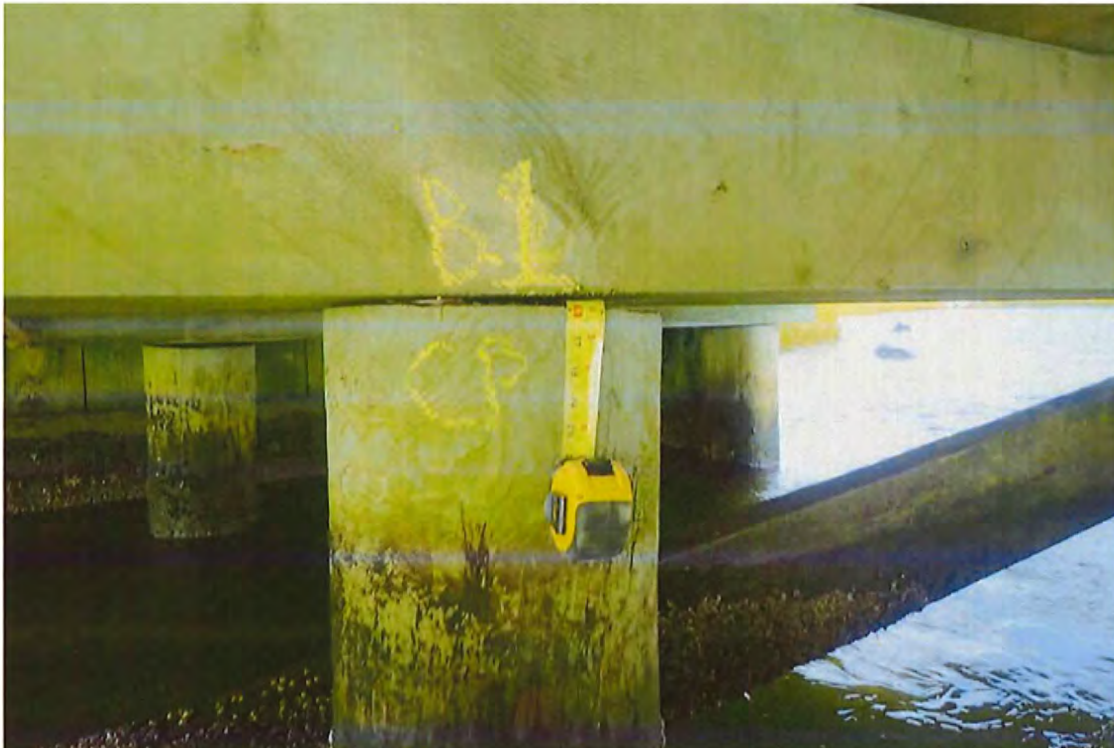
Photo 18: Bent 1 center pile east face, irregular cut off w/ gap between cap.

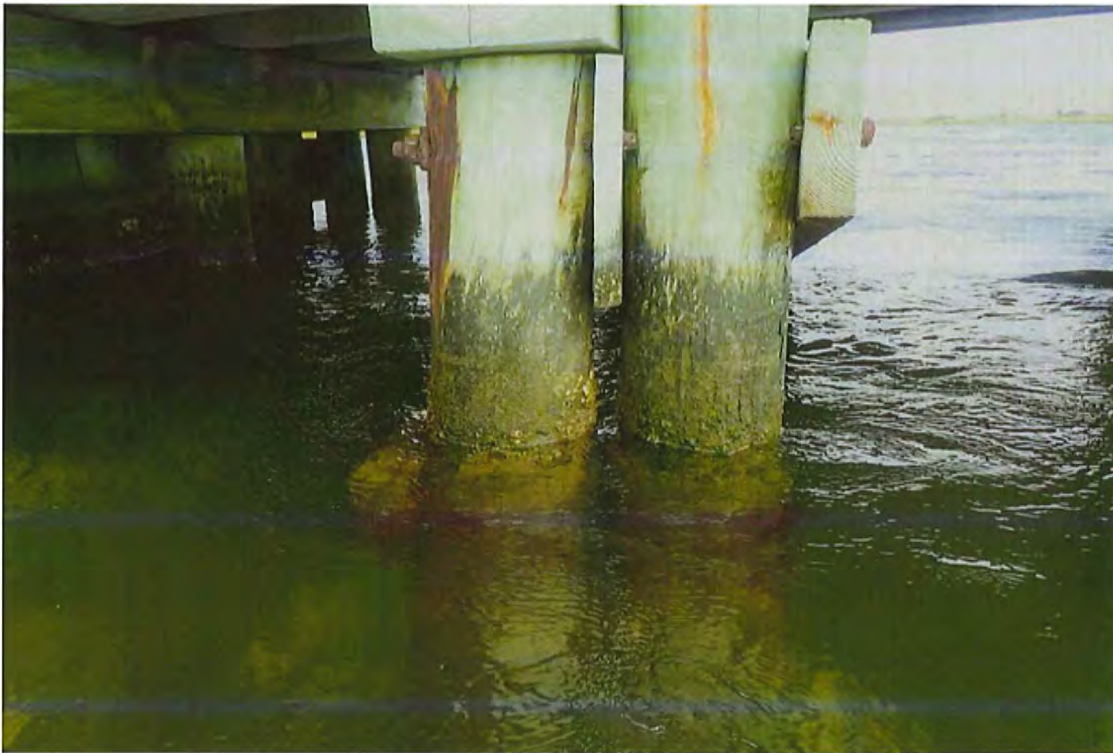
Photo 19: Bent 1 south piles, minor wane w/rust staining.

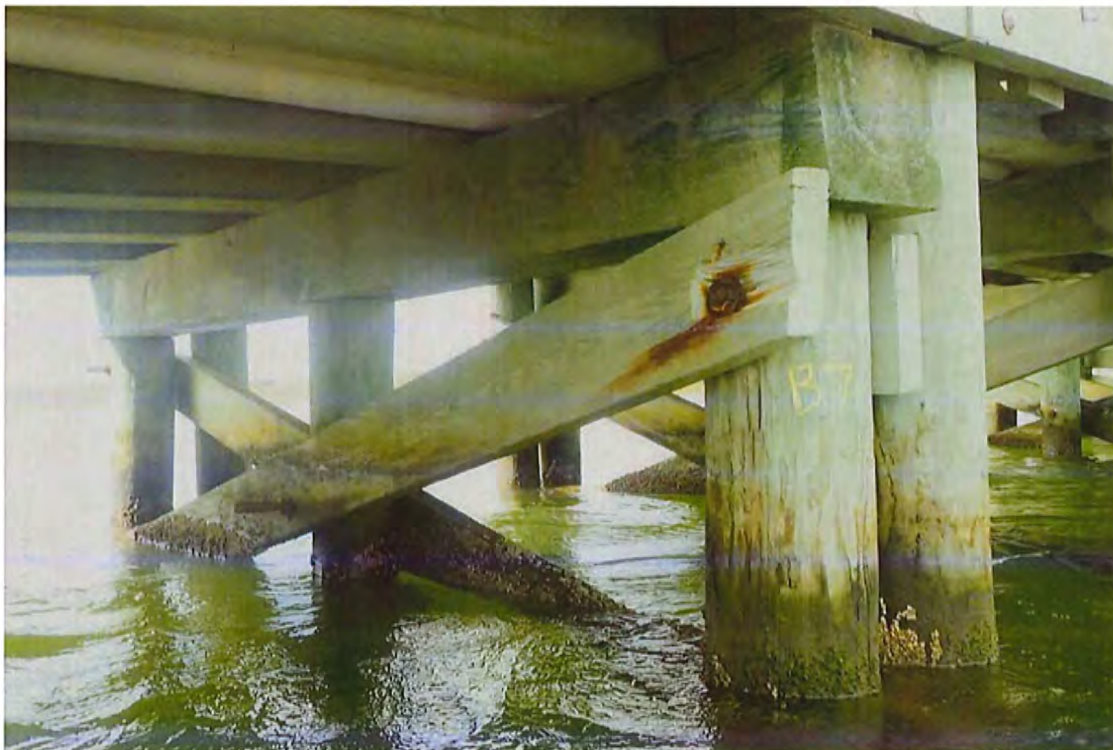
Photo 20: Bent 7 north end of east diagonal bracing, corrosion of fastener hardware.

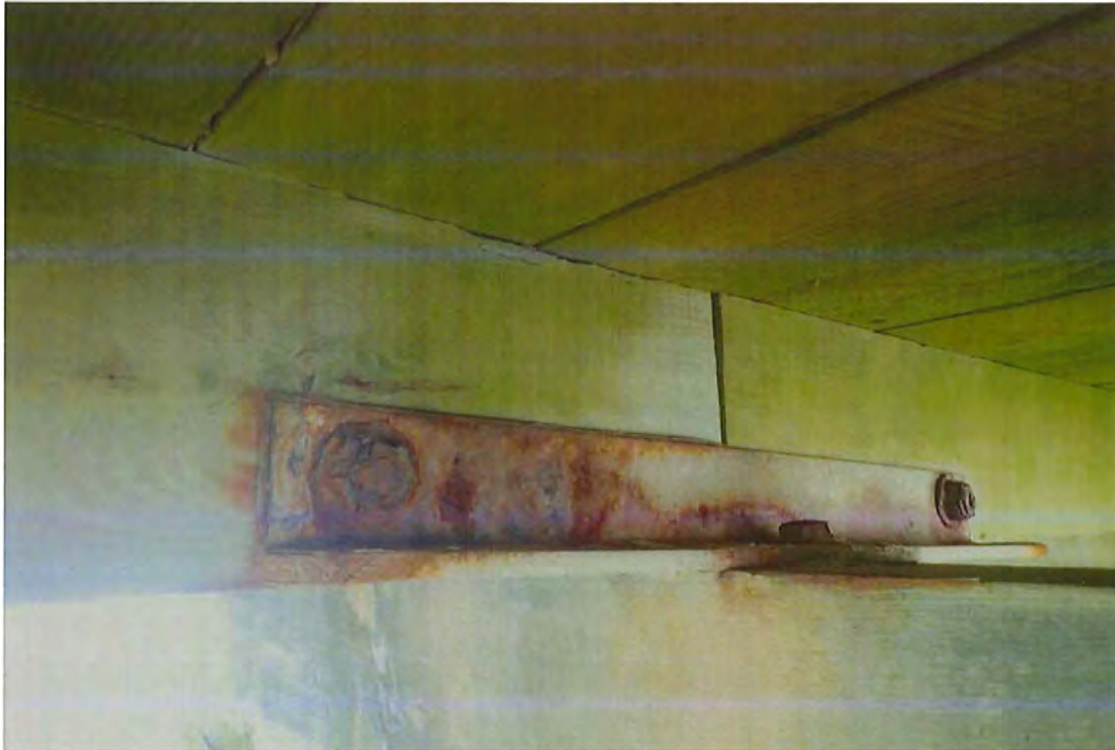
Photo 21: Bent 2 Beam 3 south keeper, corrosion to fastener hardware & angle.
