Town of Edgartown
Cape Pogue DCPC
SUPPLEMENTAL MATERIALS
June 30 5:00 P.M.

STRUCTURES INSPECTION FIELD REPORT

BR. DEPT. NO.
E-07-004

CITY/TOWN EDGARTOWN	8-STRUCTURE NO. E07004-43B-MUN-NBI	11-Kilo. POINT 001.046	41-STATUS P:POSTED	90-ROUTINE INSP. DATE SEP 29, 2021
07-FACILITY CARRIED HWY DIKE RD	MEMORIAL NAME/LOCAL NAME	27-YR BUILT 1995	106-YR REBUILT 0000	YR REHAB'D (NON 106) 0000
06-FEATURES INTERSECTED WATER POUCHA POND	26-FUNCTIONAL CLASS Rural Local	DIST. BRIDGE INSPECTION ENGINEER G. Simpson		
43-STRUCTURE TYPE 702 : Timber Stringer/Girder	22-OWNER Town Agency	21-MAINTAINER Town Agency	TEAM LEADER J. Spiezio	
107-DECK TYPE 8 : Timber	WEATHER Sunny	TEMP. (air) 10°C	TEAM MEMBERS A. DOWNING

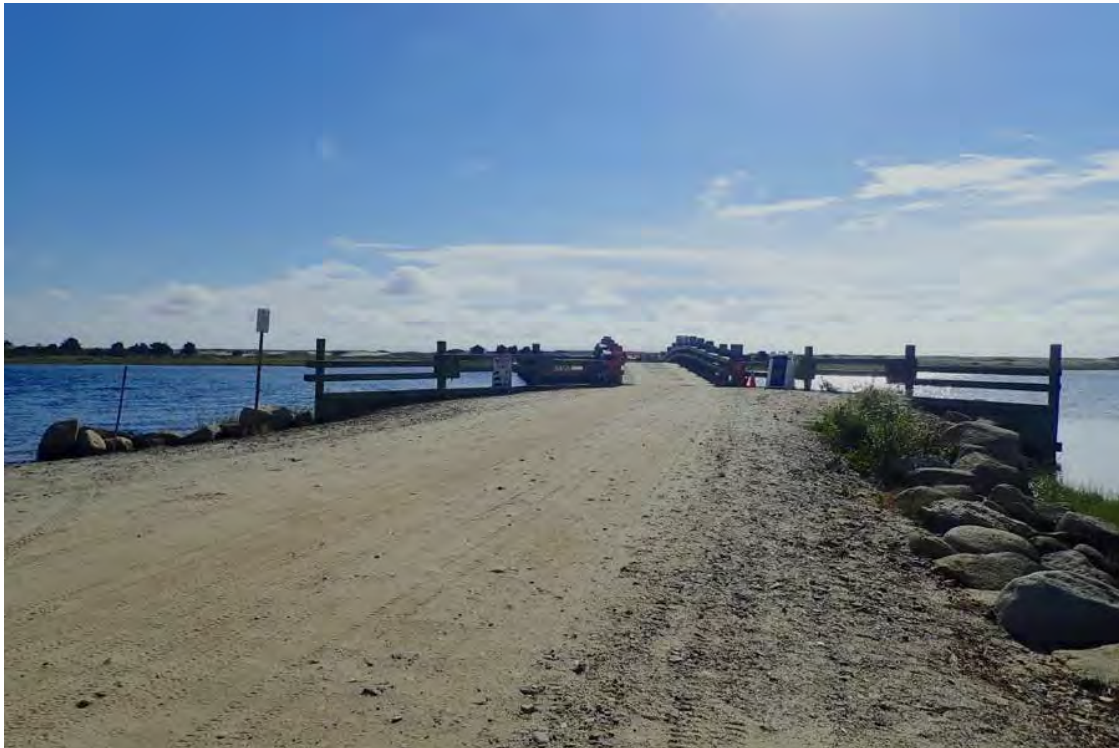
S/A - West at-bridge weight posting sign has compromised visibility due to inadequate height, see photo 1. Both advances lack weight posting signs to inform traffic of the restriction.

Photo 1: West approach, at-bridge weight posting sign installed at inadequate height.

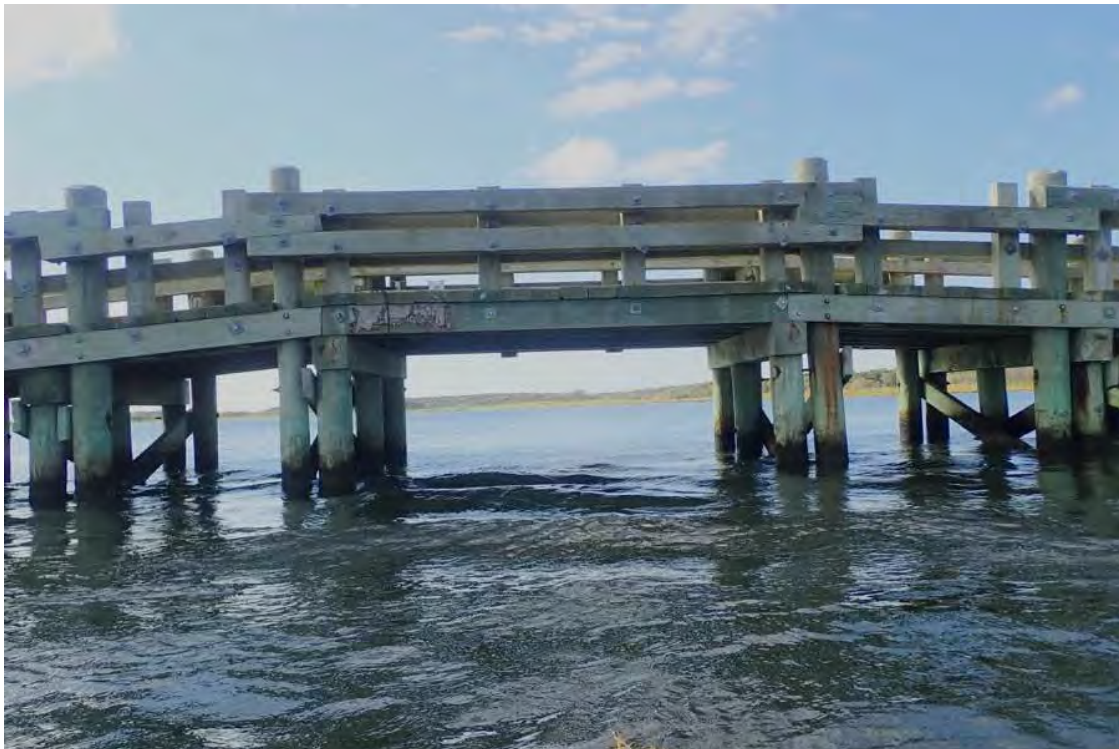
Previously installed navigation channel indicator sign attached to the north fascia board in Span 5 is broken and missing, see photo 2.

Photo 2: Span 5 north elevation, broken & missing navigation channel indicator sign.

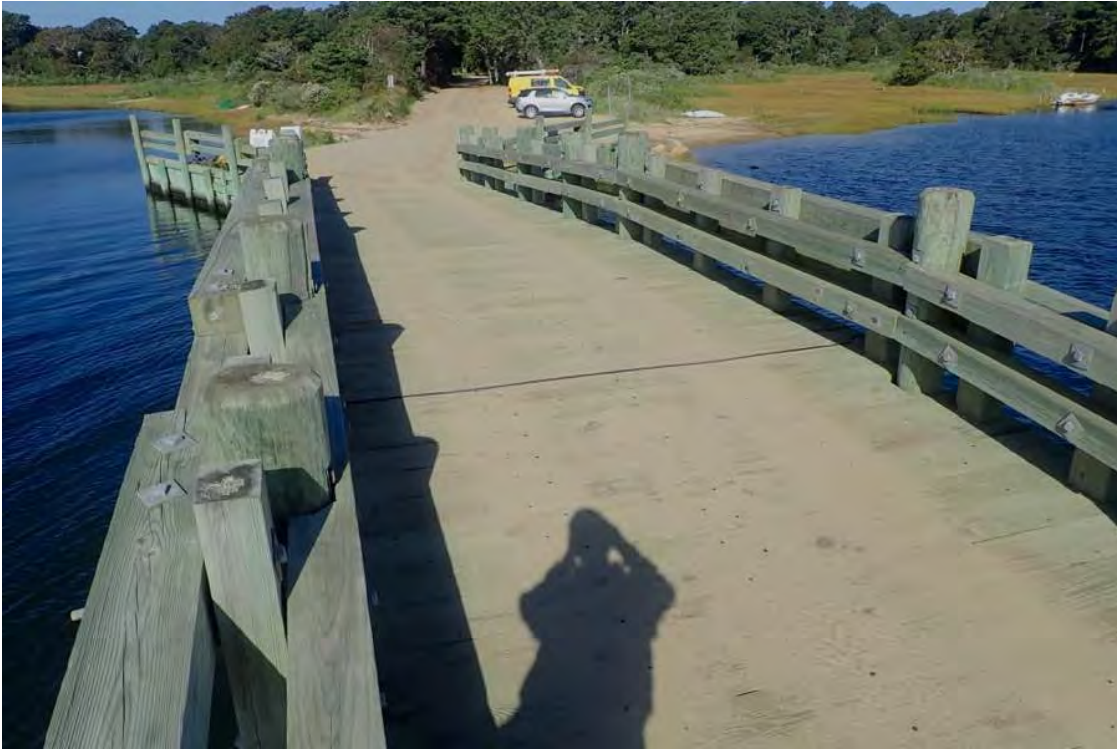
Wearing surface is comprised of single coursed 4" x 10" transversely fastened timber decking planks, see photos 3 & 4. Inspection of this item is limited to only the top side of the decking planks.

- Minor to moderate weathering and surface checking ($\leq 1/16$ "W) throughout.
- Differential elevation of planks $\leq 1/2$ "H.
- Abrasion/section loss in wheel paths ≤ 1 "D.
- $\approx 40\%$ of fasteners are protruding $\leq 1/2$ "H with nominal wear, predominately in abraded wheel paths.
- Moderate to severe sand accumulation throughout, worst in abraded wheel paths.

Bridge railing consists of two 6" x 8" horizontal members bolted to 6" x 8" vertical posts with $\approx 6'$ spacing, and 12" piles at bents see photo 3, non-standard. See item 58.8 for condition comments.

Photo 3: General wearing surface looking west, sand accumulation in abraded wheel paths.

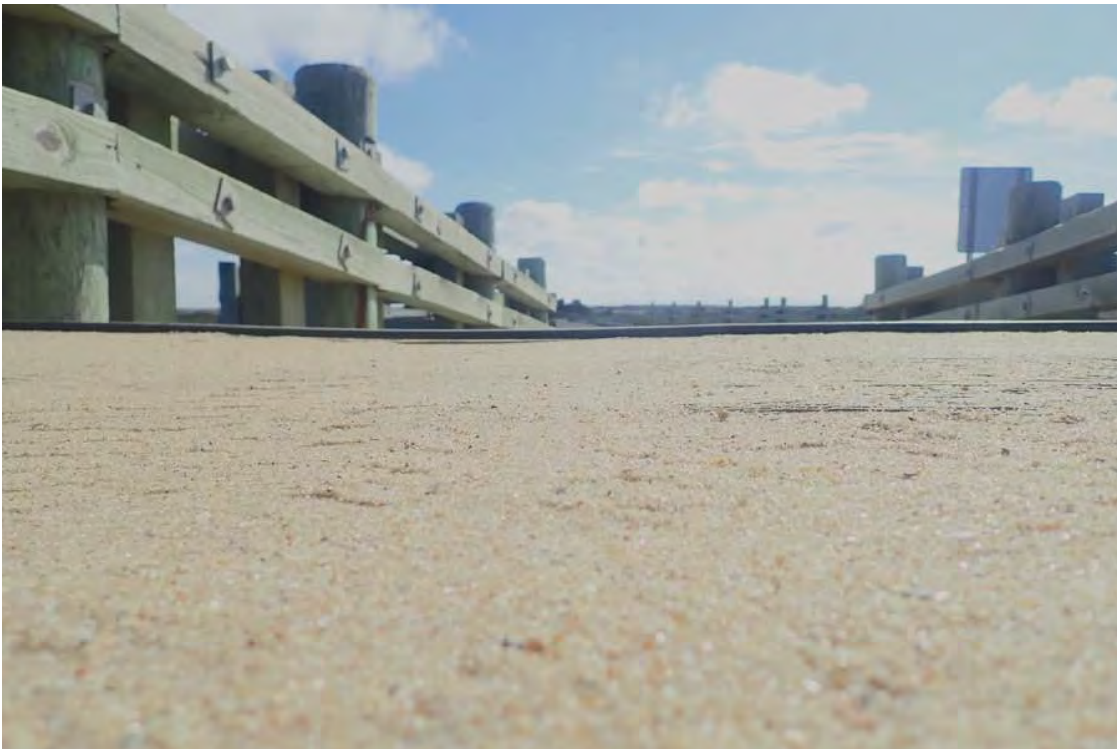
Photo 4: North wheel path looking east (Level @ Bent 4), abraded wheel path w/ sand accumulation & protruding fasteners.

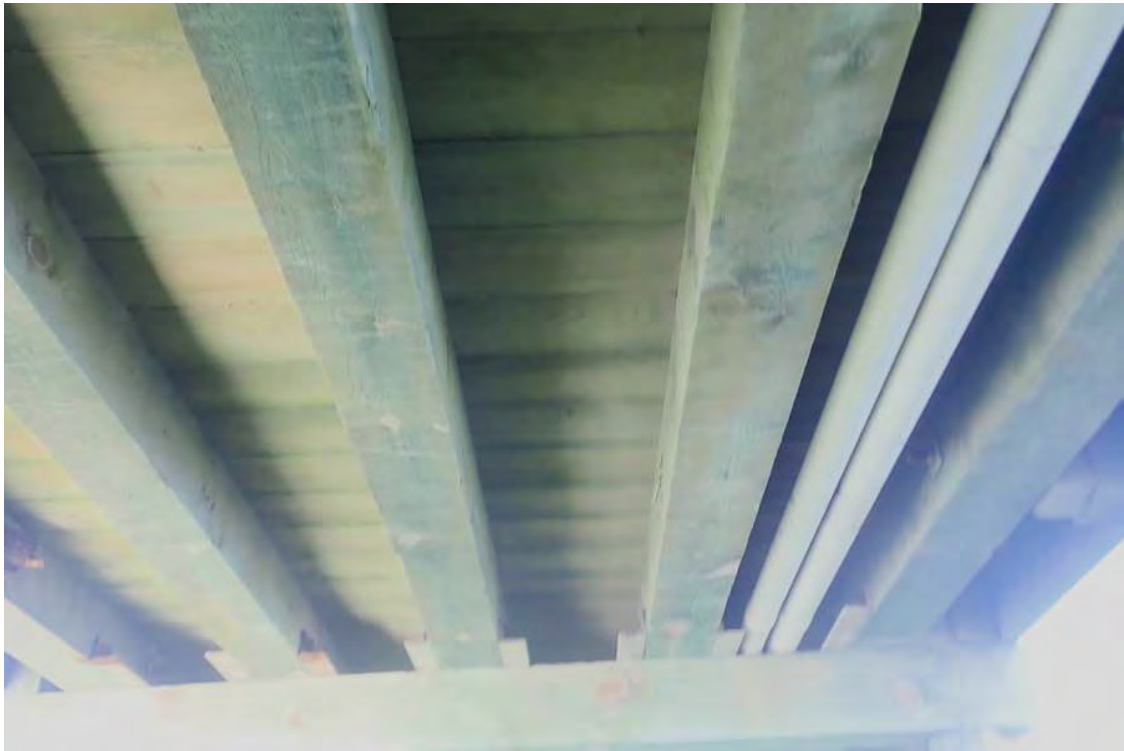
Minor mildew staining throughout deck planking soffit, see photo 5.

Photo 5: General underside Span 5 looking west, minor mildew staining throughout soffit.

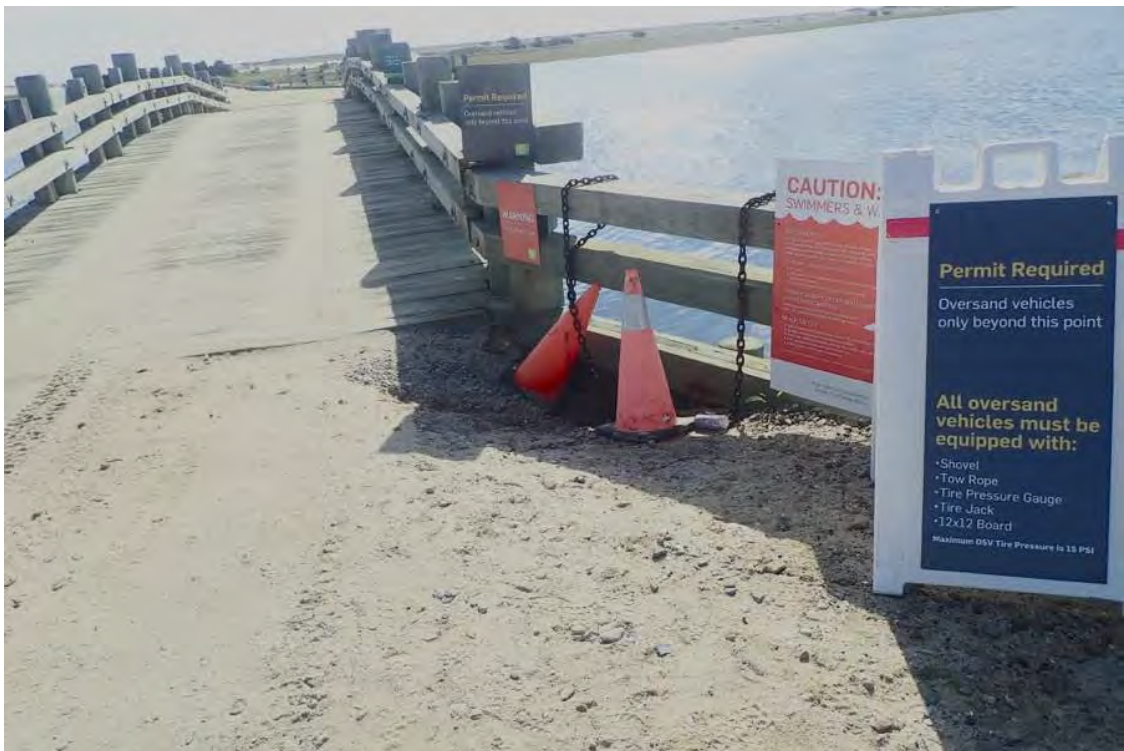
Photo 6: Southwest immediate approach roadway, erosion hole.

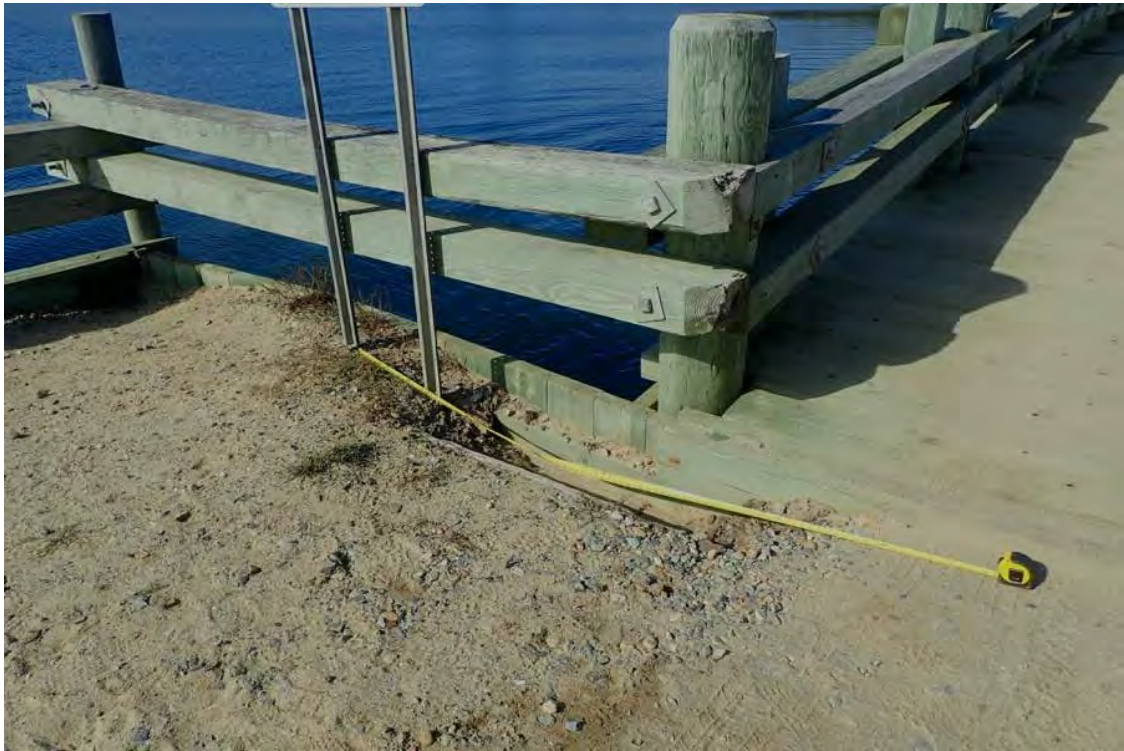
Photo 7: Southeast immediate approach roadway, erosion hole.

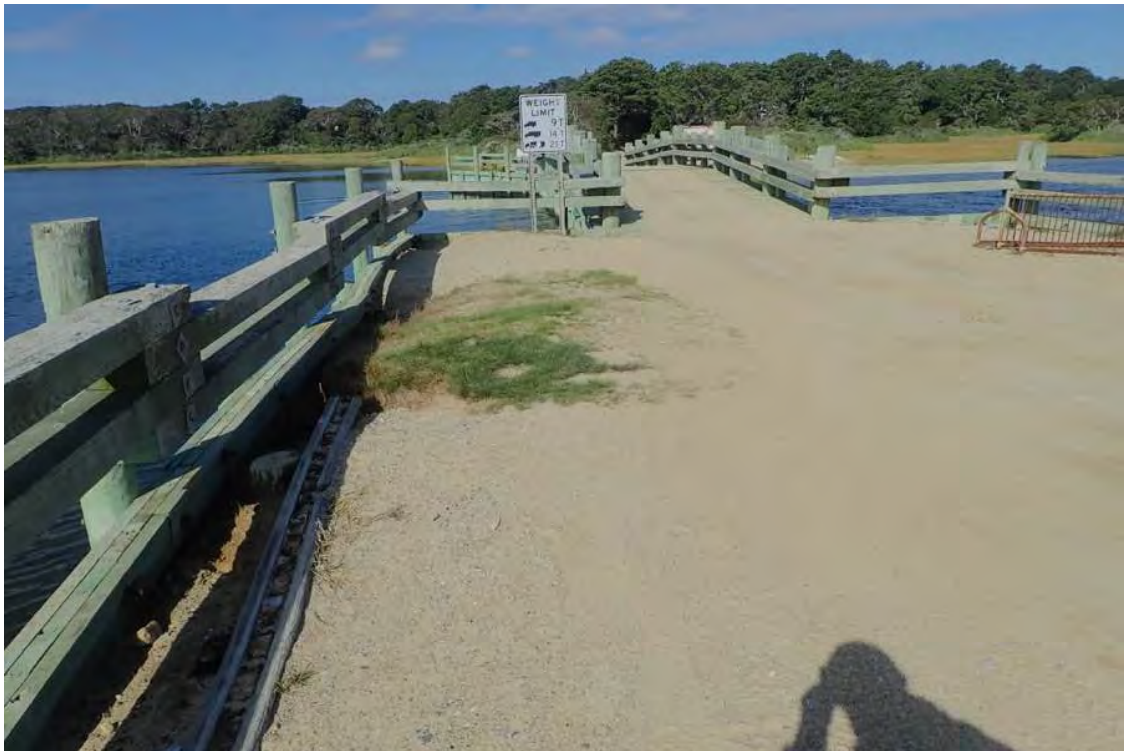
Photo 8: East approach along south wingwall bulkhead, moderate erosion.

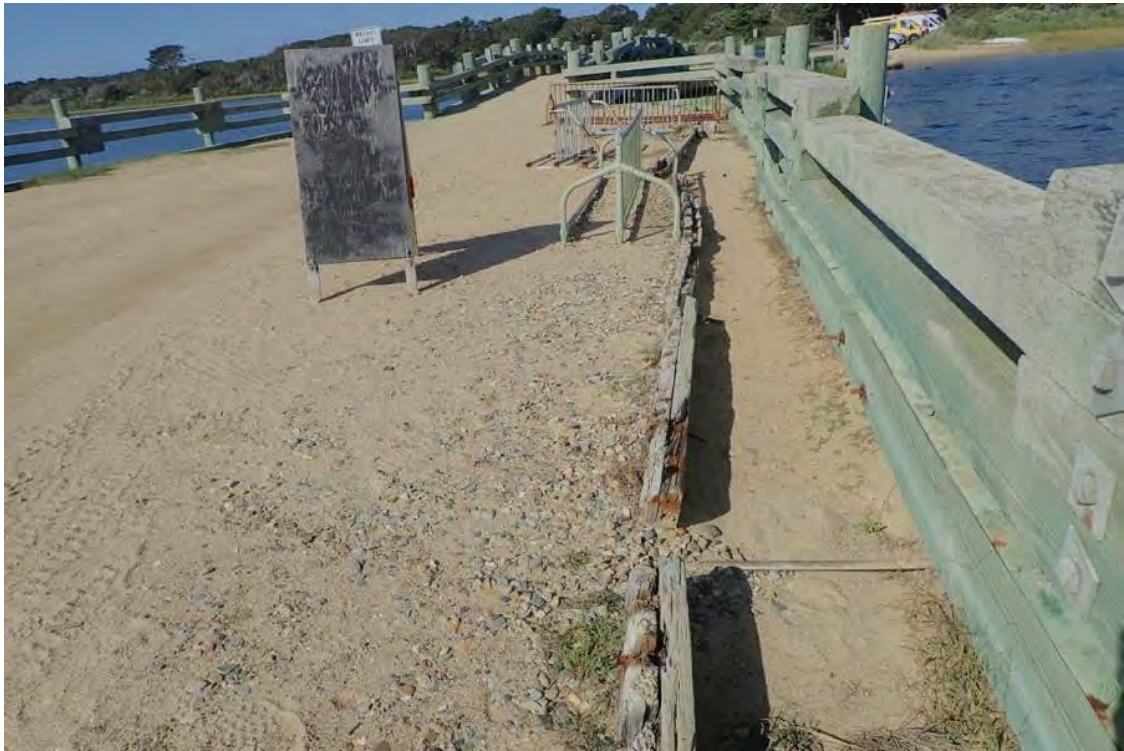
Photo 9: East approach along north wingwall bulkhead, erosion along abandoned bulkhead exposing tiebacks.

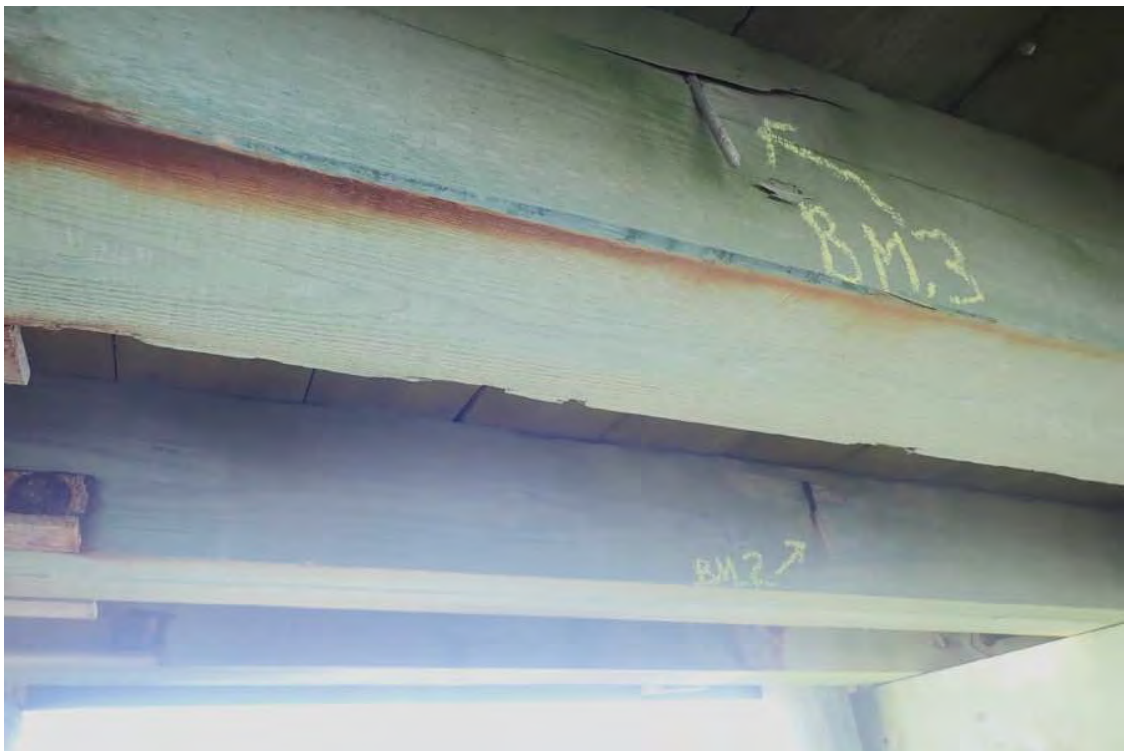
Photo 10: Span 2 Beam 2 north face, top edge split from misguided deck fastener.

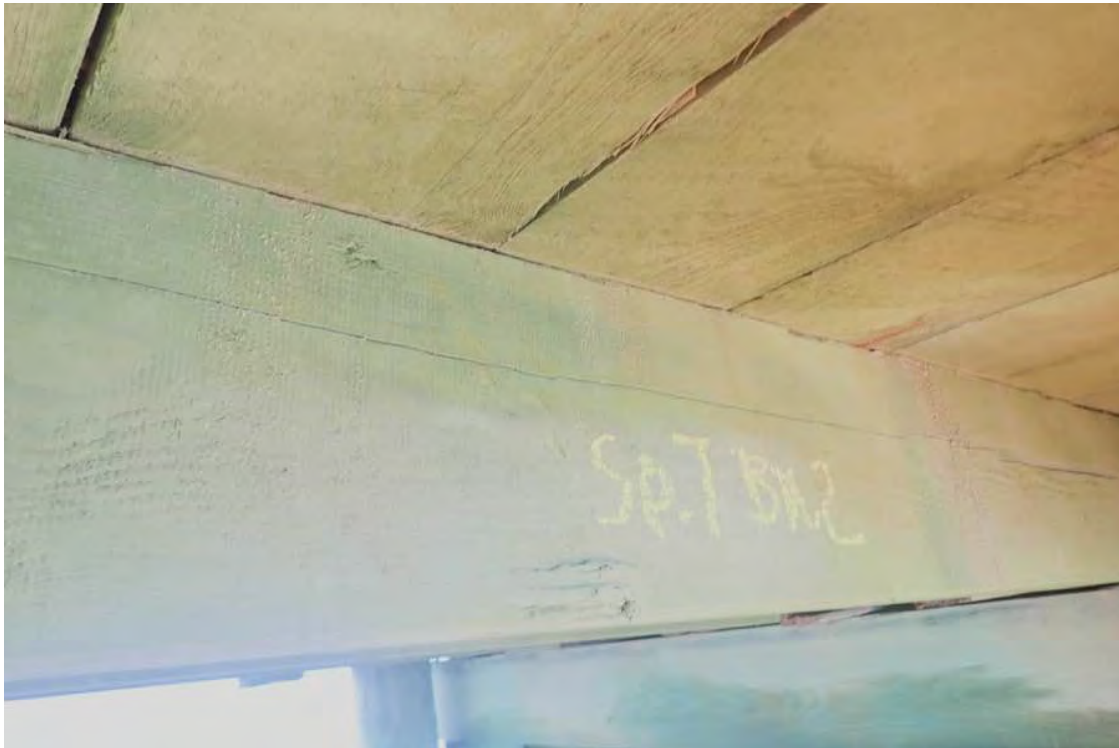
Photo 11: Span 7 Beam 2 south face, horizontal surface checking.

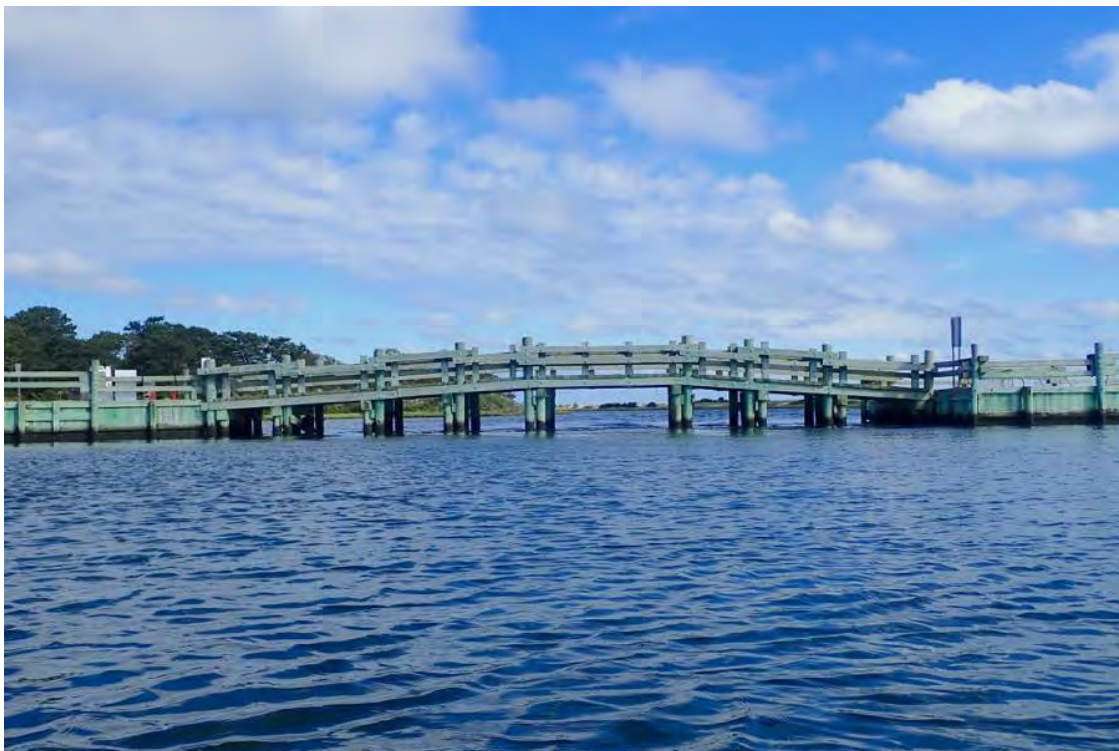
Photo 12: South elevation, typical vertical alignment of spans.

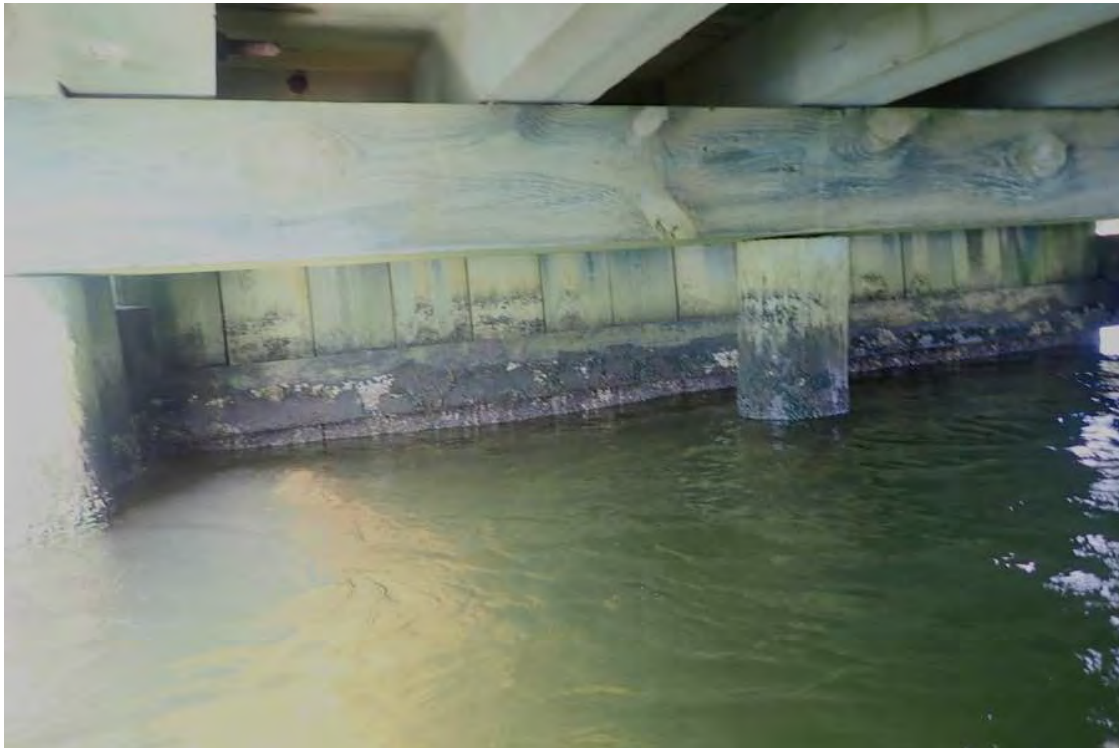
- Both abutment bulkheads exhibit minor to moderate mildew staining above tidal zone, and moderate to heavy marine growth within tidal zone, see photo 13.
- East abutment bulkhead, bulging/bowing 1" seaward, see photo 14.

Photo 13: General view of west abutment bent & bulkhead, mildew staining & marine growth throughout.

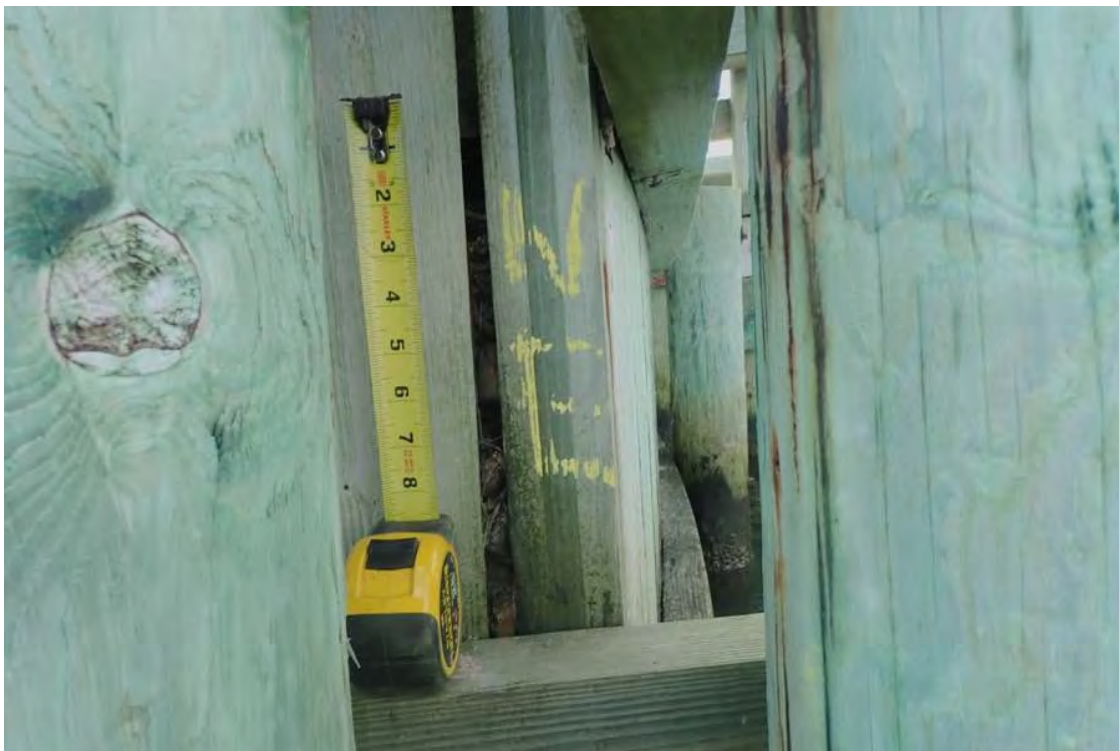
- All wingwall bulkheads exhibit minor mildew staining above tidal zone, surface checks and moderate to heavy marine growth within tidal zone, see photo 15.
- Both east wingwall bulkheads exhibit bulging/bowing ≤ 2 " seaward and gaps between sheathing & wales, worst at northeast wingwall bulkhead at first tieback from west, see photo 16.
- Northeast wingwall bulkhead between 1st & 2nd piles from west, split middle wale, see photo 15.
- **S/A : Northeast wingwall bulkhead at interface with abutment bulkhead, $\leq 1/2$ " gap allowing fill loss, see photo 14.**

Photo 14: North corner of east abutment bulkhead looking south, bulging/bowing & gap w/ wingwall bulkhead.

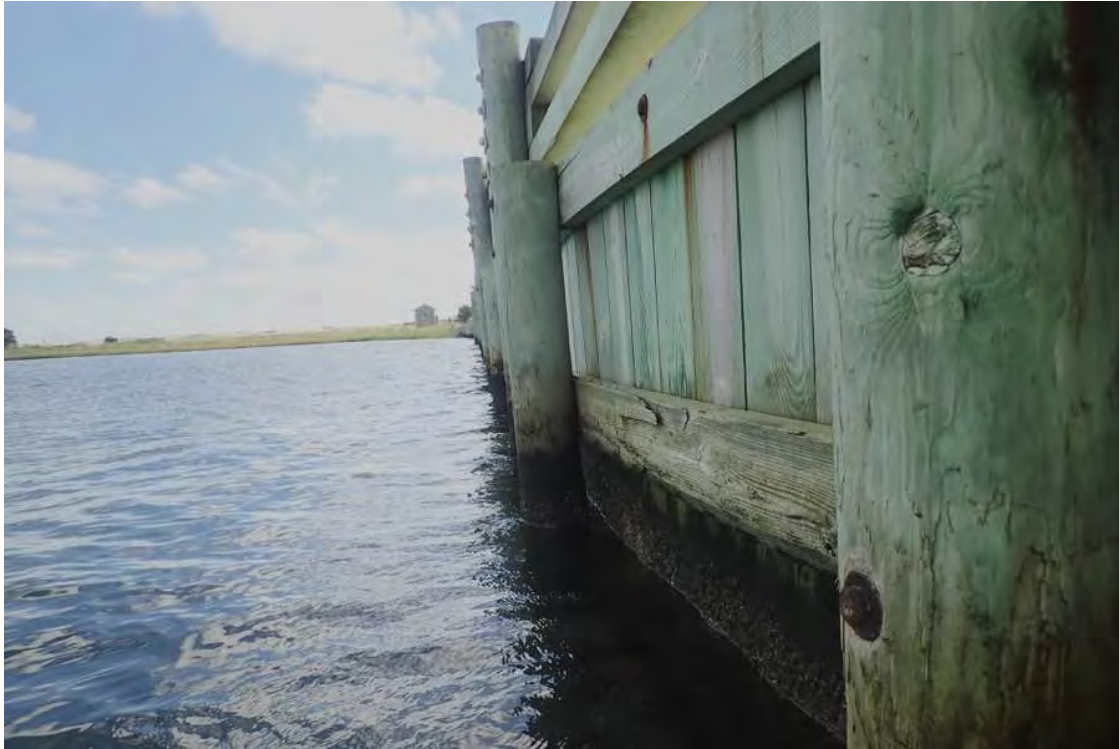
- All exposed fasteners and plates exhibit minor to moderate corrosion, see photo 15.

Photo 15: Northeast wingwall bulkhead between 1st & 2nd piles from west, split in middle wale.

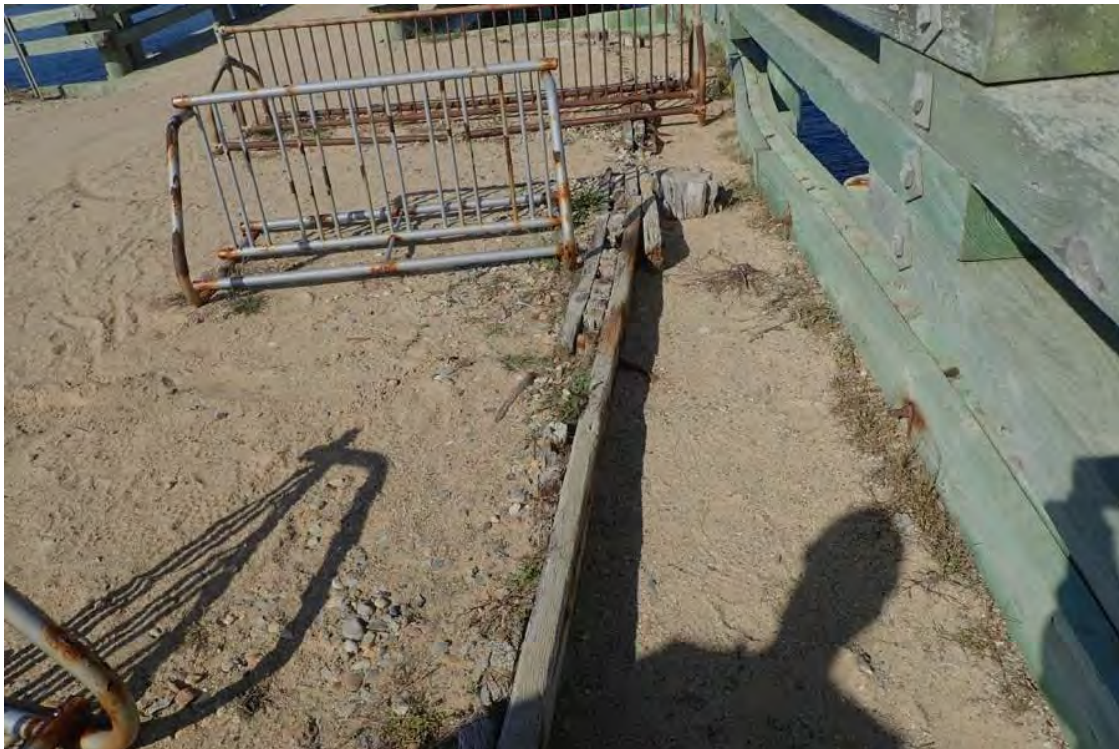
Photo 16: Northeast wingwall bulkhead at first tieback from west, bulging/bowing w/ gaps between sheathing & wales.

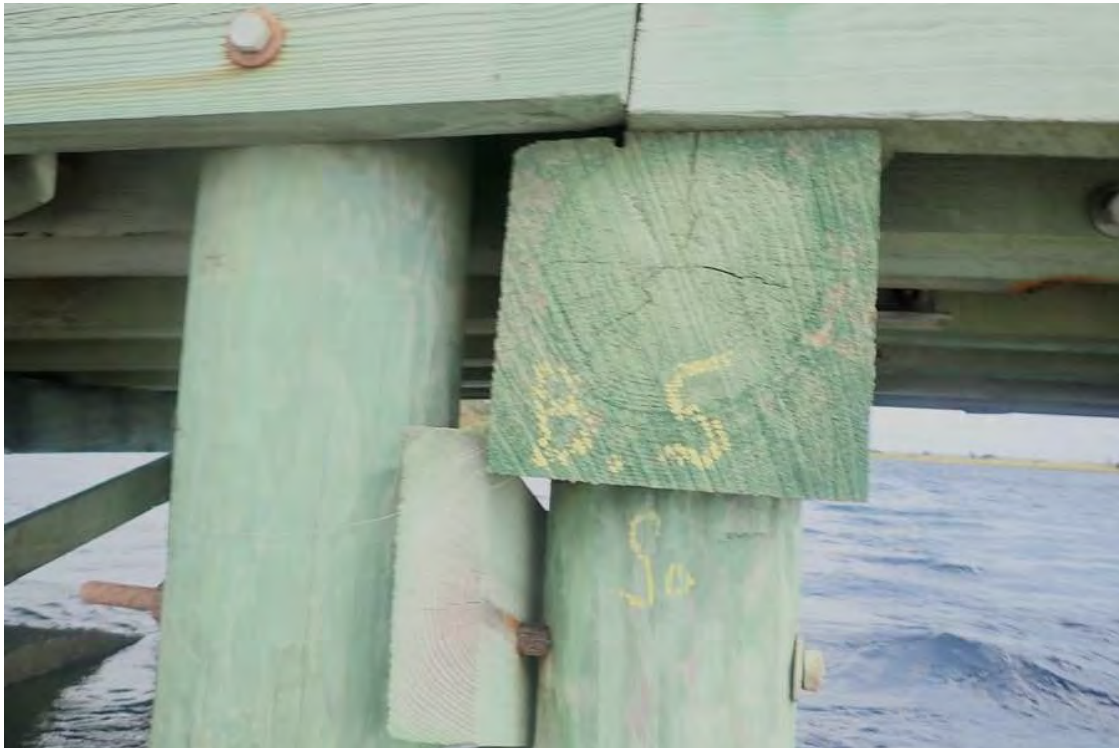
Photo 17: Bent 5 south face of cap, vertical end surface checks.

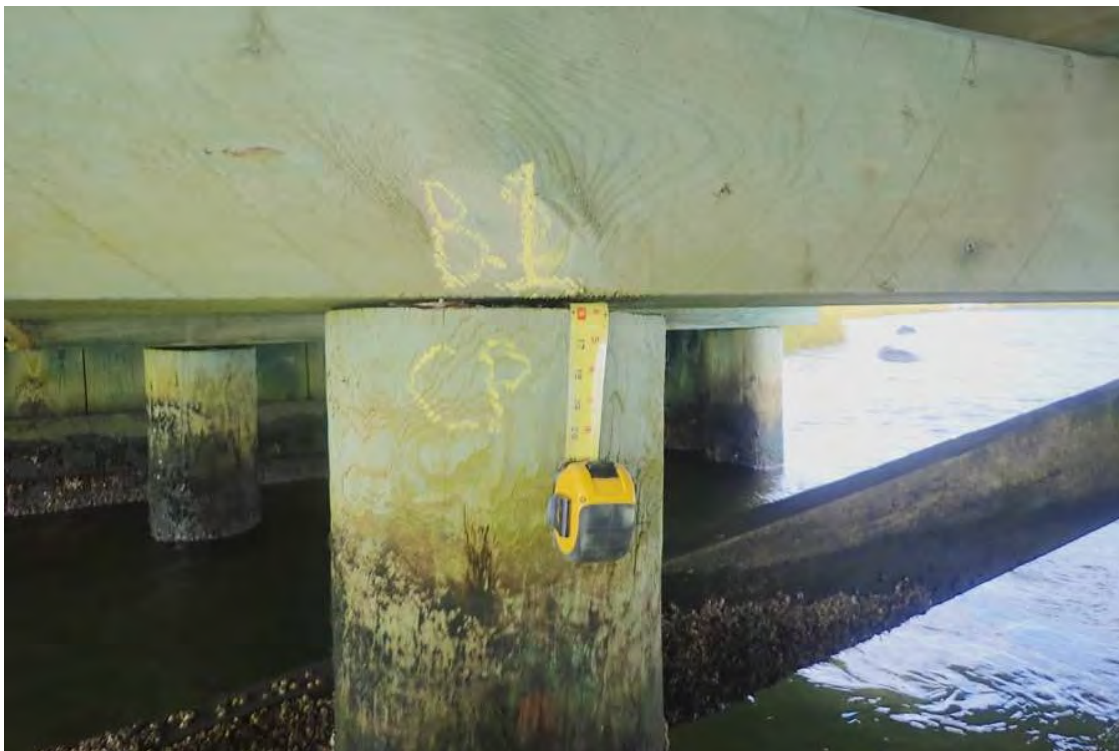
- Scattered irregular pile cut offs reducing bearing area & creating $\leq 1/2$ " gaps between cap, see photo 18.
- Bent 1 southwest pile, minor wane with rust staining, see photo 19.

Photo 18: Bent 1 center pile east face, irregular cut off w/ gap between cap.

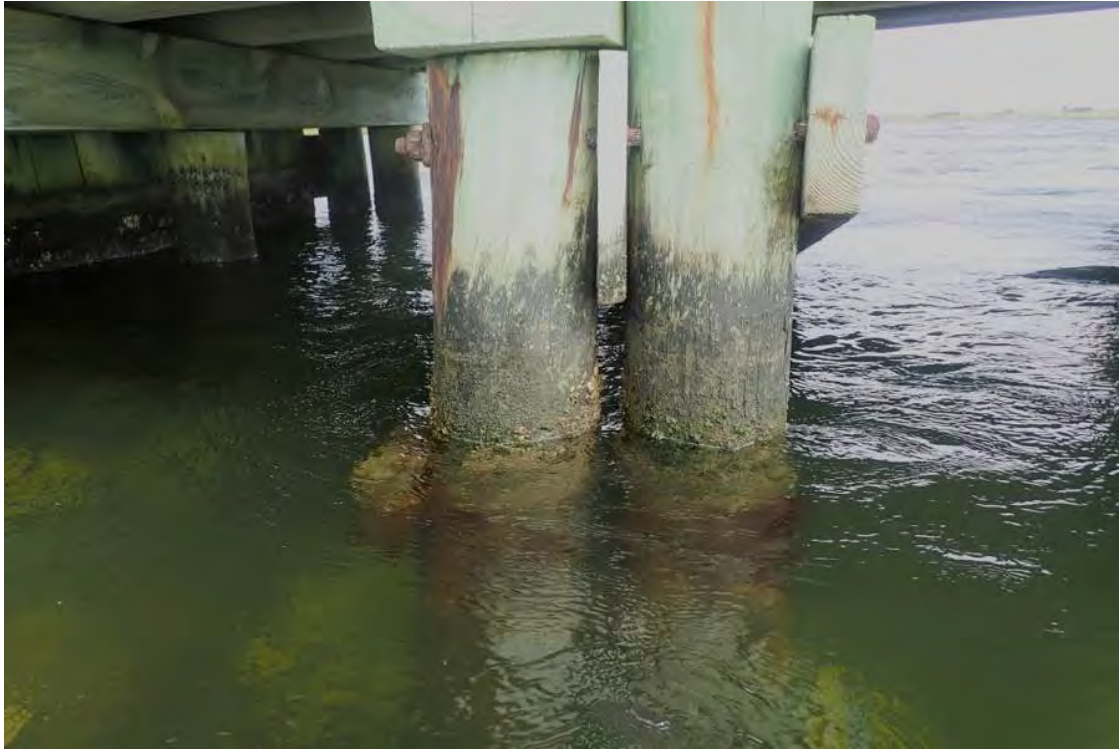
Photo 19: Bent 1 south piles, minor wane w/rust staining.

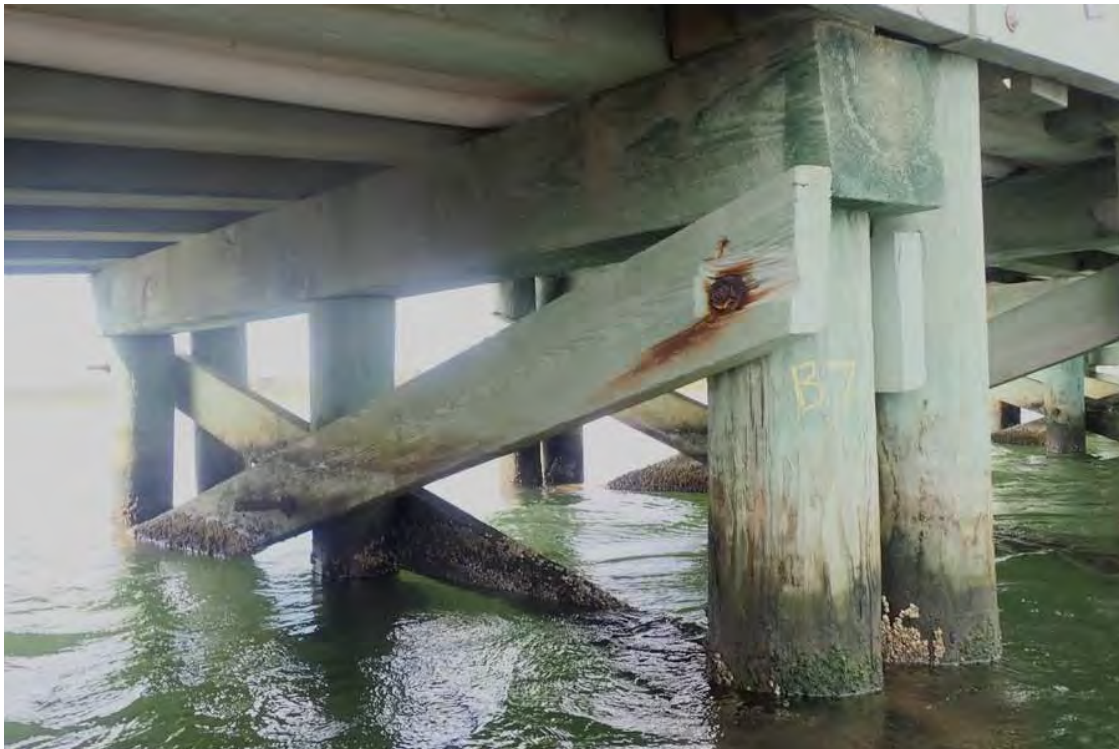
Moderate to heavy marine growth in tidal zone with scattered rust staining from fasteners, see photo 20.

All fasteners and angles exhibit minor to moderate corrosion, see photos 20 & 21.

Photo 20: Bent 7 north end of east diagonal bracing, corrosion of fastener hardware.

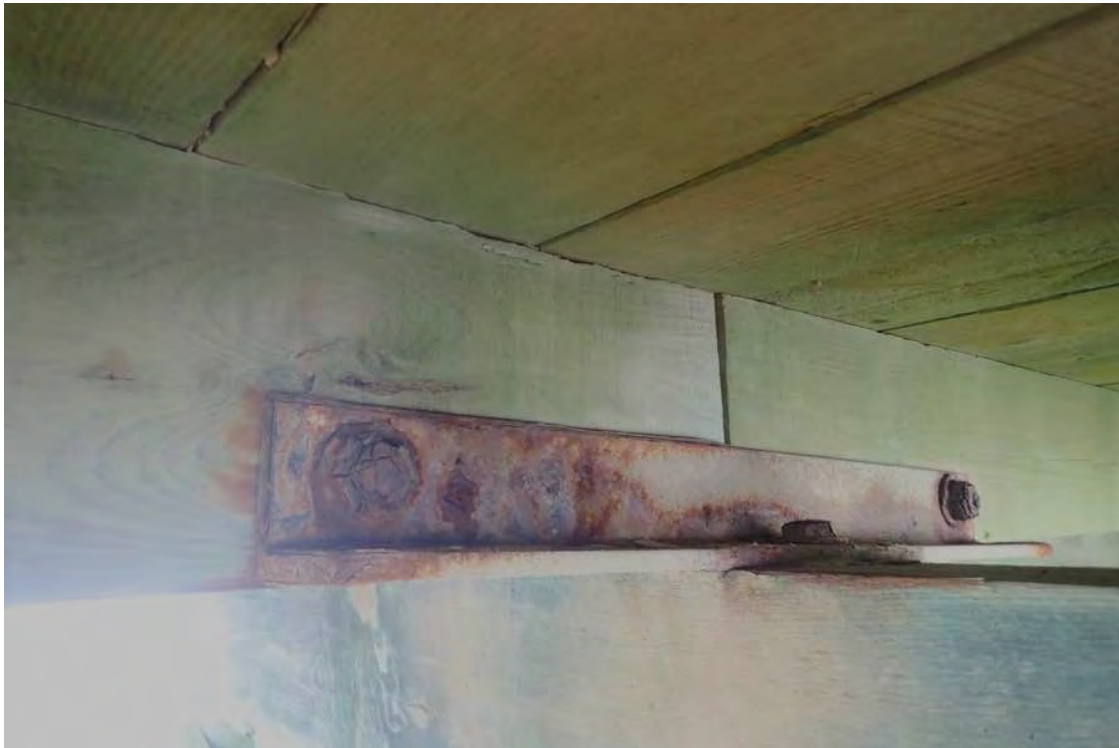
Photo 21: Bent 2 Beam 3 south keeper, corrosion to fastener hardware & angle.

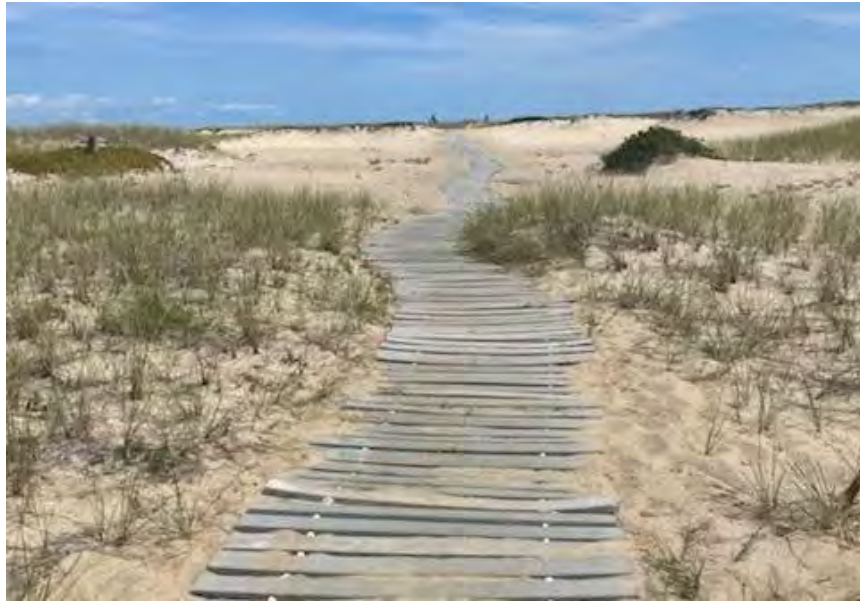
One boardwalk is maintained near the Dike Bridge on the adjacent Cape Poge Wildlife Refuge and provides access through the dunes for visitors parking or accessing the beach at the Dike Bridge (Figure 4). While technically on the Cape Poge Wildlife Refuge, this boardwalk provides access to pedestrians visiting Leland Beach just to the south. This boardwalk was constructed to minimize conflicts between pedestrians and OSVs (i.e., for visitor safety) and to reduce impacts to dune vegetation. This boardwalk is approximately 400 feet long and made of Trex (recycled synthetic material) and thus very little maintenance is needed.

Figure 4: Boardwalk to Swimming Beach on Cape Poge Wildlife Refuge

At the Dike Bridge, pedestrians have access to a boardwalk (cable and synthetic wood design (Figure 4) that provides direct access to the swim beach and the rest of the Cape Poge Wildlife Refuge to the north. Alternatively, pedestrians can then walk south to Leland Beach. The boardwalk is assessed annually by Trustees staff and routine maintenance is performed. This includes but is not limited to leveling and re-aligning the boardwalk by hand. Signs advising visitors of uneven surface are maintained.

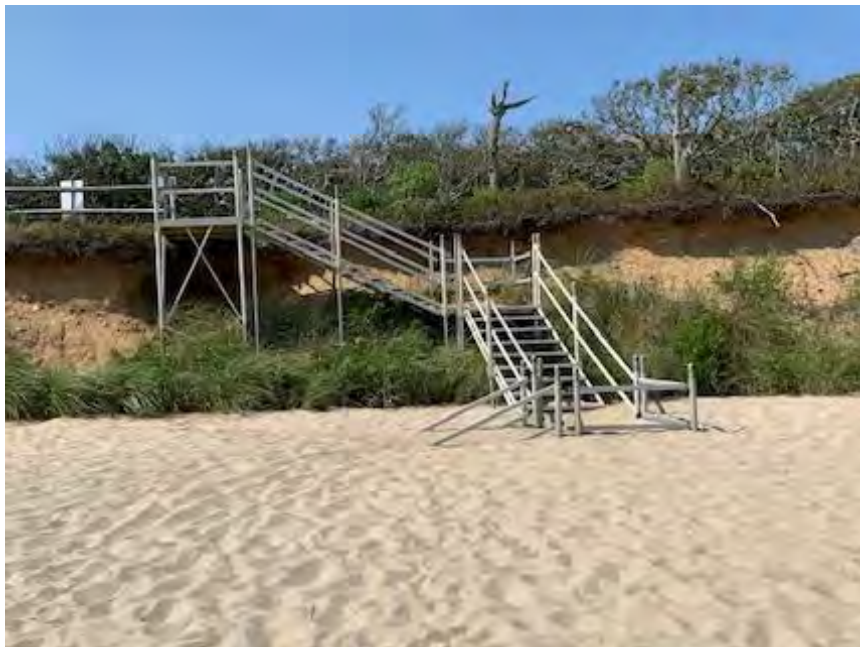
Aluminum stairs are maintained at Wasque to allow visitors to access the beach from the parking lots (Figure 5). Prior to the 2006 Norton Point Beach breach, wooden stairs were maintained at the Fisherman's Lot that provided access to Wasque Beach and Wasque Point, a popular fishing destination. This boardwalk and many acres of upland were eroded away as a result of the breach. After the beach site closed in 2015, the Trustees replaced the wooden stairs with modular and removable aluminum stairs. These stairs require little maintenance but may need to be adjusted annually for safety and can be removed, if necessary, to prevent storm damage or loss given enough warning.

Figure 5: Modular stairs at Wasque Reservation

There are two lots at the Wasque Reservation that visitors can park at and access the beach. The stairs at the Fisherman’s Lot (Figure 5) allow visitors to navigate the coastal bank safely without creating erosion. These stairs are aluminum and modular to allow removal should erosion and storms threaten their integrity and require little maintenance. Visitors to the Swim Beach Lot can access the beach via a pedestrian path directly between the beach and the lot (Figure 4). This path is also used by staff to access the beach via ATV/UTV for resource management and enforcement. OSV permit holders are not allowed access to the beach via this path. This path is graded occasionally to maintain safe passage for pedestrians and the Trustees may use “traction mats” for staff access using UTV/ATVs. Fencing is used to define this access and prevent erosion and loss of vegetation.

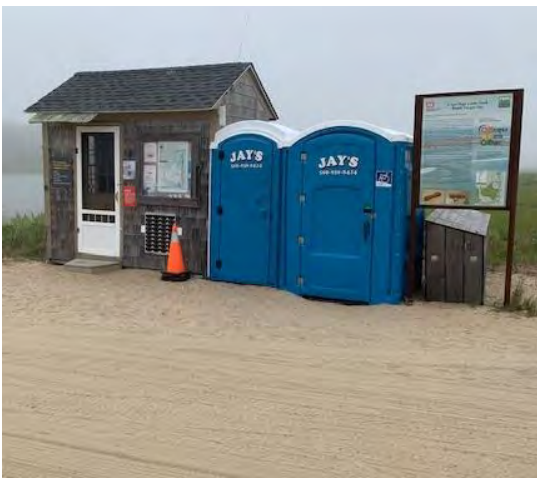
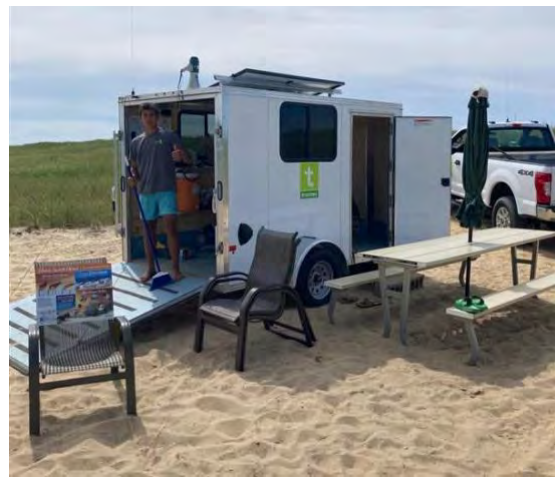
The Trustees maintains a gatehouse at the western end of Norton Point Beach and another gatehouse on the beach side of the Dike Bridge (Figure 6). Both of these gatehouses are staffed seasonally. The Dike Bridge gatehouse is constructed of wood and can be moved with heavy equipment. The Norton Point gate house is an aluminum enclosed trailer easily moved with a pick-up truck. The Norton Point gatehouse was moved onto a refurbished OSV trail in 2022 as part of the Norton Point Dune Restoration and Beach Resiliency project approved by the Edgartown Conservation Commission in July 2021. The gatehouse is approximately 0.4 miles from the entrance of Norton Point Beach at Katama Road and Atlantic Avenue.

Figure 6: The Trustees gatehouses at beach entrances. East Beach/Dike Bridge Gatehouse (left) and historic Norton Point gatehouse (right).

The Dike Bridge gatehouse also includes two seasonal portable bathrooms, including one with universal access, and a small storage locker. The portable bathrooms are removed seasonally. When present, bathrooms are pumped twice a week and cleaned daily (Figure 6).

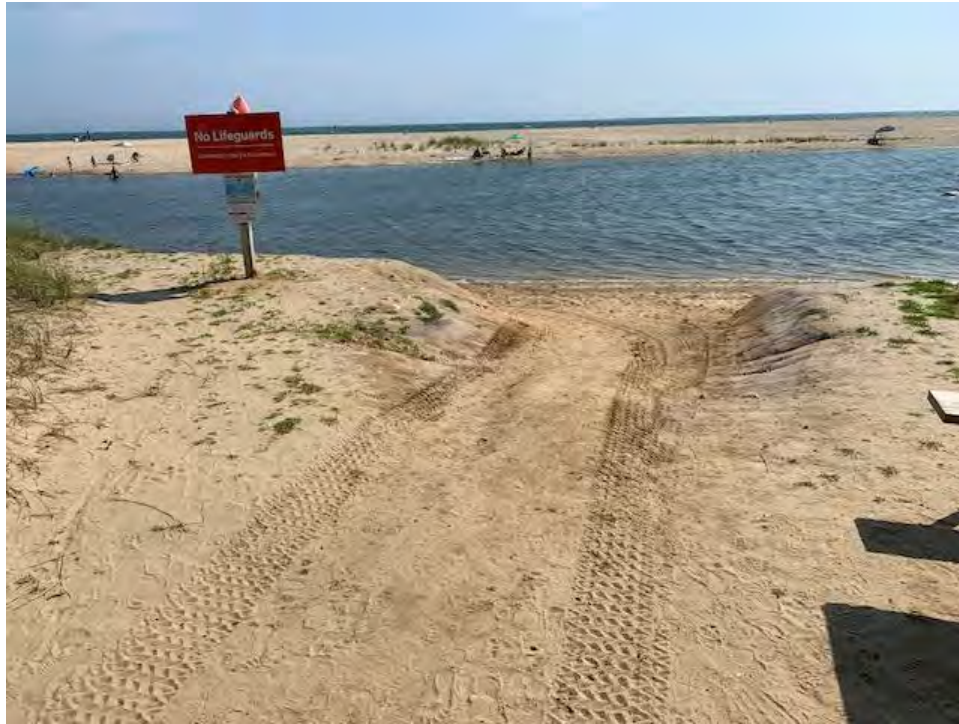
Figure 9: Wasque Swim Beach pedestrian and staff OSV access path.
