Town of Edgartown
Cape Pogue DCPC
SUPPLEMENTAL MATERIALS
June 30 5:00 P.M.

STRUCTURES INSPECTION FIELD REPORT

BR. DEPT. NO.
E-07-004

CITY/TOWN EDGARTOWN	8-STRUCTURE NO. E07004-43B-MUN-NBI	11-Kilo. POINT 001.046	41-STATUS P:POSTED	90-ROUTINE INSP. DATE SEP 29, 2021
07-FACILITY CARRIED HWY DIKE RD	MEMORIAL NAME/LOCAL NAME	27-YR BUILT 1995	106-YR REBUILT 0000	YR REHAB'D (NON 106) 0000
06-FEATURES INTERSECTED WATER POUCHA POND	26-FUNCTIONAL CLASS Rural Local	DIST. BRIDGE INSPECTION ENGINEER G. Simpson		
43-STRUCTURE TYPE 702 : Timber Stringer/Girder	22-OWNER Town Agency	21-MAINTAINER Town Agency	TEAM LEADER J. Spiezio	
107-DECK TYPE 8 : Timber	WEATHER Sunny	TEMP. (air) 10°C	TEAM MEMBERS A. DOWNING

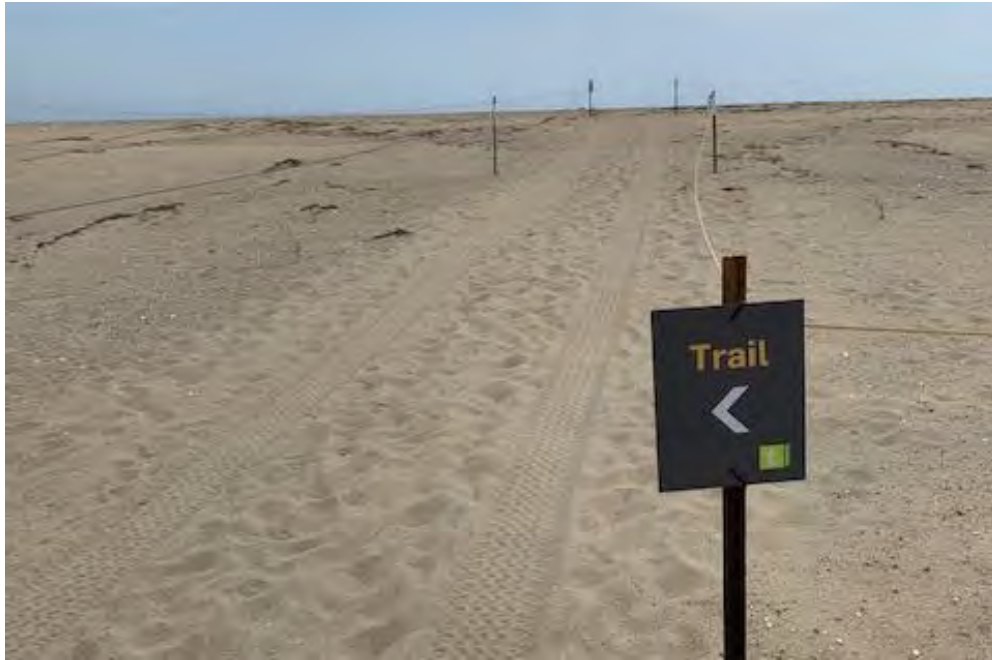
Figure 10: Example of fencing designating pedestrian and essential vehicle cross over at Wasque and Norton Point beaches.

On the beaches, restricted area fencing (post and rope; Figure 10) is erected for shorebird nesting habitat (seasonal) and dune protection. This fencing protects nesting shorebirds, nests, and chicks from human disturbance and the Maritime Beach Strand and Maritime Dune natural communities (both priority Community Types in Massachusetts) from foot traffic. This fencing is particularly important for protecting dune building and beach resiliency. Fencing is erected along nearly all 12 miles of beach from April 1st – Sept 30th (significant storms may impact the duration that fencing is in place after the breeding season is over). Fencing is particularly important during this period due to high visitation, but sections may be left in place longer to protect sensitive resources (e.g., migrating shorebirds, rare plants, dunes, coastal banks) from visitors and pets. Current dune protection policies and regulations currently in place include the following.

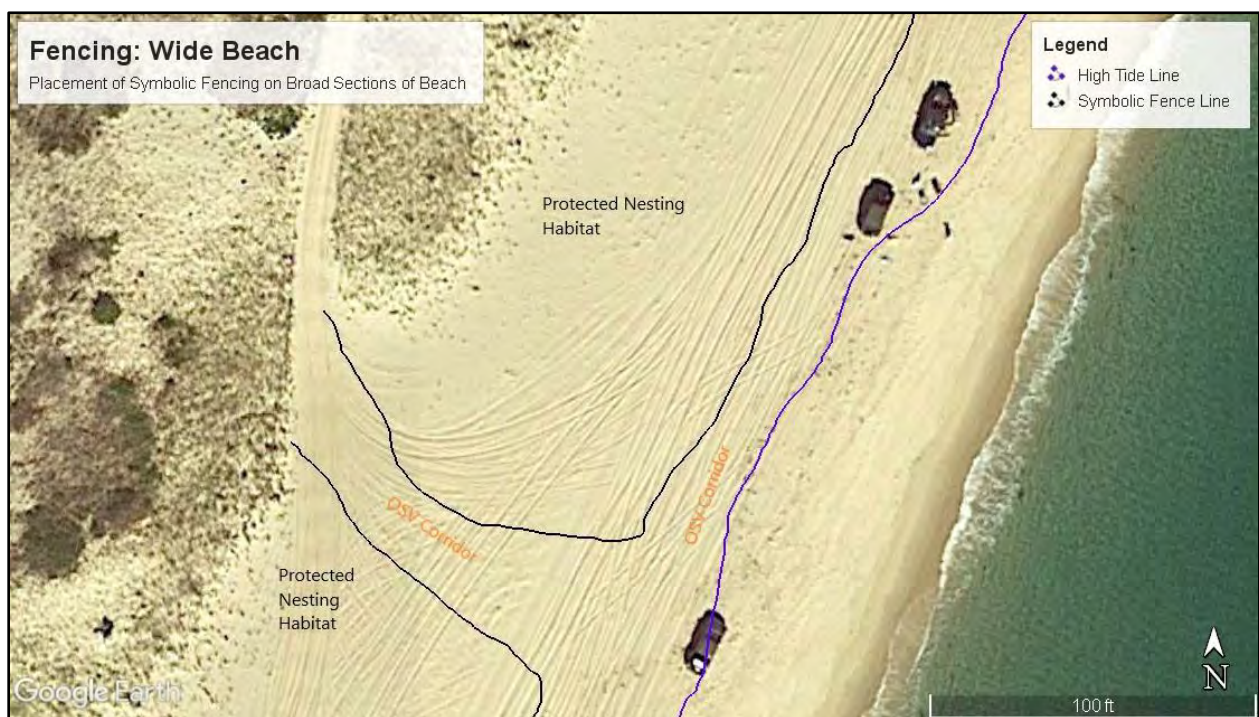
Figure 13: Example of fence placement for wide sections of beach and access points. OSVs are restricted to defined corridors allowing passage and, where desired, parking above the high tide line.

between the fence line and the high tide line and or berm (Figure 13 and Figure 14). The inland edge of a corridor should be as far as possible from the toe of the dune while still leaving room for safe OSV travel on the beach. OSV corridors are least 10 feet seaward from the seaward-most extent of vegetation or Spring tide. This provision complies with the 1994 Guidelines described above. When disturbance is minimized, dunes grow and expand, increasing the resilience of our beaches and the continued availability of them for access, including OSV. If there is insufficient space for an adequate corridor between the lowest vegetation and the high tide line, that section of beach is not wide enough to support appropriate OSV use and shall be closed to OSV traffic until such time as beach accretion produces space for an adequate corridor. Conversely, should the beach and dunes overwash, OSV corridors may be reestablished following the guidelines. The potential length of the beach corridor is designated in blue in Figure 1 and will be open to OSV access when beach conditions can accommodate travel according to the guidelines in this Plan.

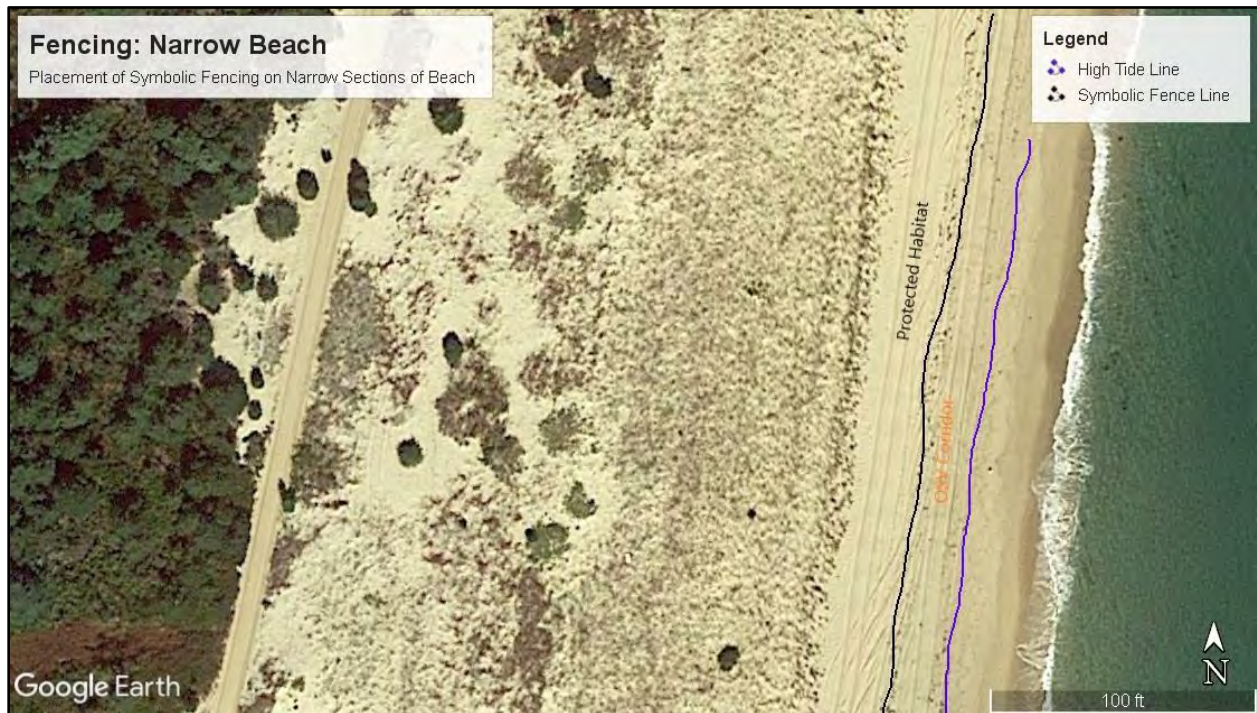
Figure 14: Example of fence placement on narrow sections of beach. As on wide sections, OSV use is restricted to a defined corridor above the high tide line. Narrow beaches may not provide parking in addition to a travel corridor.

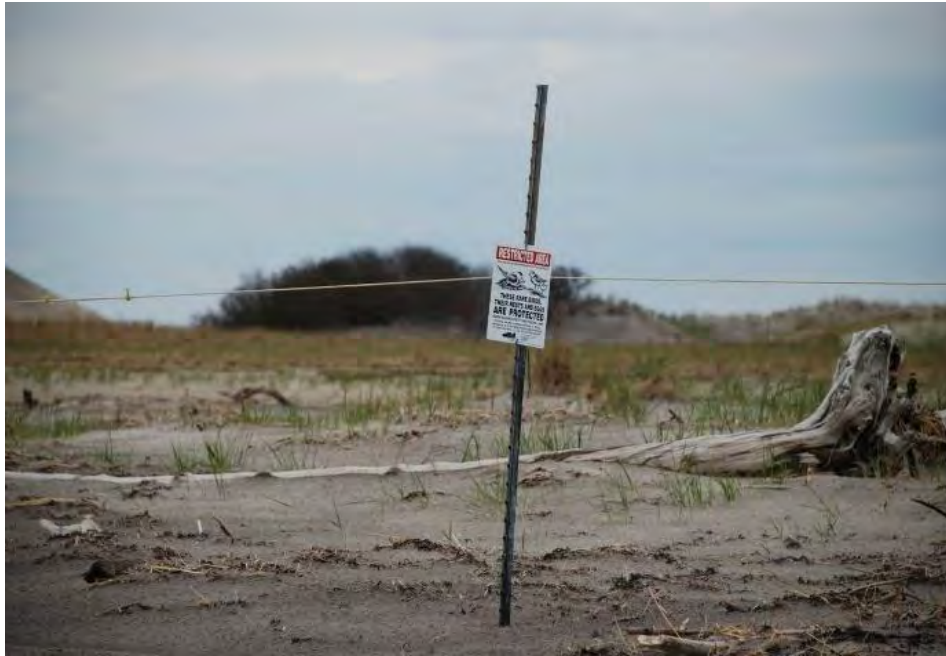
Figure 17: Typical example of fencing materials used to protect shorebirds from pedestrians and OSVs.

- Ecology staff delineates breeding habitat in early April and seasonal restricted-area fencing and signage are erected for shorebird nesting habitat (Figure 17). Fencing is adjusted throughout the season to ensure breeding birds have sufficient space – minimum of 50 yds from the closest plover nest, or up to the high tide line if there is not ample beach to include the 50 yd buffer. Fencing is maintained from April 1st through September or when breeding is complete and staff determine fencing is no longer needed.
