MASSACHUSETTS HIGHWAY DEPARTMENT
STRUCTURES INSPECTION FIELD REPORT

ROUTINE INSPECTION

BR. DEPT. NO. E-07-004

CITY/TOWN EDGARTOWN	8-STRUCTURE NO. E07004-43B-MUN-NBI	11-Kilo. POINT 001.046	41-STATUS A:OPEN	90-ROUTINE INSP. DATE SEP 16, 2003
07-FACILITY CARRIED HWY DIKE RD	MEMORIAL NAME/LOCAL NAME	27-YR BUILT 1995	106-YR REBUILT 0000	YR REHAB'D (NON 106) 0000
06-FEATURES INTERSECTED WATER POUCHA POND	26-FUNCTIONAL CLASS Rural Local	DIST. BRIDGE INSPECTION ENGINEER D. A. Palmer		
43-STRUCTURE TYPE Timber Stringer/Girder	22-OWNER Town Agency	21-MAINTAINER Town Agency	TEAM LEADER T. J. McKenna	
107-DECK TYPE Timber	WEATHER sunny	TEMP. (air) 70°C	TEAM MEMBERS S. R. WARN

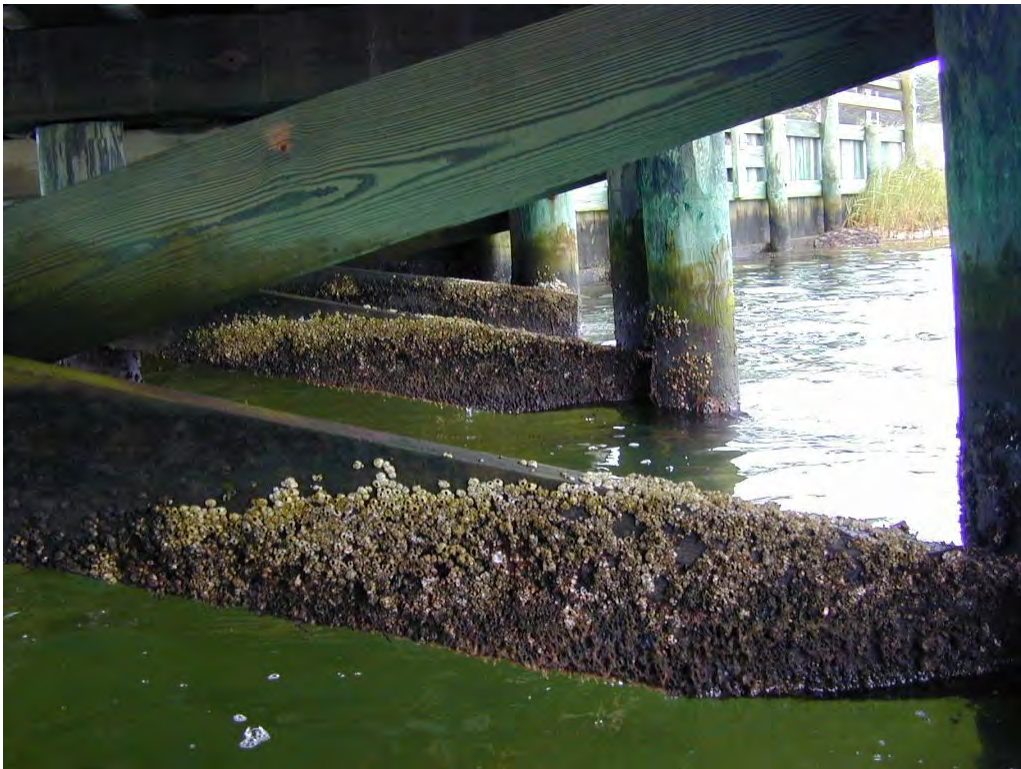
Photo 4: Build up of marine growth on all cross frames at high water mark down

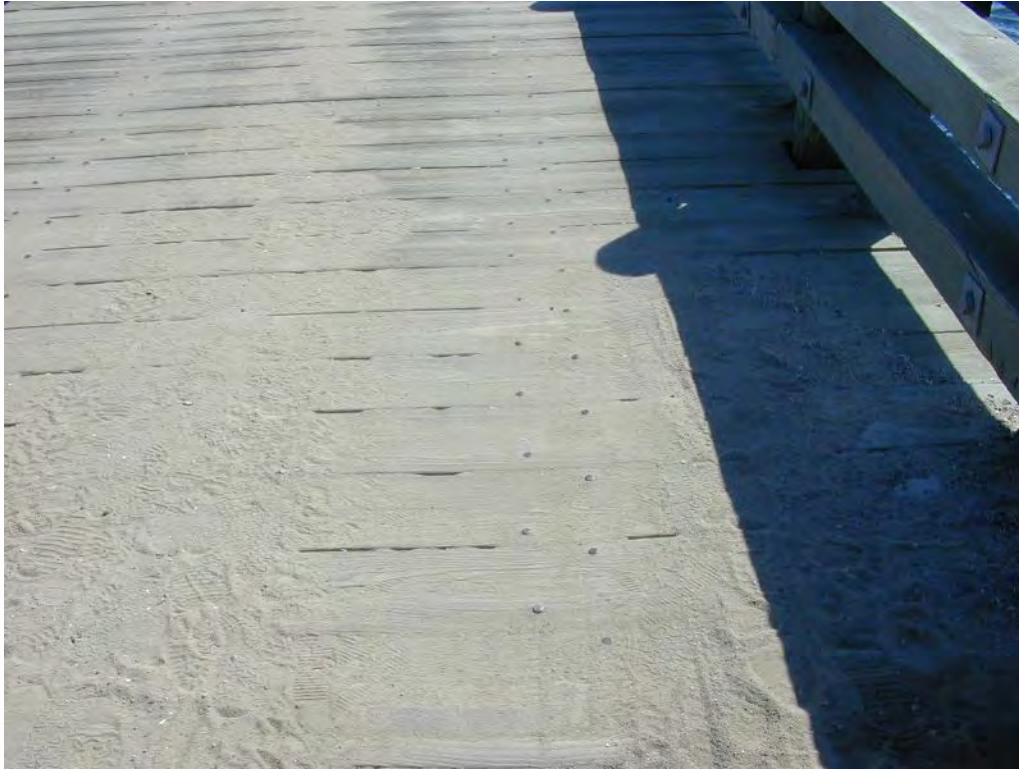
The wearing surface-deck is one layer of timber planking. The upper portion has wheel path wear with nails slightly lifted, see photo.

Photo 5: Roadway wheel path nails lifting.

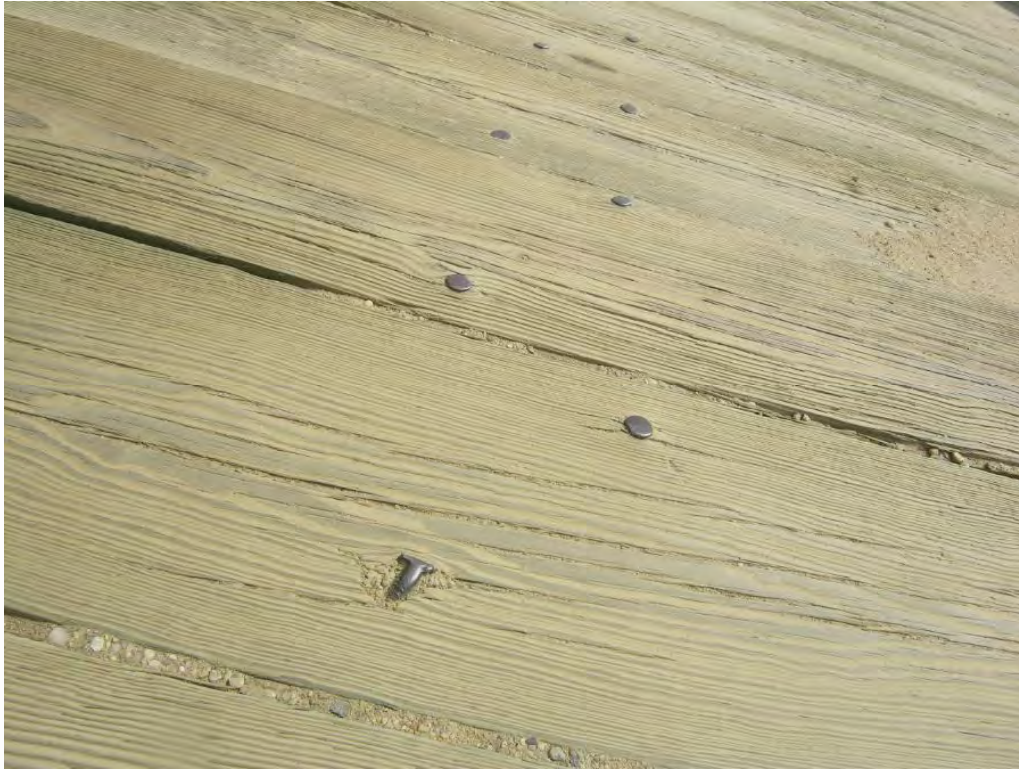
Photo 5: Two bent nails only.

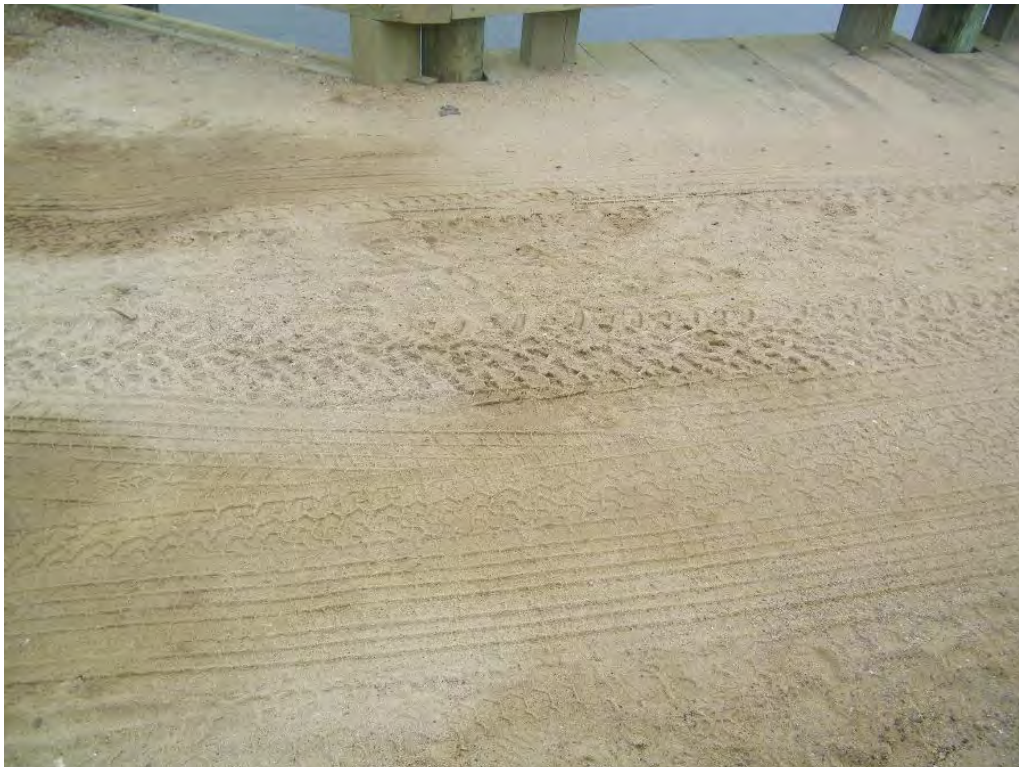
Photo 2: View west approx. and deck span #1, sand debris.

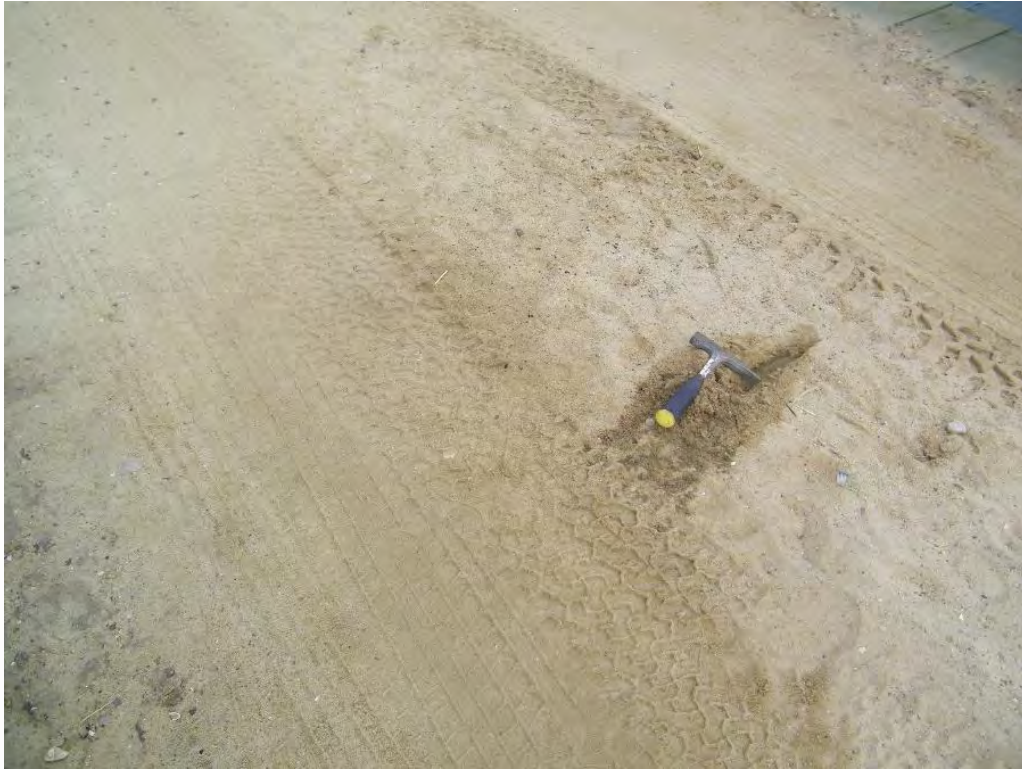
Photo 3: View east appro. and deck span #8, +/-2" deep sand debris.

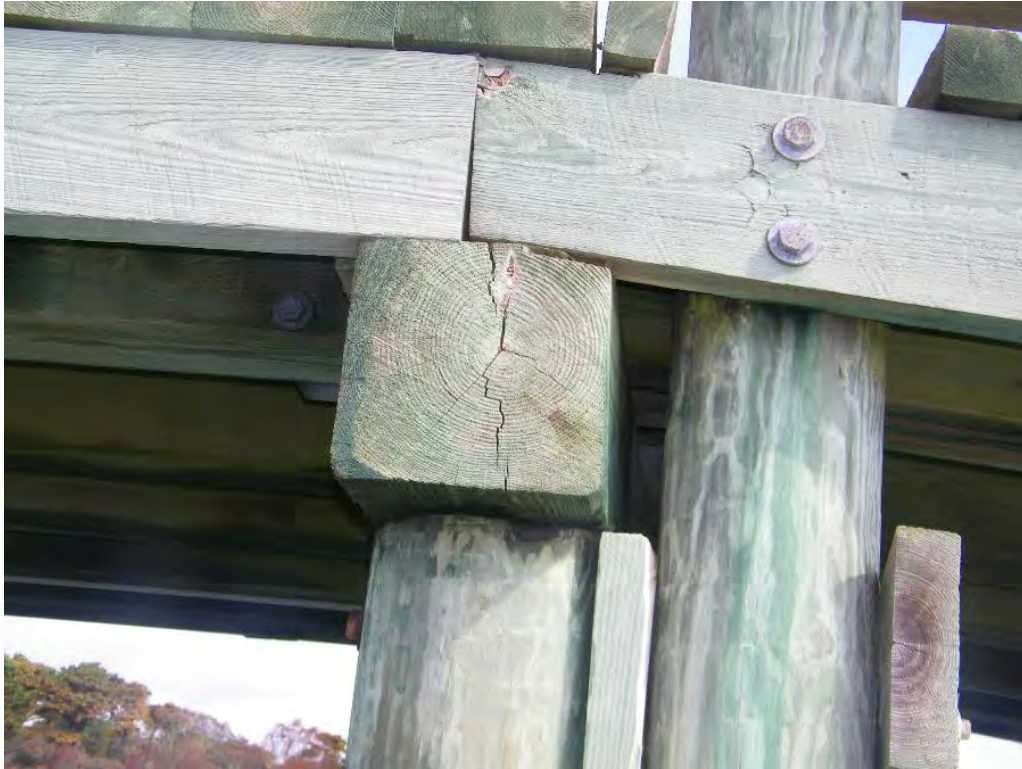
Photo 9: South end timber pier cap #6, +/-1/8" wide checking.

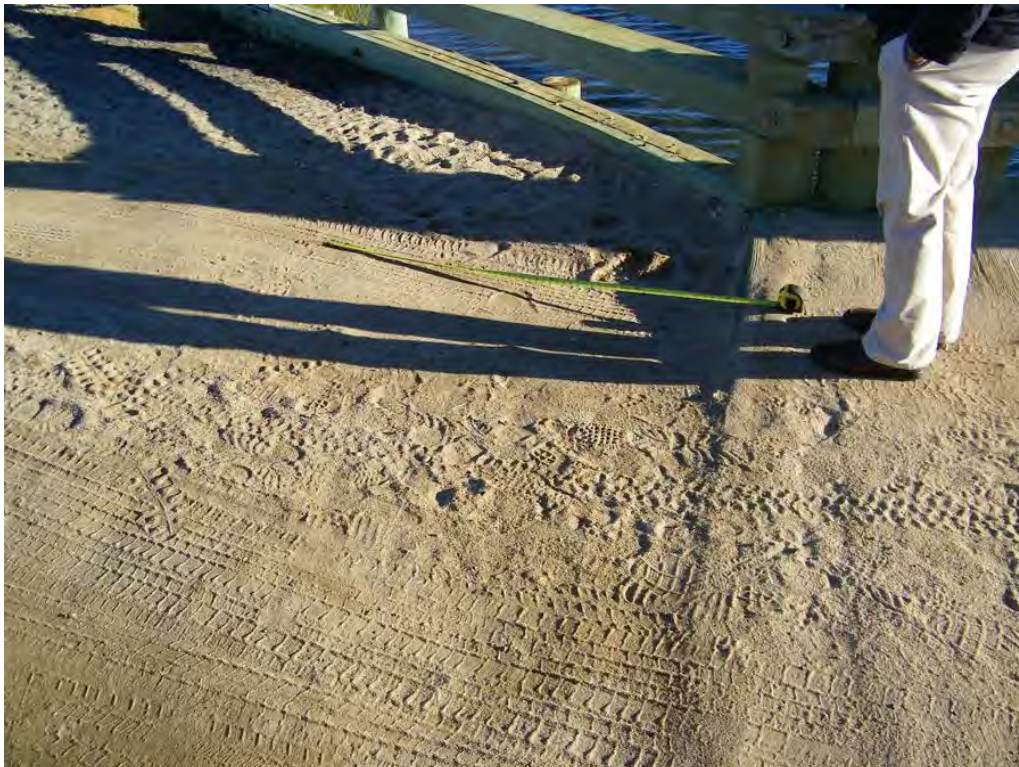
Photo 2: View west approach surface at span 1, 3' x 3' x 5" erosion/pothole.

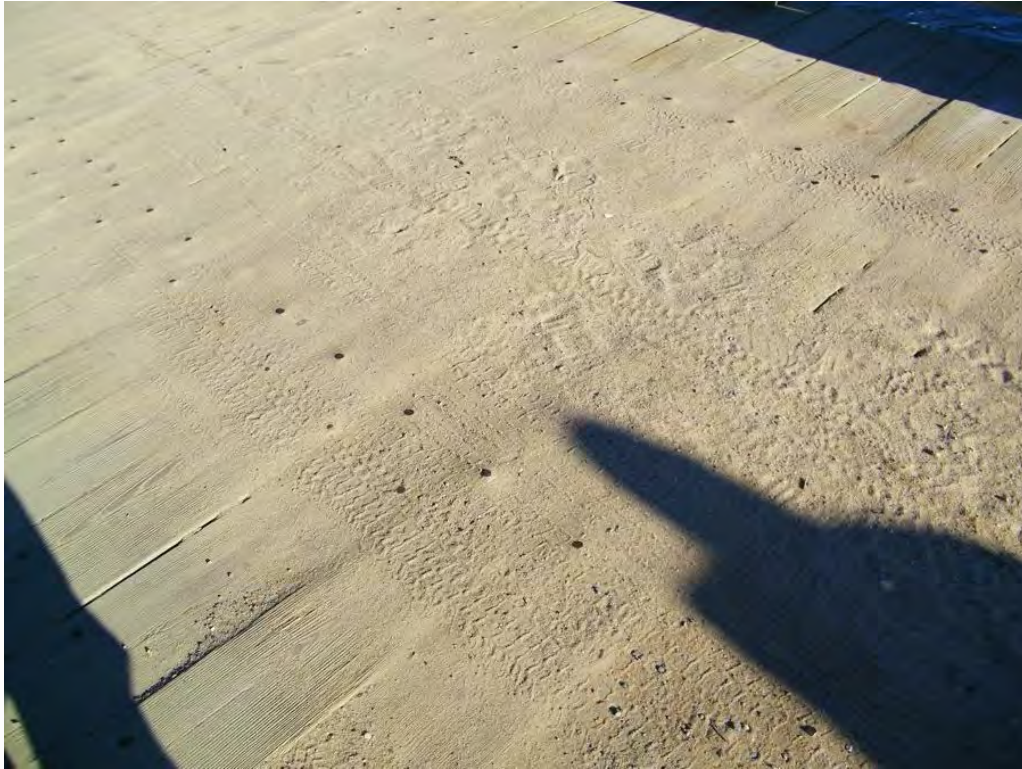
Photo 3: View east approach and deck span 8, 1/2" deep sand debris.

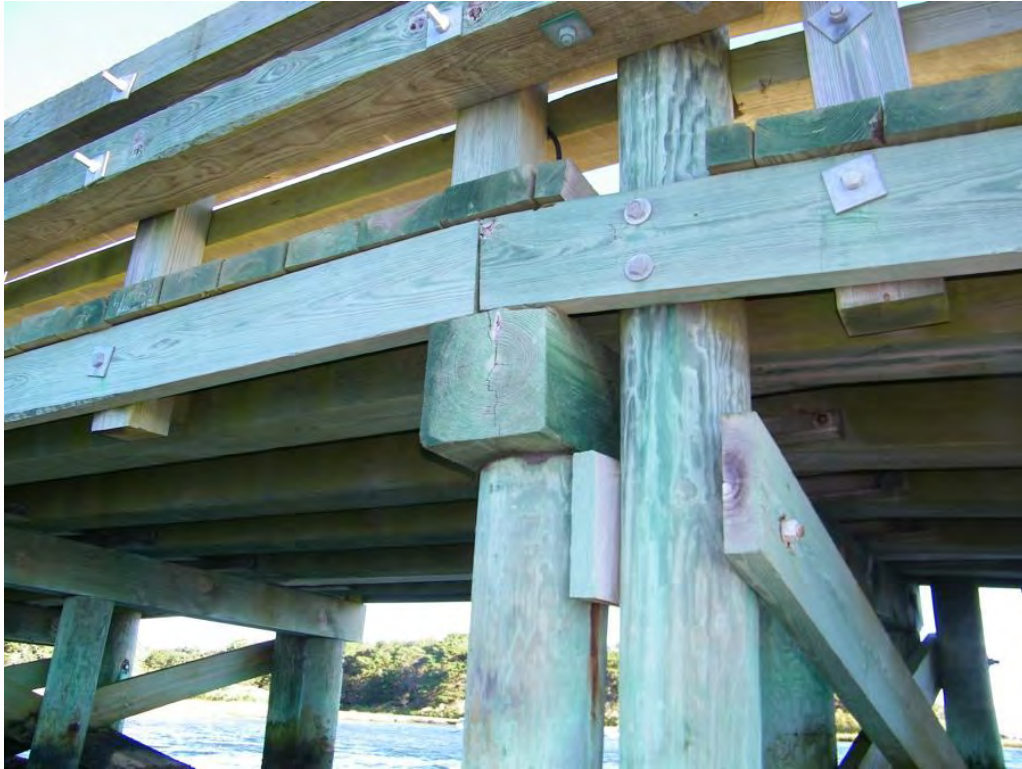
Photo 9: South end of timber pier cap 6, 1/8" wide splitting.

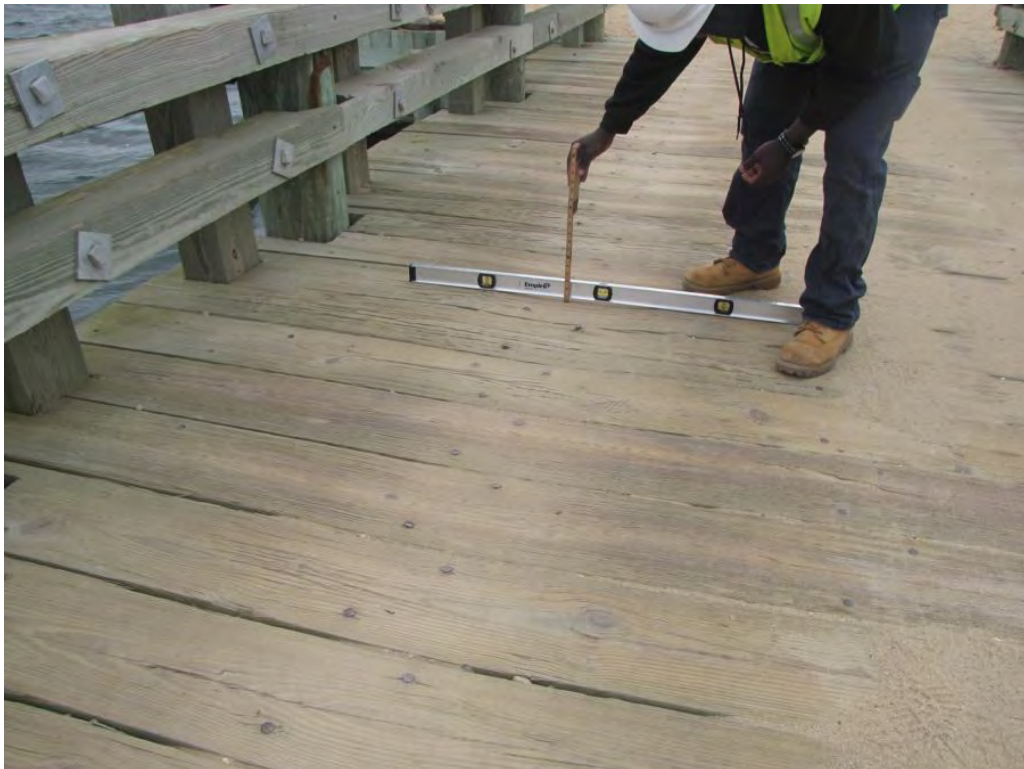
Photo 2: Overview of rutting

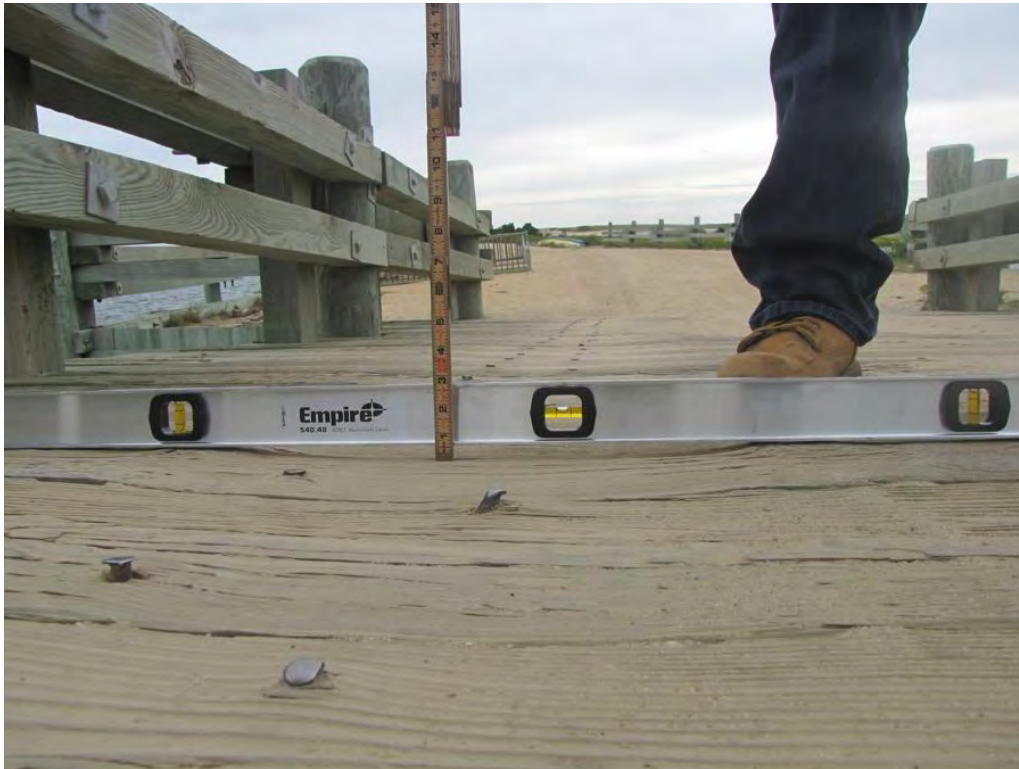
Photo 3: Close up of previous photo. Rutting and nails protruding up to 3/4"

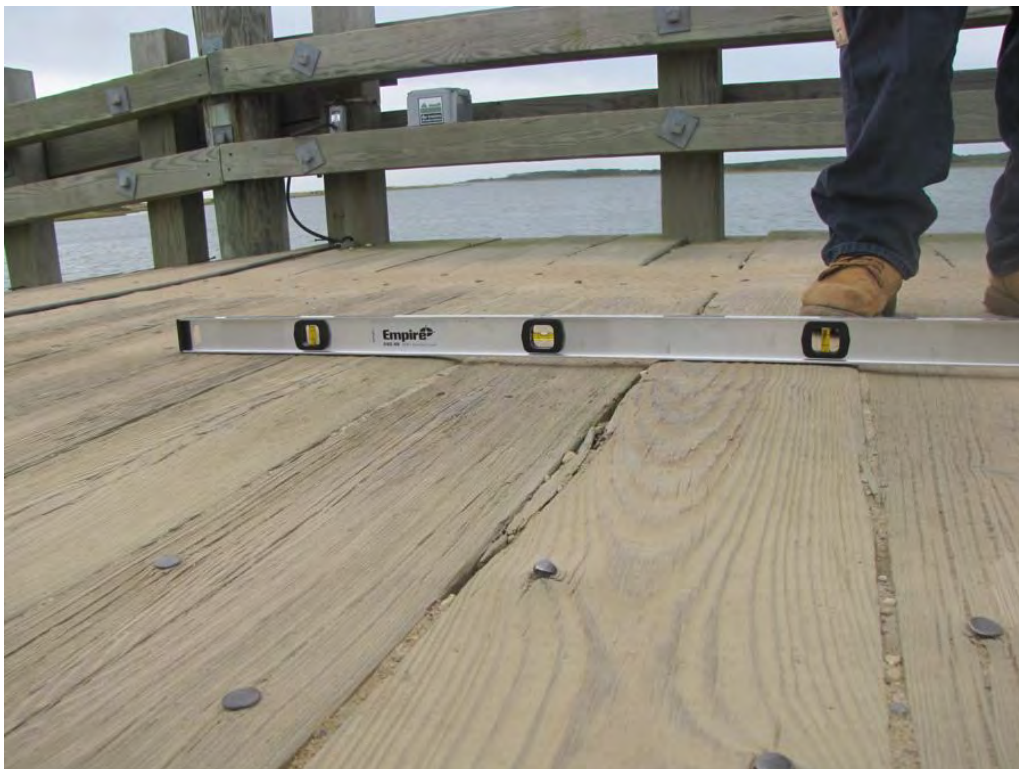
Photo 4: Typical washing boarding

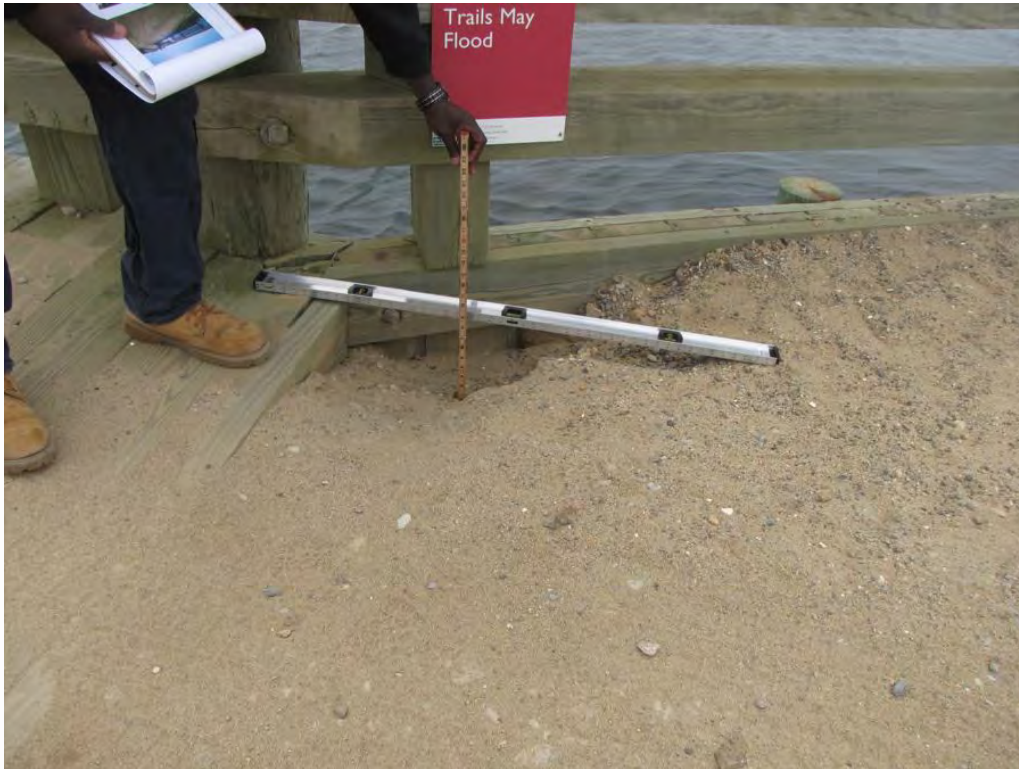
Photo 11: SW approach isolated sinkhole 2' W by 3' L by 1' D

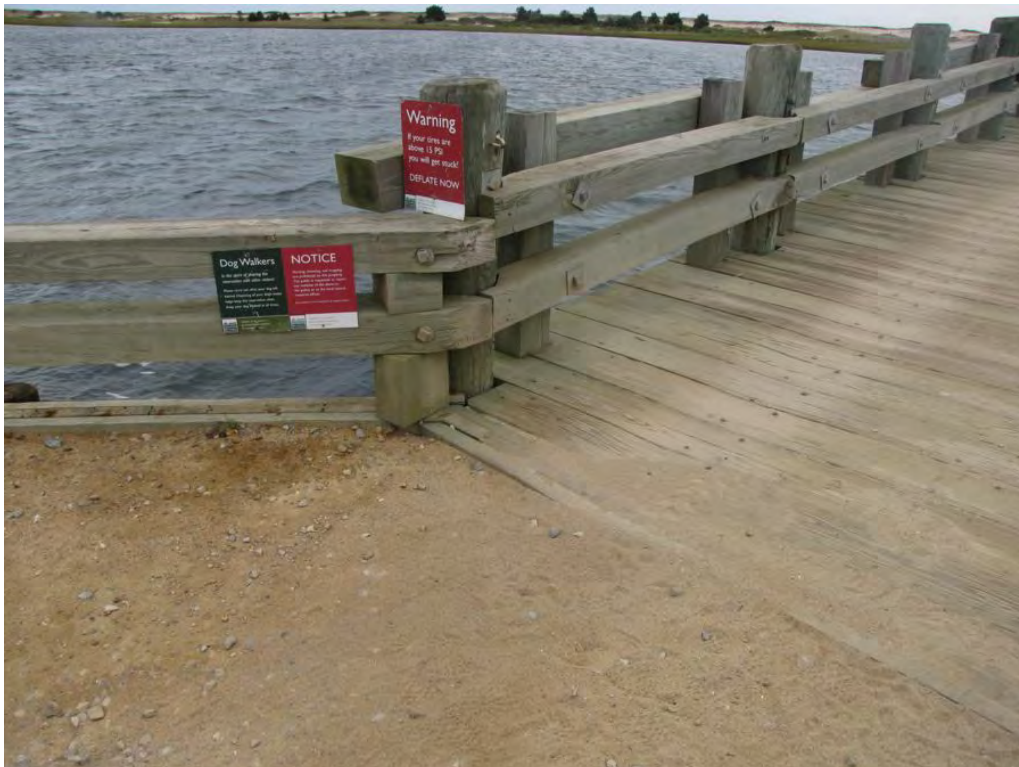
Photo 12: Overview of NW approach. Area has been filled in, since previous inspection

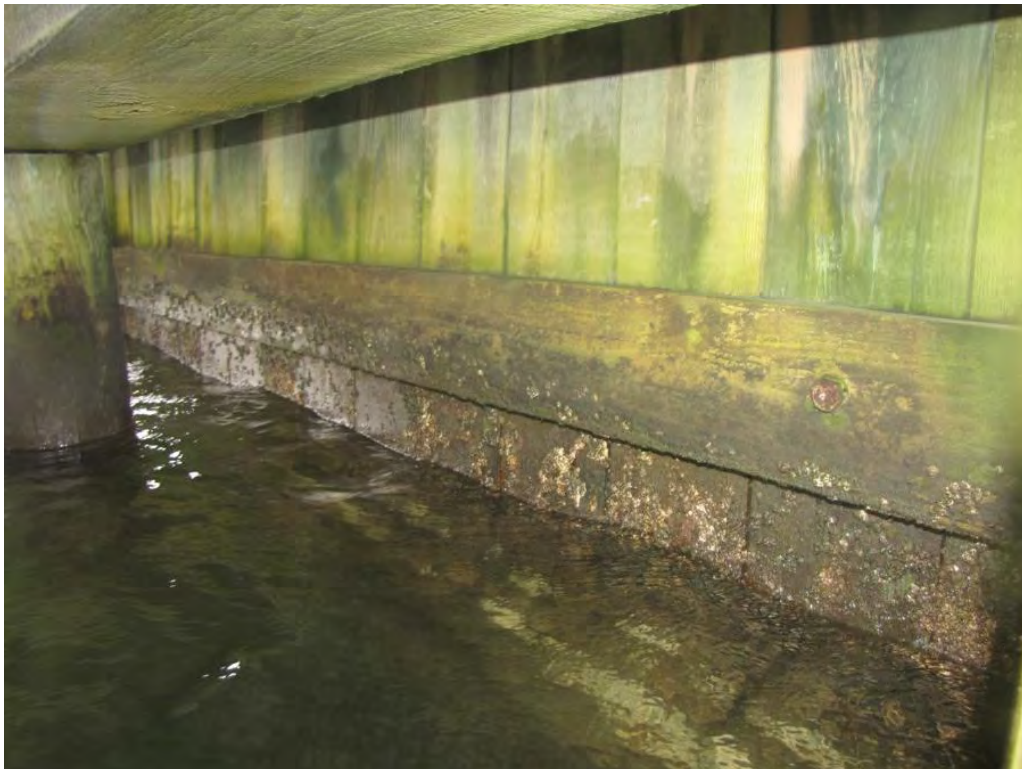
See photos 14 and 15 for typical piles along the wingwalls and breastwalls. Also see latest underwater dive report dated 9/5/2013.

Photo 14: Typical pile and bulkhead along abutments

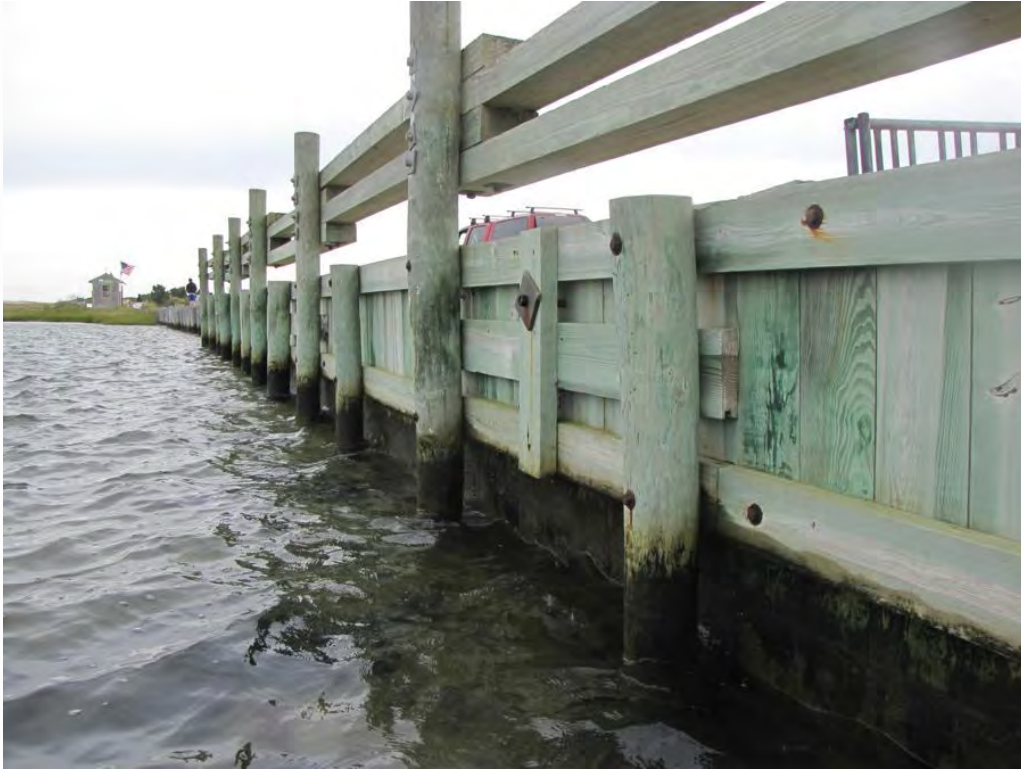
Photo 15: Typical wingwall and fasteners

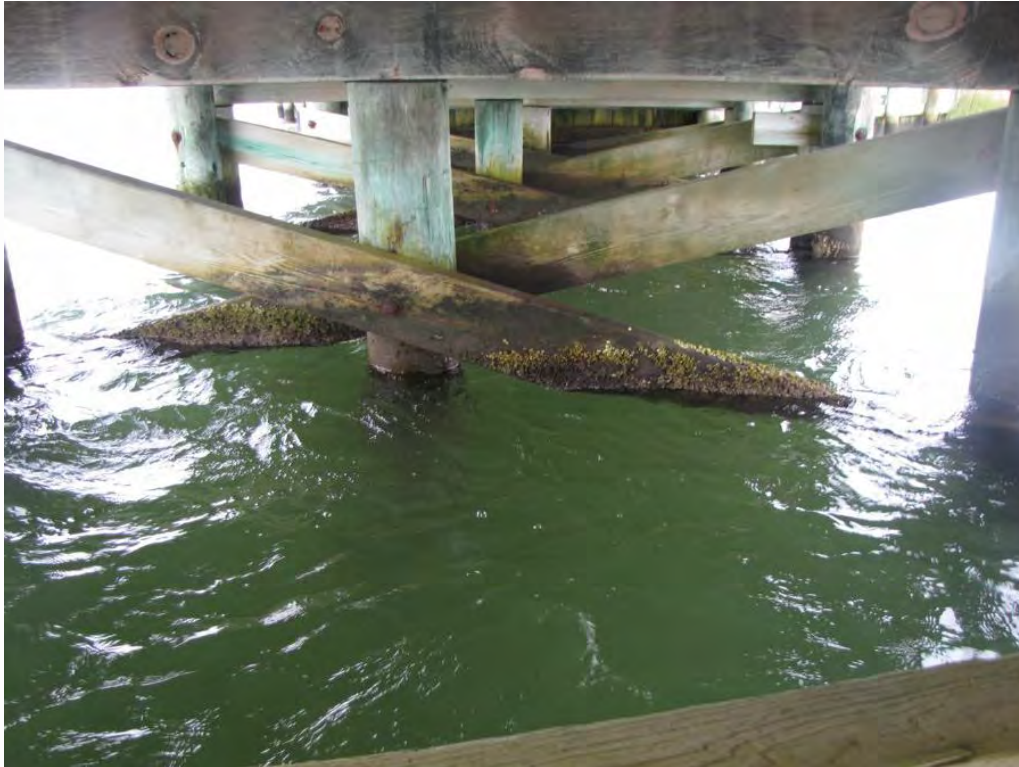
See photo 17 for typical view of typical piles and diagonal bracing. Also see latest underwater dive report dated 9/5/2013.

Marine growth is at and below the tidal zone, see photo 17. Also see latest underwater dive report dated 9/5/2013.

Photo 17: Typical overview of pile bents and diagonal bracing

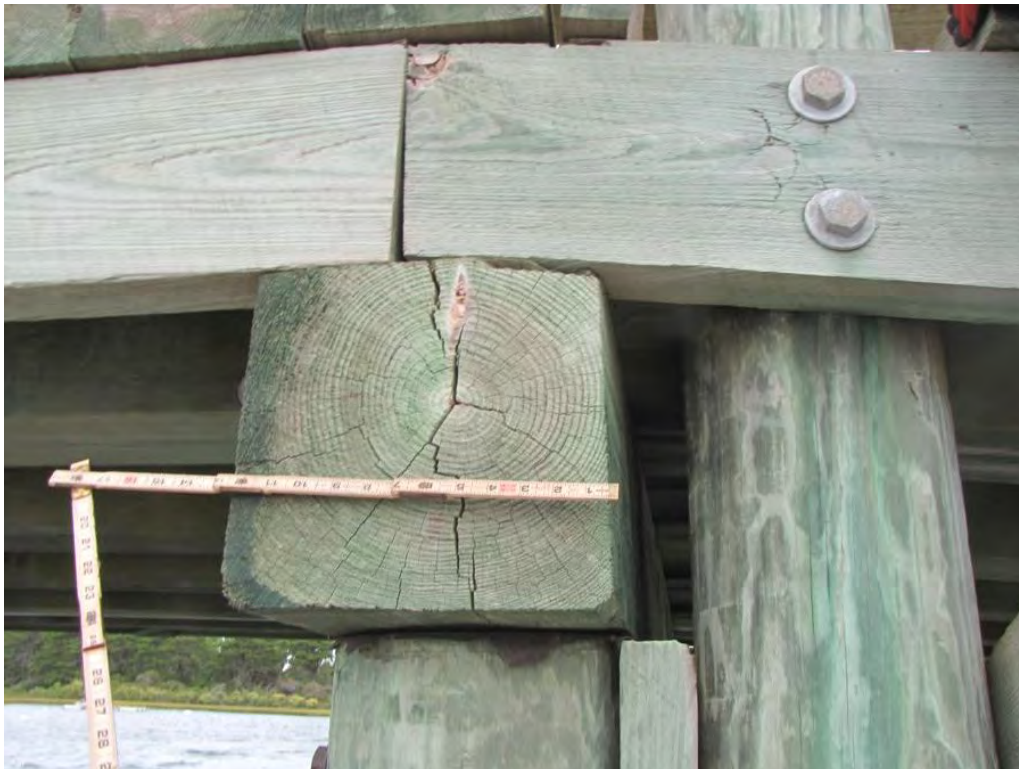
There is isolated 1/8" wide timber checking at the end of timber bent pier cap 6, see photo 18.

Photo 18: South end of timber pier cap 6. Isolated splitting up to 1/8" wide. No notable change

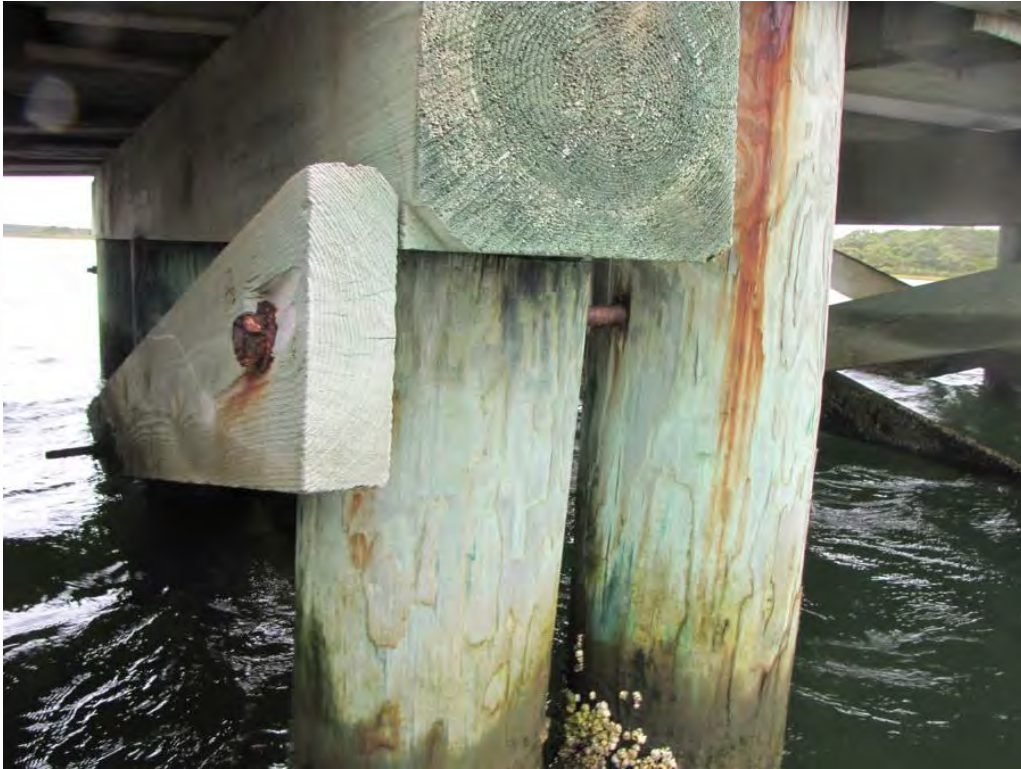
All of the fasteners in the tidal zone have some surface rust. Some scattered areas of corrosion and some section loss, see photos 19, 20, and 21 for examples. Also see latest underwater dive report dated 9/5/2013.

Photo 19: North bent fastener, isolated head of bolt starting to mushroom

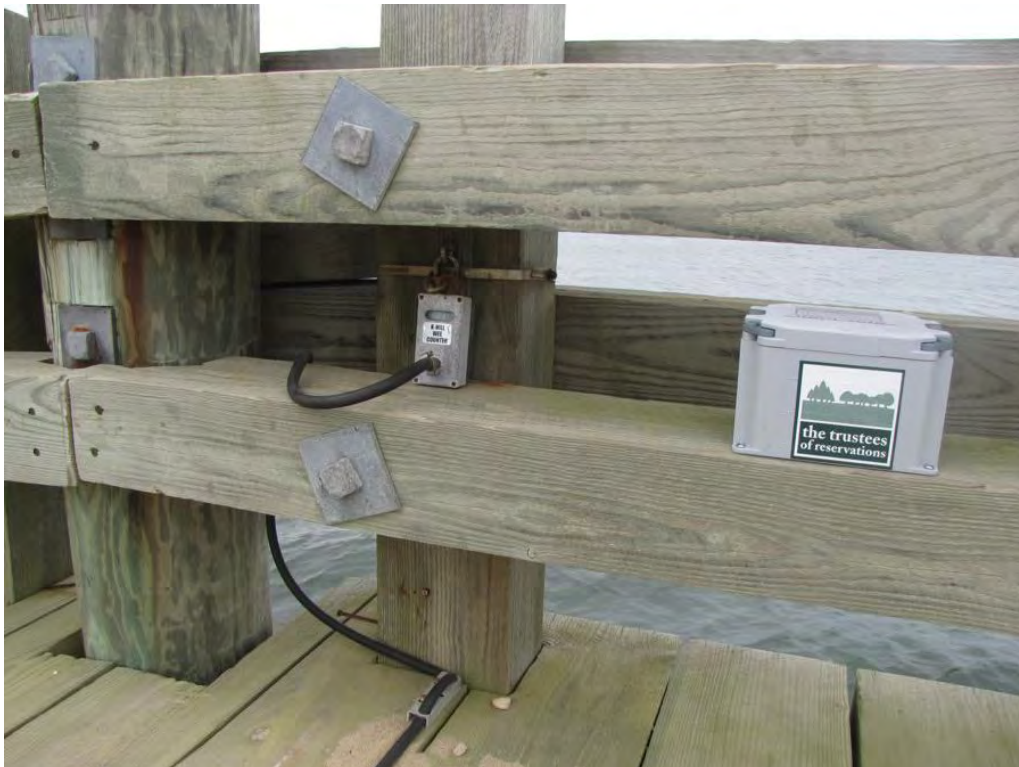
Photo 22: Overview of ADT counter. Previous and existing counter to the left (Count reads 37,668). New counter to the right, not connected up yet

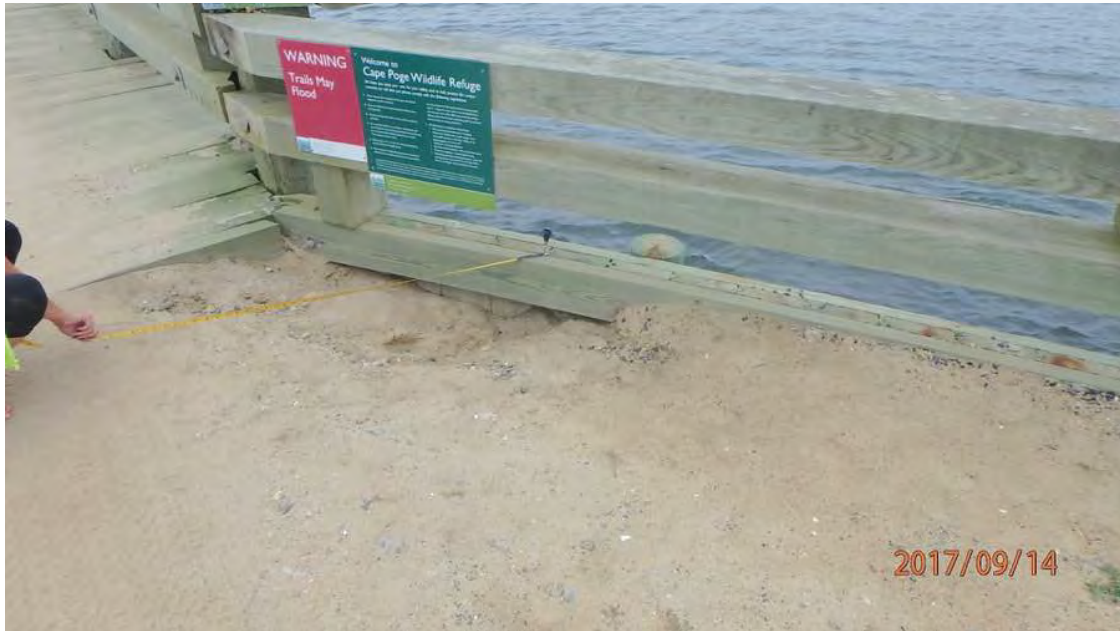
Photo 1: West approach, southwest corner erosion hole 7' x 2' x 10".

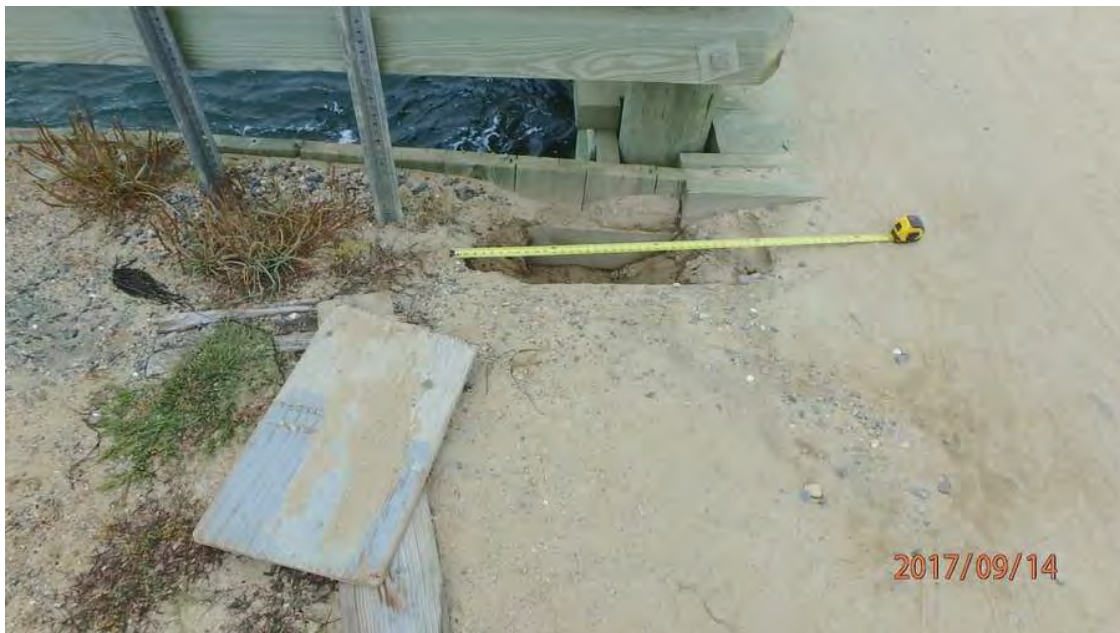
Photo 2: East approach, southeast corner erosion hole 3' x 20" x 14".

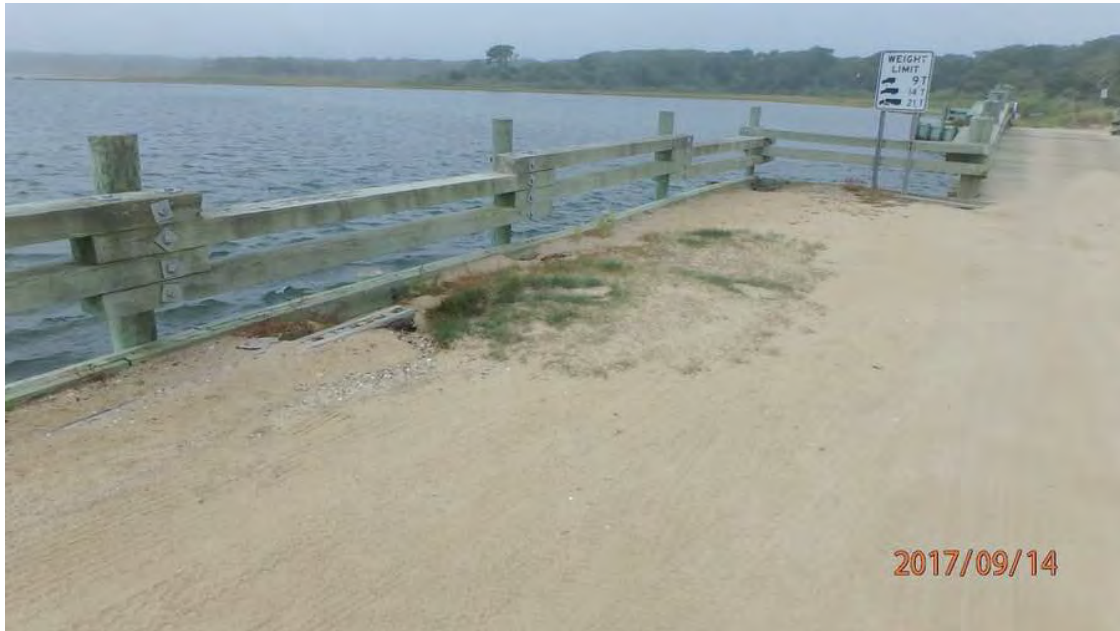
Photo 3: Southeast approach, minor erosion along retaining wall.

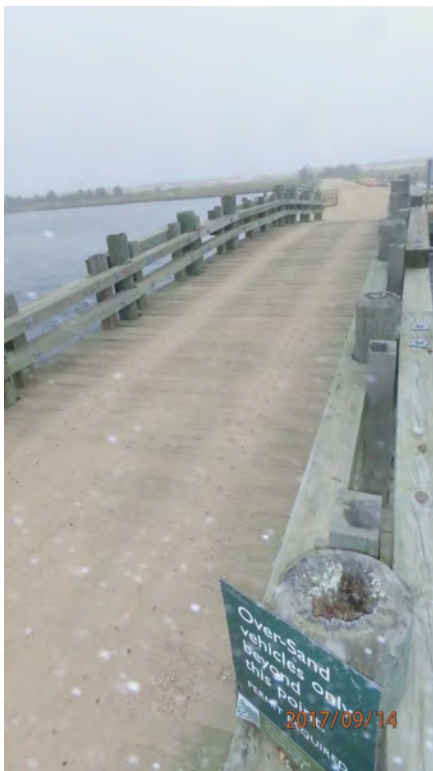
Photo 4: Looking east, general wearing surface condition.

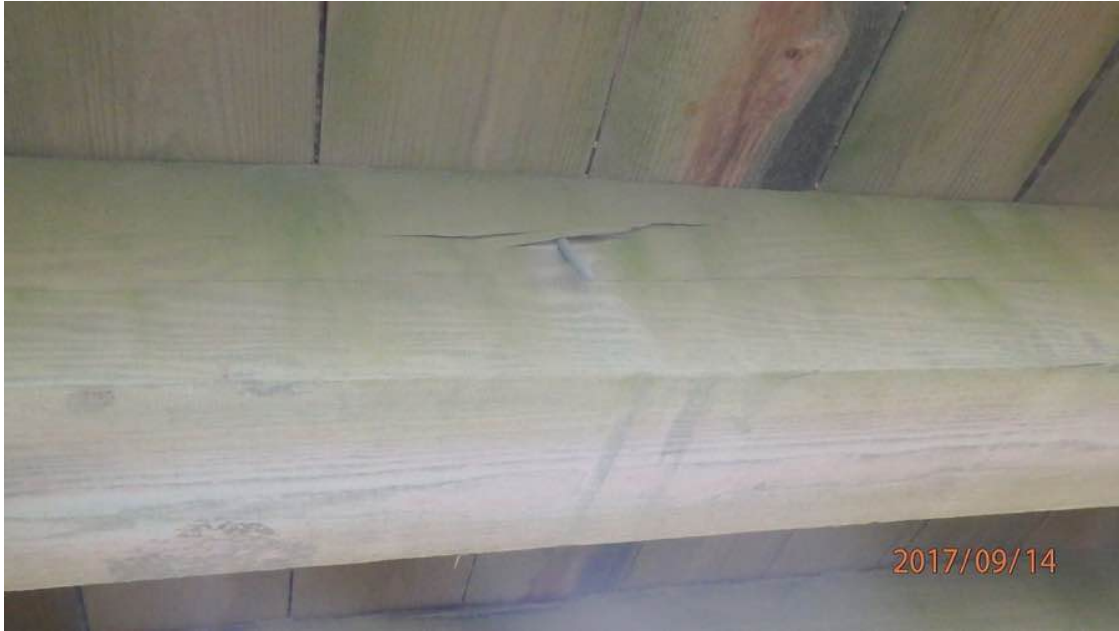
Photo 7: Scattered deck spikes puncturing side of beams.

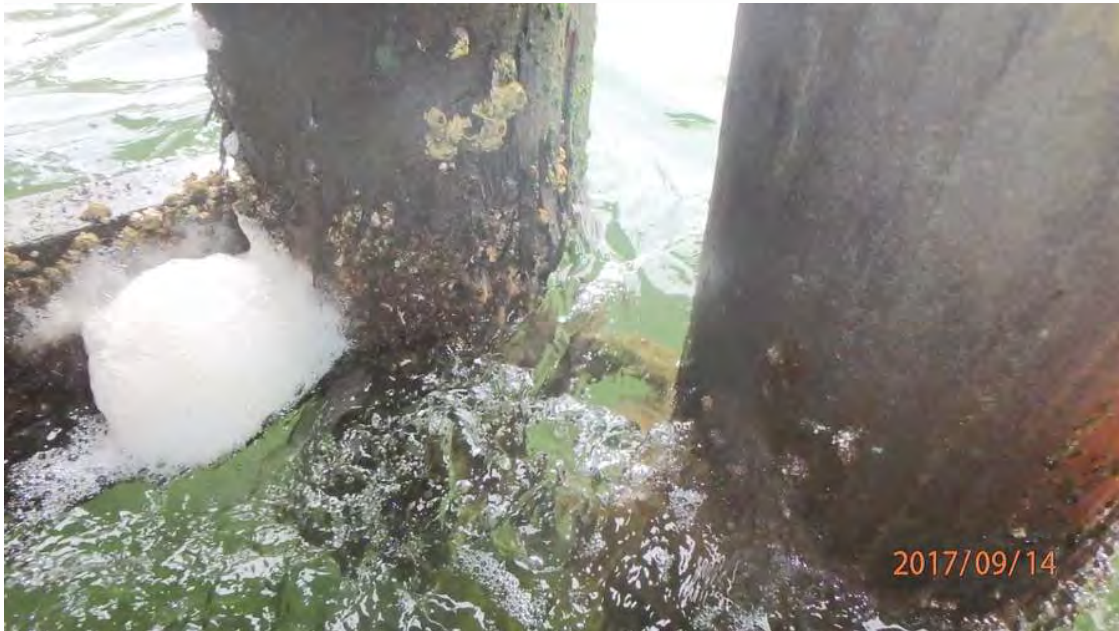
Photo 11: South end bent 7, southeast pile, notable abrasion/splintering in the tidal zone.

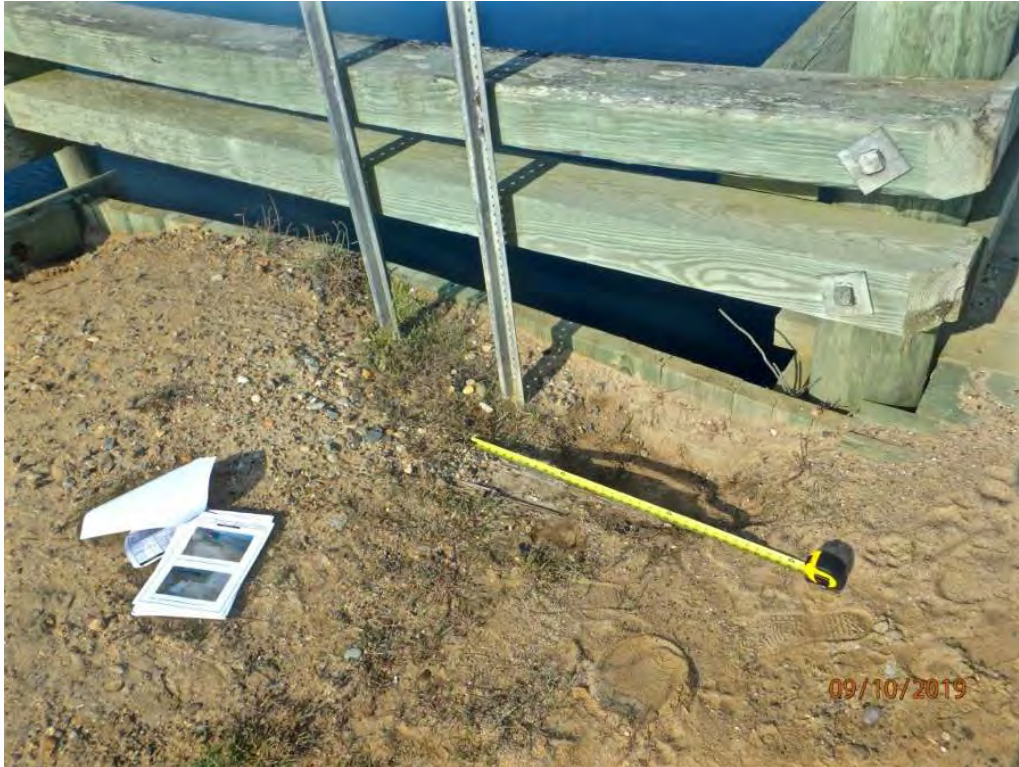
Photo 7: Southeast immediate approach roadway, corrective action taken since last inspection only minor erosion remains

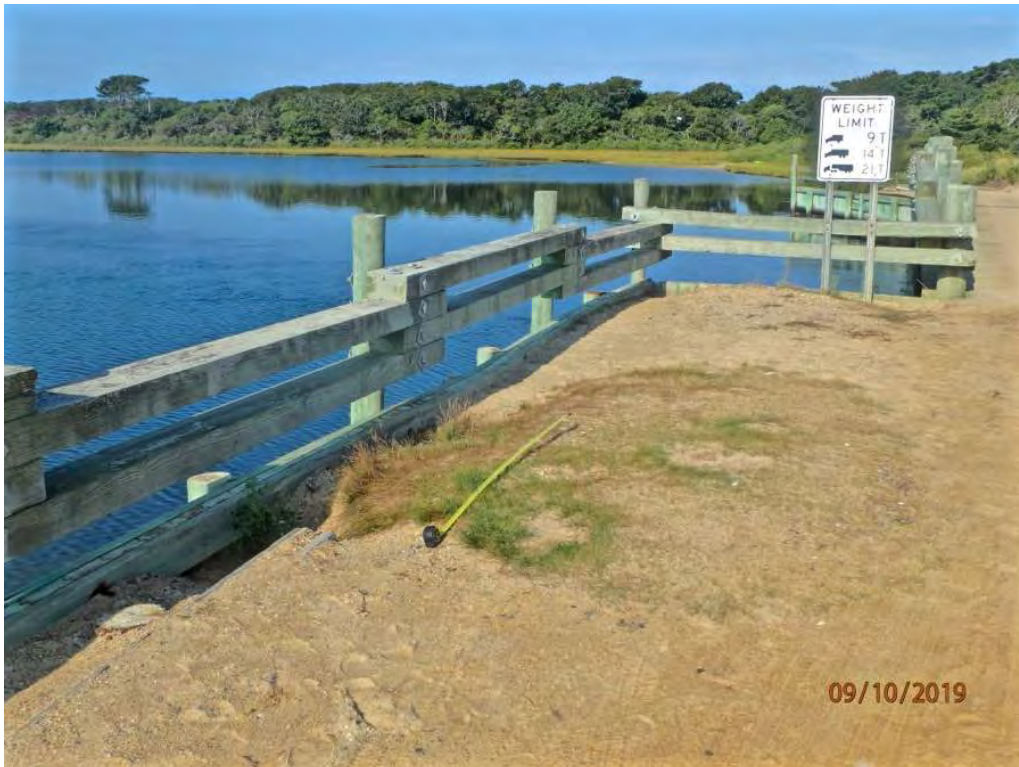
Photo 8: East approach along south wingwall bulkhead, correction action taken since last inspection moderate erosion remains

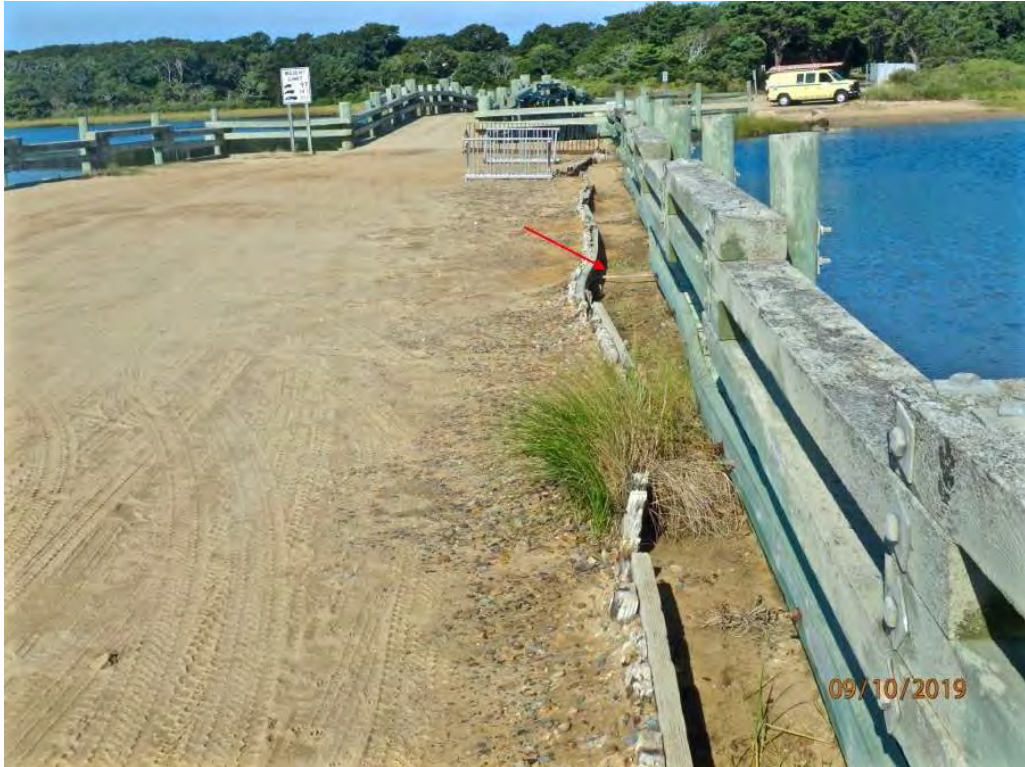
Photo 9: East approach along north wingwall bulkhead, erosion along abandoned bulkhead exposing tiebacks
