MASSACHUSETTS HIGHWAY DEPARTMENT
STRUCTURES INSPECTION FIELD REPORT

ROUTINE INSPECTION

BR. DEPT. NO. E-07-004

CITY/TOWN EDGARTOWN	8-STRUCTURE NO. E07004-43B-MUN-NBI	11-Kilo. POINT 001.046	41-STATUS A:OPEN	90-ROUTINE INSP. DATE SEP 16, 2003
07-FACILITY CARRIED HWY DIKE RD	MEMORIAL NAME/LOCAL NAME	27-YR BUILT 1995	106-YR REBUILT 0000	YR REHAB'D (NON 106) 0000
06-FEATURES INTERSECTED WATER POUCHA POND	26-FUNCTIONAL CLASS Rural Local	DIST. BRIDGE INSPECTION ENGINEER D. A. Palmer		
43-STRUCTURE TYPE Timber Stringer/Girder	22-OWNER Town Agency	21-MAINTAINER Town Agency	TEAM LEADER T. J. McKenna	
107-DECK TYPE Timber	WEATHER sunny	TEMP. (air) 70°C	TEAM MEMBERS S. R. WARN

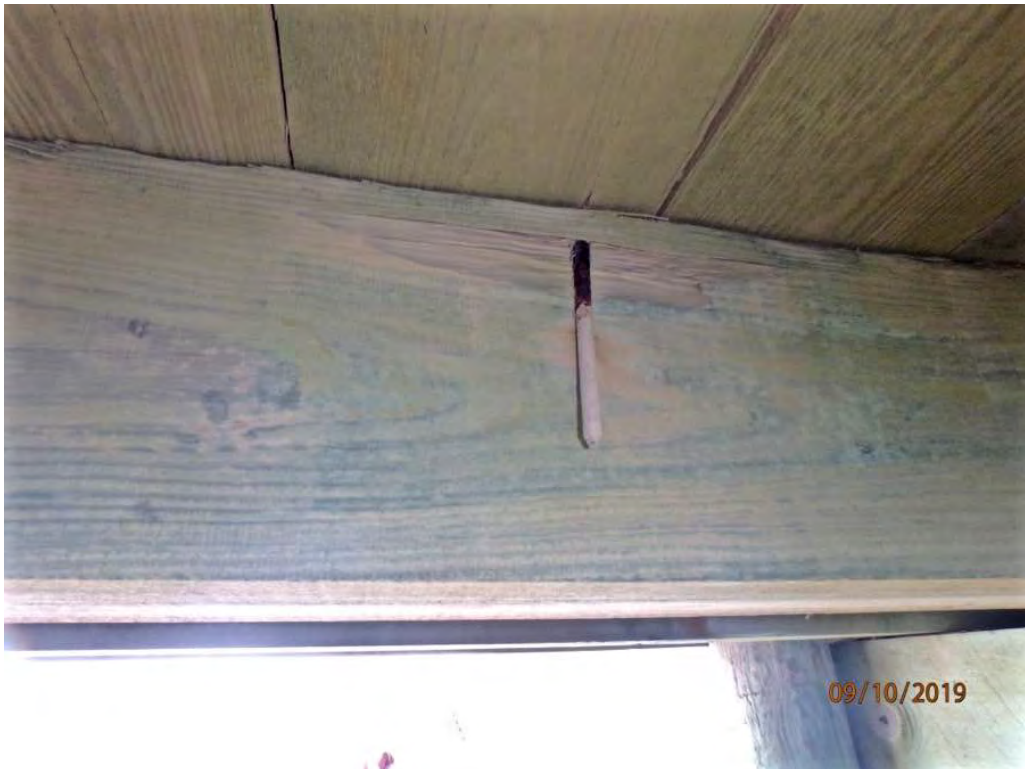
Photo 10: Span 2 Beam 2 north face, top edge split from misguided deck fastener

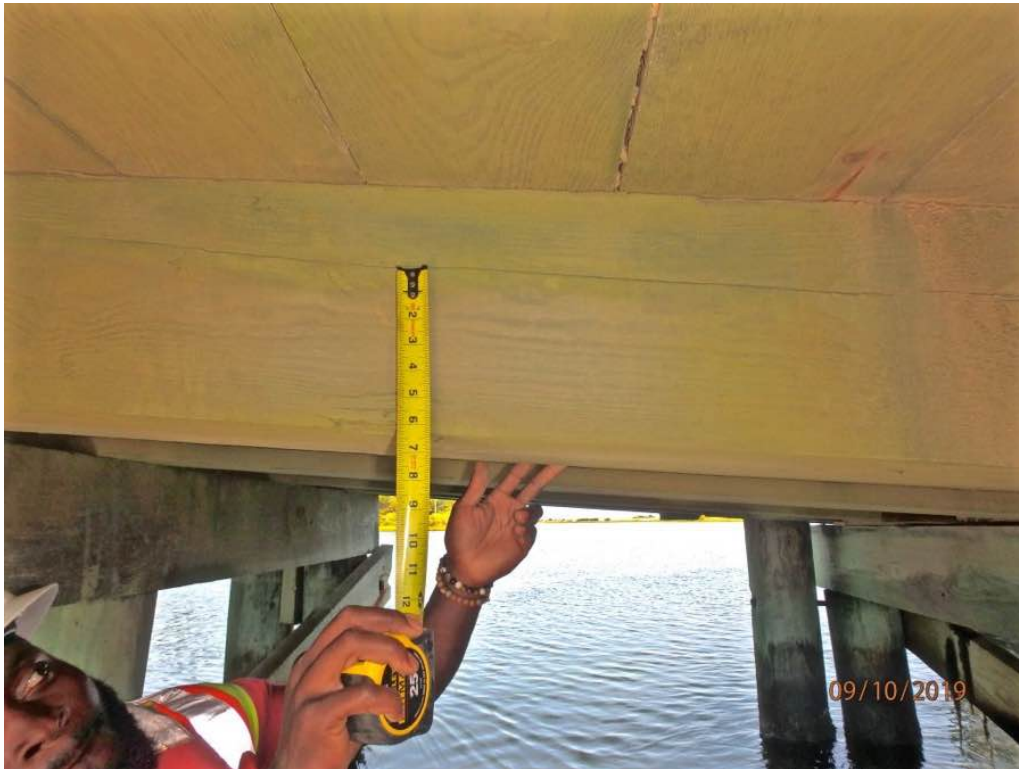
Photo 11: Span 7 Beam 2 south face, horizontal checking

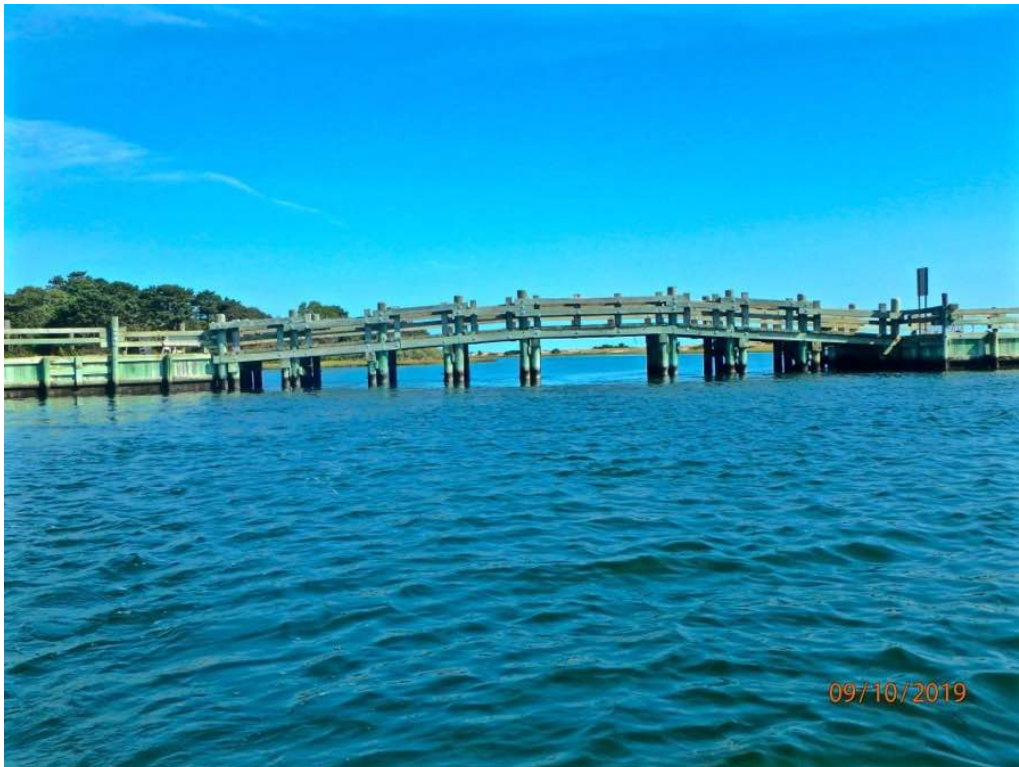
Photo 12: South elevation, typical vertical alignment of spans

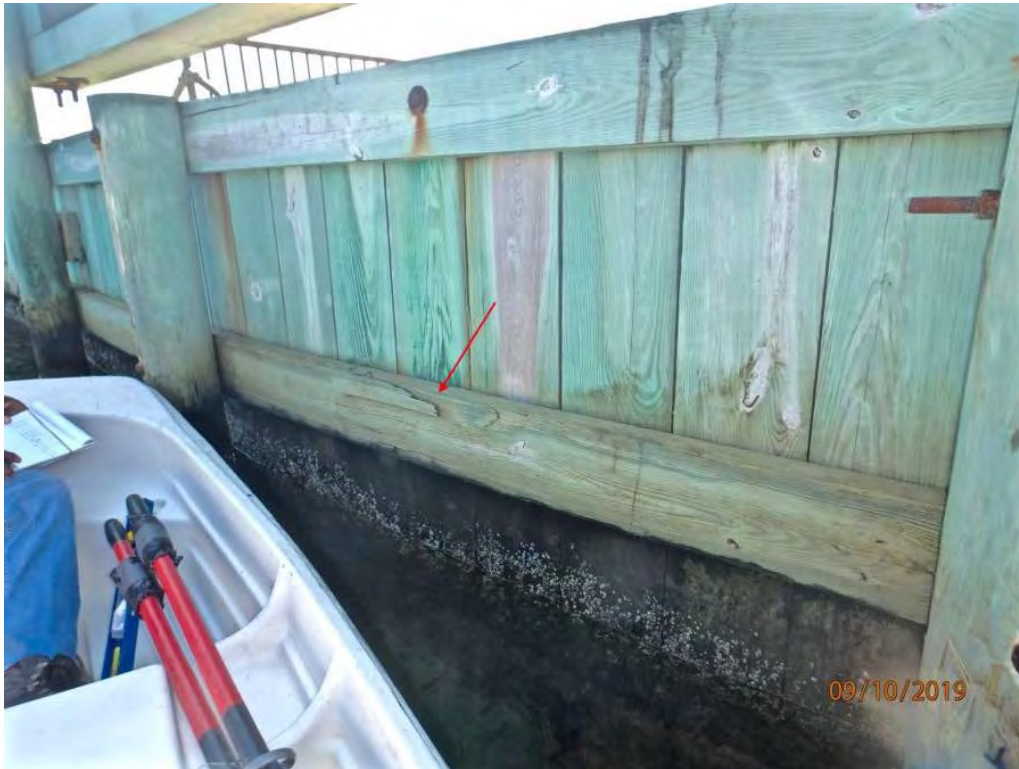
Photo 15: Northeast wingwall bulkhead between 1st & 2nd piles from west, split in middle wale

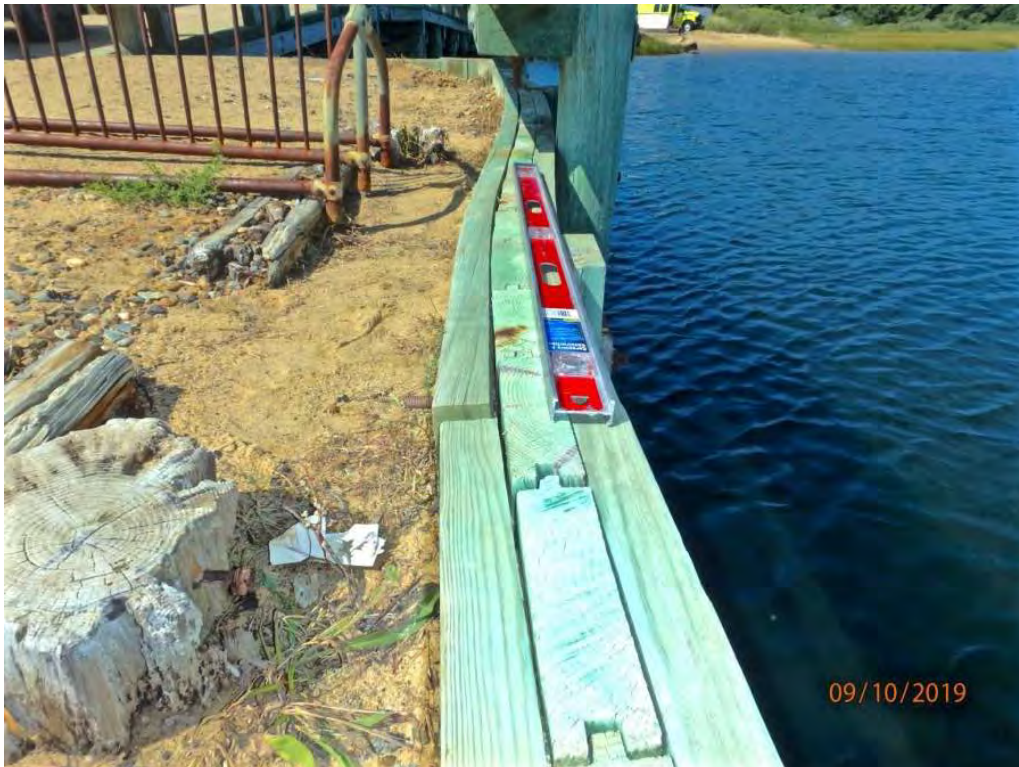
Photo 16: Northeast wingwall bulkhead at first tieback from west, bulging/bowing w/ gaps between sheathing & wales

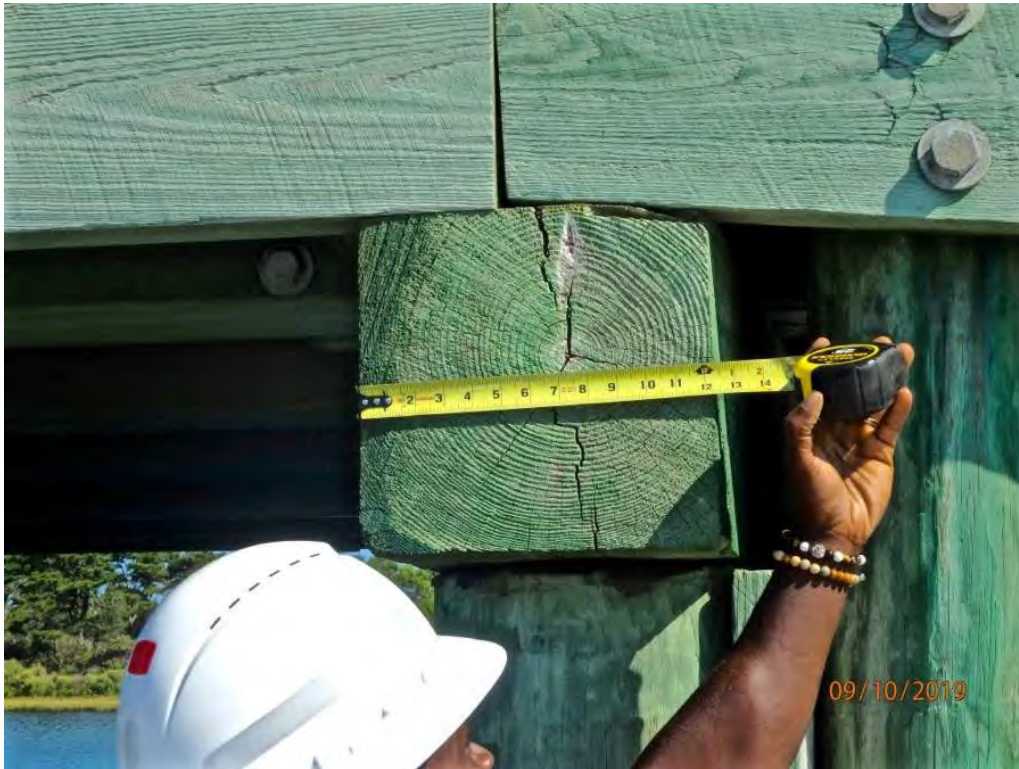
Bent 5 south face of cap, full height vertical end check $\leq 1/16$ "W, see photo 17.

Photo 17: Bent 5 south face of cap, vertical end check

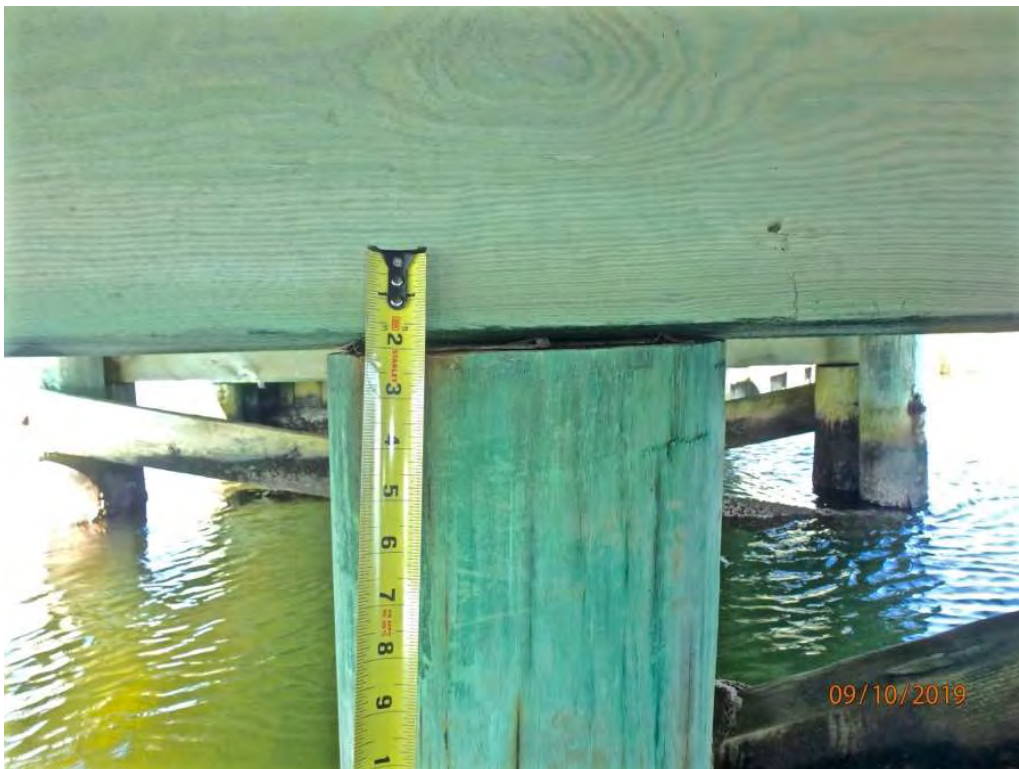
- Scattered irregular pile cutoffs reducing bearing area & creating 1/2" gaps between cap, see photo 18.
- Bent 1 southwest pile, minor wane with rust staining, previously reported rot was not observed, see photo 19.

- Photo 18 : Bent 2 center pile east face, irregular cutoff w/ gap between cap
- Photo 19 : Bent 1 south piles, minor wane w/ rust staining
- Photo 20 : Bent 7 north end of east diagonal bracing, corrosion of fastener hardware

Photo 18: Bent 2 center pile east face, irregular cutoff w/ gap between cap

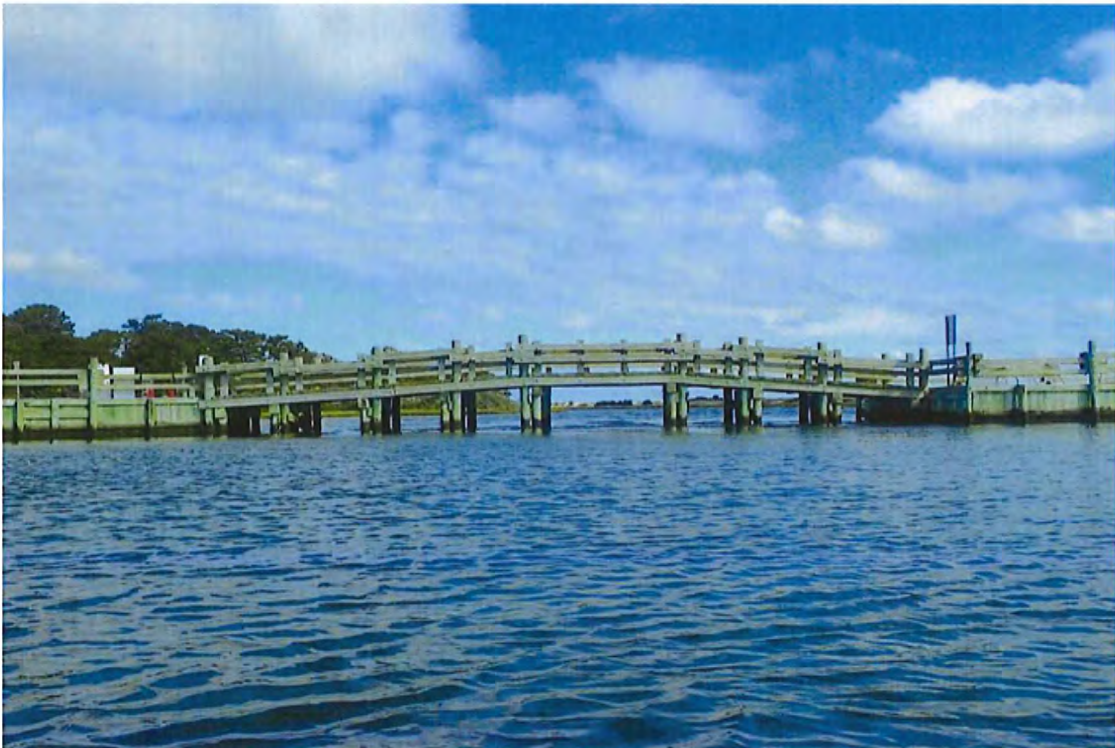
Photo 12: South elevation, typical vertical alignment of spans.

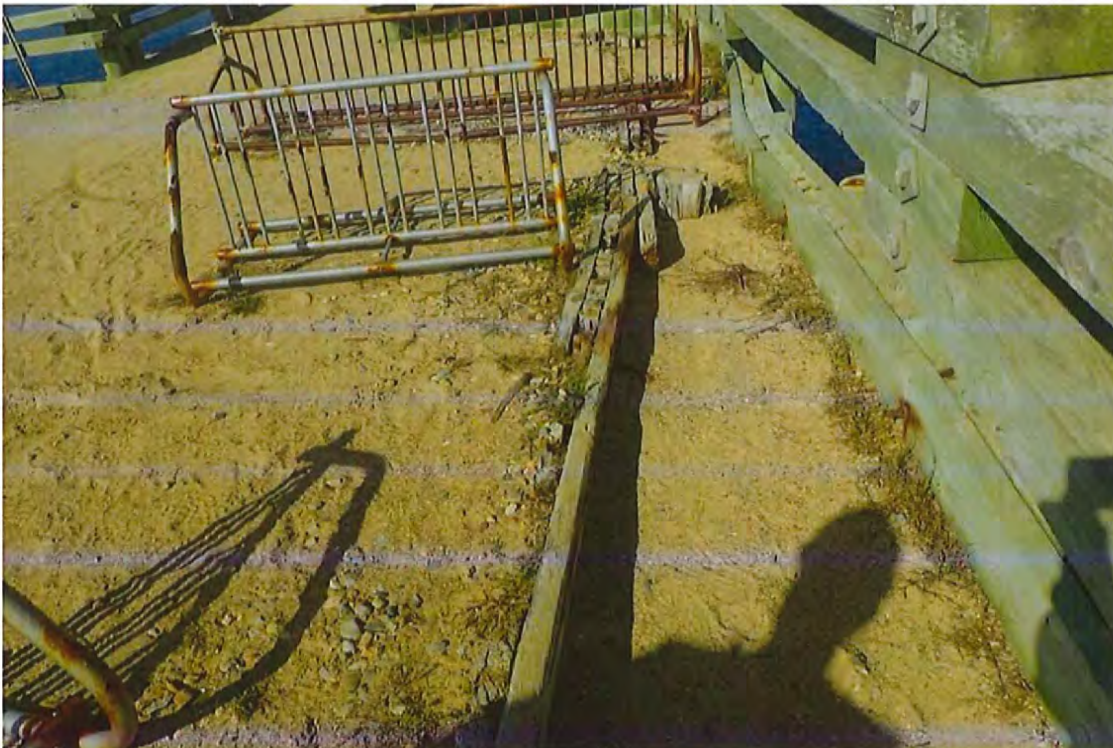
- All wingwall bulkheads exhibit minor mildew staining above tidal zone, surface checks and moderate to heavy marine growth within tidal zone, see photo 15.
- Both east wingwall bulkheads exhibit bulging/bowing ≤ 2 " seaward and gaps between sheathing & wales, worst at northeast wingwall bulkhead at first tieback from west, see photo 16.
- Northeast wingwall bulkhead between 1st & 2nd piles from west, split middle wale, see photo 15.
- **S/A : Northeast wingwall bulkhead at interface with abutment bulkhead, $\leq 1/2$ " gap allowing fill loss, see photo 14.**

- Photo 16 : Northeast wingwall bulkhead at first tieback from west, bulging/bowing w/ gaps between sheathing & wales.
- Photo 17 : Bent 5 south face of cap, vertical end surface checks.

Photo 16: Northeast wingwall bulkhead at first tieback from west, bulging/bowing w/ gaps between sheathing & wales.
