MASSACHUSETTS HIGHWAY DEPARTMENT
STRUCTURES INSPECTION FIELD REPORT

ROUTINE INSPECTION

BR. DEPT. NO. E-07-004

CITY/TOWN EDGARTOWN	8-STRUCTURE NO. E07004-43B-MUN-NBI	11-Kilo. POINT 001.046	41-STATUS A:OPEN	90-ROUTINE INSP. DATE SEP 16, 2003
07-FACILITY CARRIED HWY DIKE RD	MEMORIAL NAME/LOCAL NAME	27-YR BUILT 1995	106-YR REBUILT 0000	YR REHAB'D (NON 106) 0000
06-FEATURES INTERSECTED WATER POUCHA POND	26-FUNCTIONAL CLASS Rural Local	DIST. BRIDGE INSPECTION ENGINEER D. A. Palmer		
43-STRUCTURE TYPE Timber Stringer/Girder	22-OWNER Town Agency	21-MAINTAINER Town Agency	TEAM LEADER T. J. McKenna	
107-DECK TYPE Timber	WEATHER sunny	TEMP. (air) 70°C	TEAM MEMBERS S. R. WARN

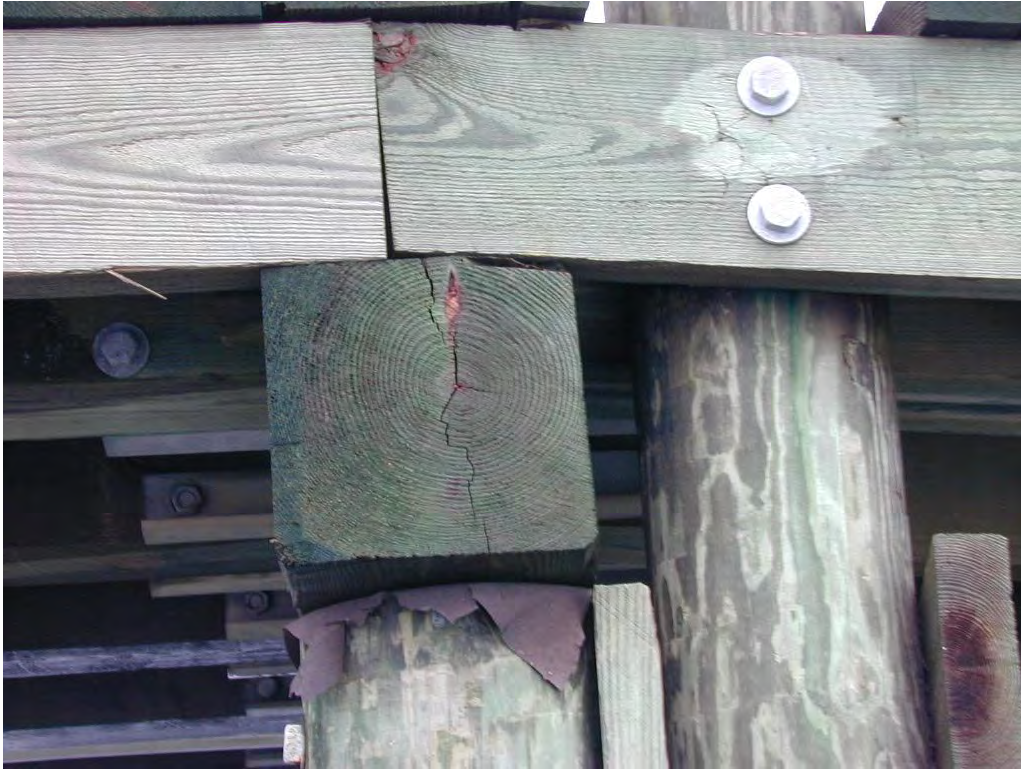
Photo 3: Sixth cap from west, south end, split

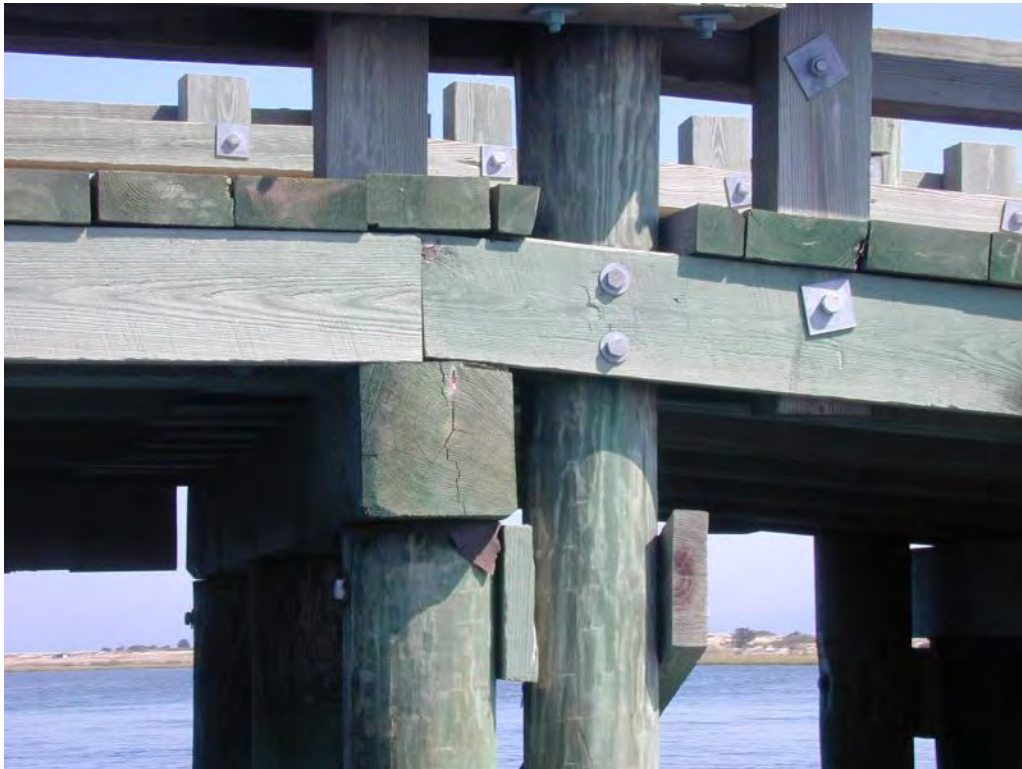
Photo 3: Sixth cap from West South nose split.

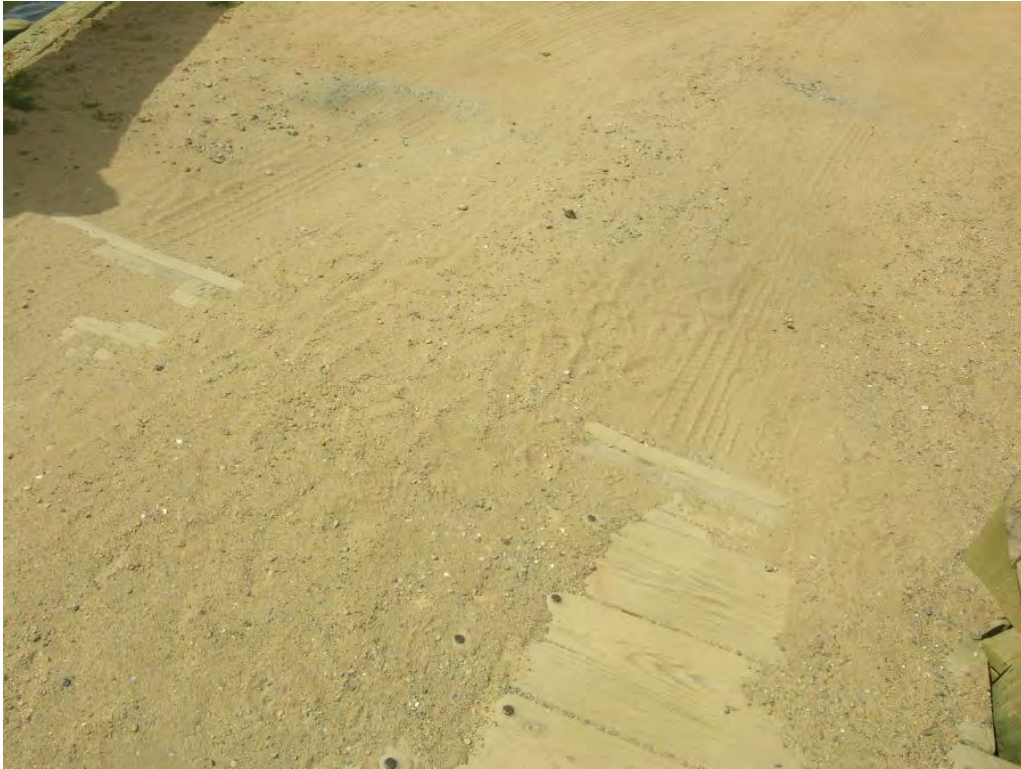
Photo 3: West approach settlement.

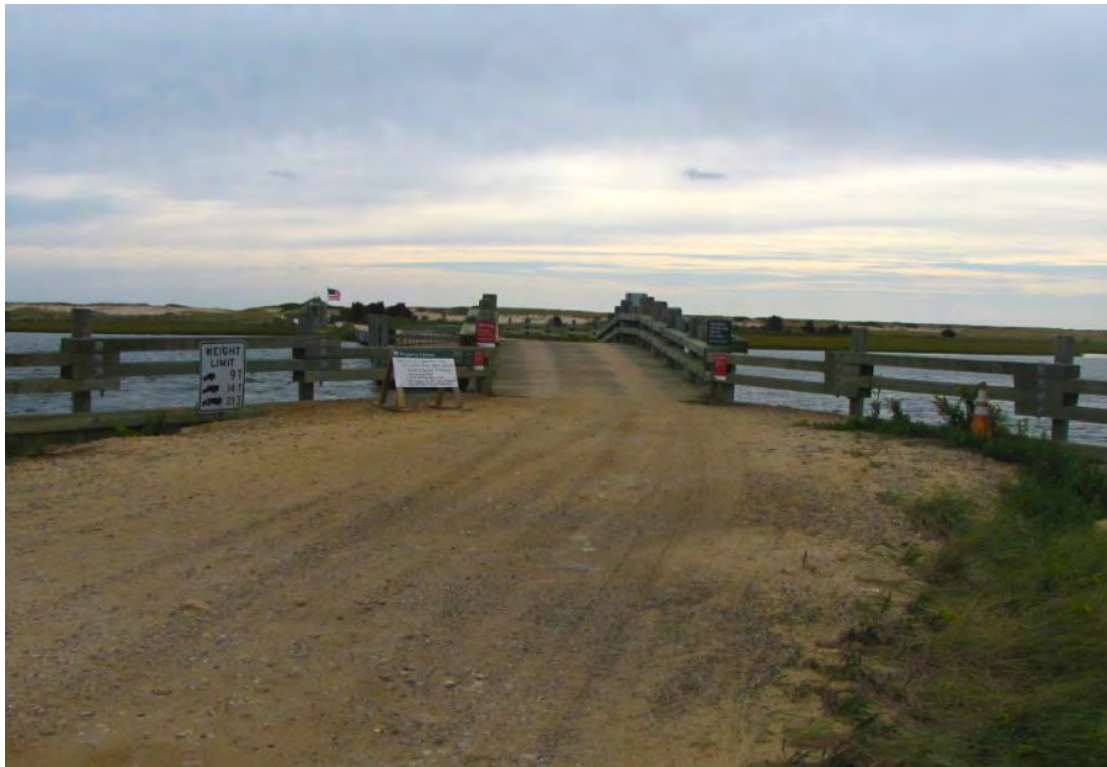
Photo 10: Overview of west approach

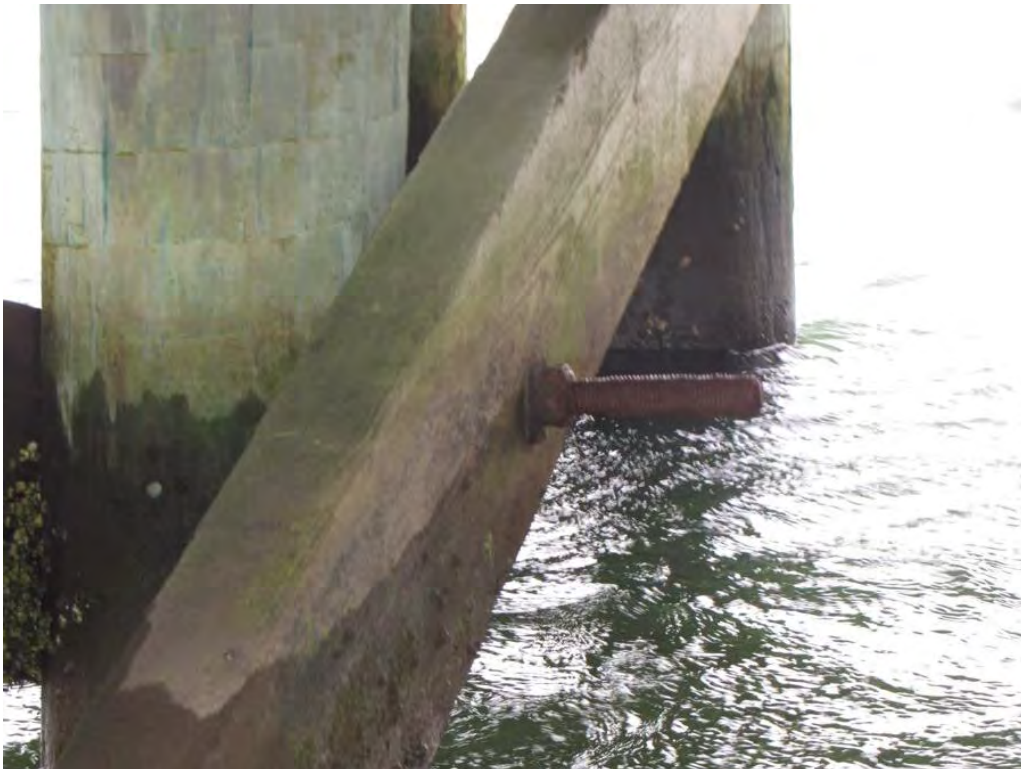
Photo 20: Isolated bolt starting to neck near nut
